U.S. Efforts in Support of Examinations at Fukushima Daiichi - 2019 Evaluations

Nuclear Engineering Division

U. S. Department of Energy - Office of Nuclear Energy

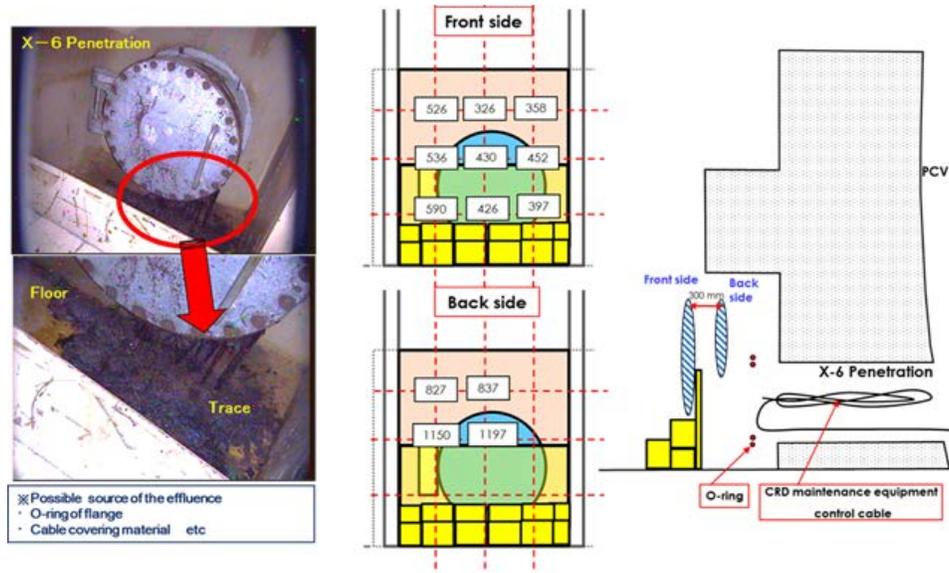
Figure 3-1. Photographs and radiation surveys (in mSv/hr) near 1F2 X-6 penetration (values measured in 13 locations). (Courtesy of TEPCO Holdings [12,14])

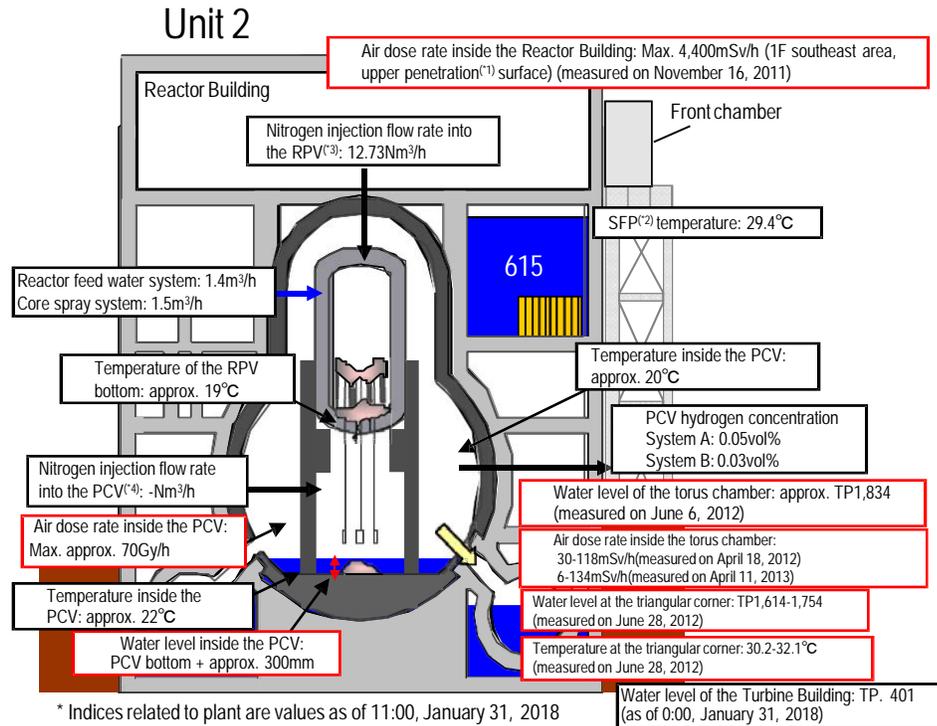
Figure 4-5 summarizes dose measurements and surveys within the 1F2 reactor building at selected times. This figure also provides indications of the current temperature and water level at selected locations within the reactor building. 1F2 air does rates within the reactor building are slightly lower than 1F1 values but nearly an order of magnitude higher in the PC. The higher PCV air dose rates may be partially due to the lower water levels in 1F2.

Figure 4-5. 1F2 status. (Courtesy of TEPCO Holdings [130])

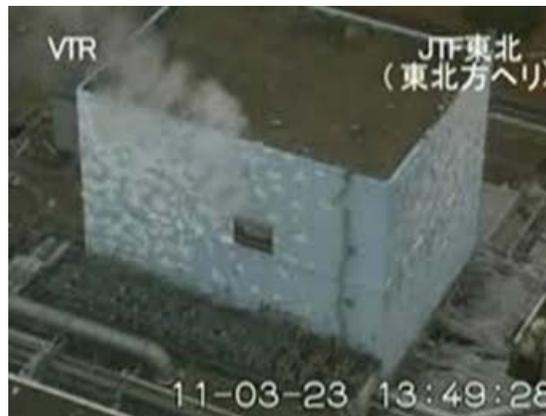
Currently, personnel access to the 1F2 reactor building is less restricted than at 1F1; combustion of any flammable gas leakage from containment impairments did not occur at 1F2. This is likely due to the opening of the reactor building blowout panel on the refueling floor, which occurred due to gas rarefaction following the pressure waves propagating away from the 1F1 reactor building flammable gas explosion. (Figure 4-6 shows the open blowout panel in the 1F2 reactor building).

Figure 4-6. 1F2 reactor building with open blowout panel. (Courtesy of TEPCO Holdings [173])

The hydrogen explosion at 1F1 significantly hindered other recovery efforts. Debris from the explosion damaged power lines that had been laid down at 1F2 as well as the power lines being readied at 1F3. This adversely impacted work being done to restore power at both 1F2 and 1F3. In addition, as discussed in Section 4.3.2, it is believed that pressure waves from the 1F1 explosion caused the 1F2 reactor building blowout panel to open (see Figure 4-6). This opening is believed to have averted an explosion in the 1F2 building because it allowed any accumulated hydrogen to vent.

Currently, personnel access to the 1F2 reactor building is less restricted than at 1F1; combustion of any flammable gas leakage from containment impairments did not occur at 1F2. This is likely due to the opening of the reactor building blowout panel on the refueling floor, which occurred due to gas rarefaction following the pressure waves propagating away from the 1F1 reactor building flammable gas explosion (see Figure 4-6).

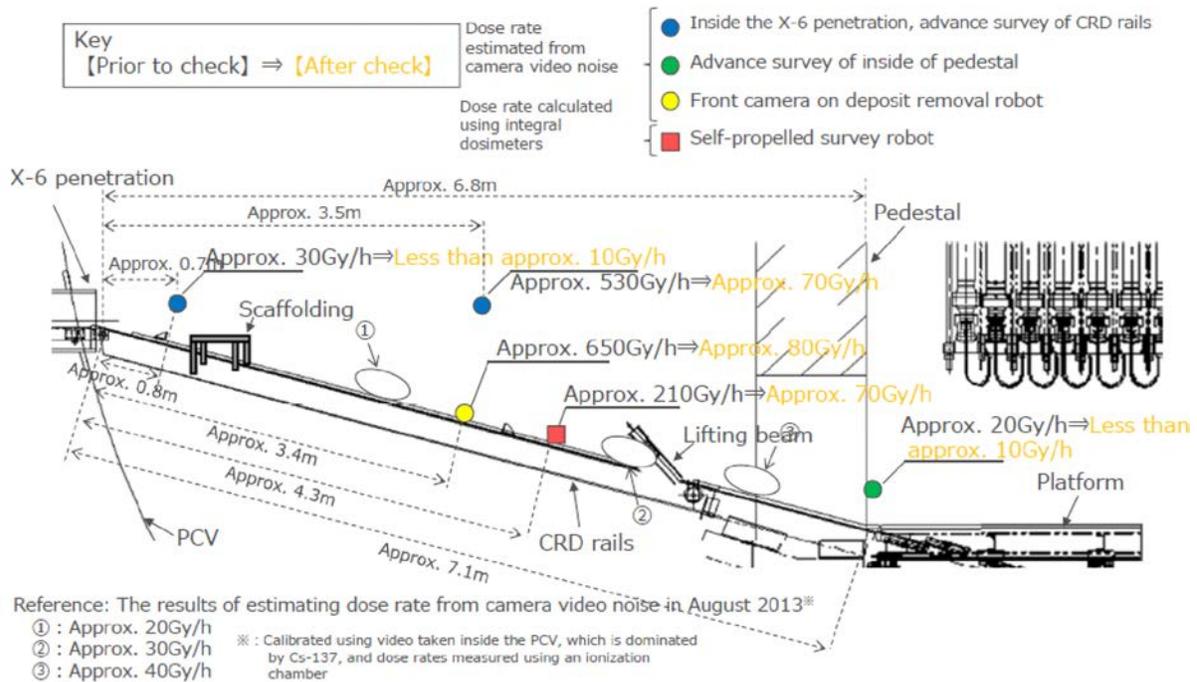
Figure 4-7. Dose revisions calculated during subsequent analysis of 1F2 entry. (Courtesy of TEPCO Holdings [174])

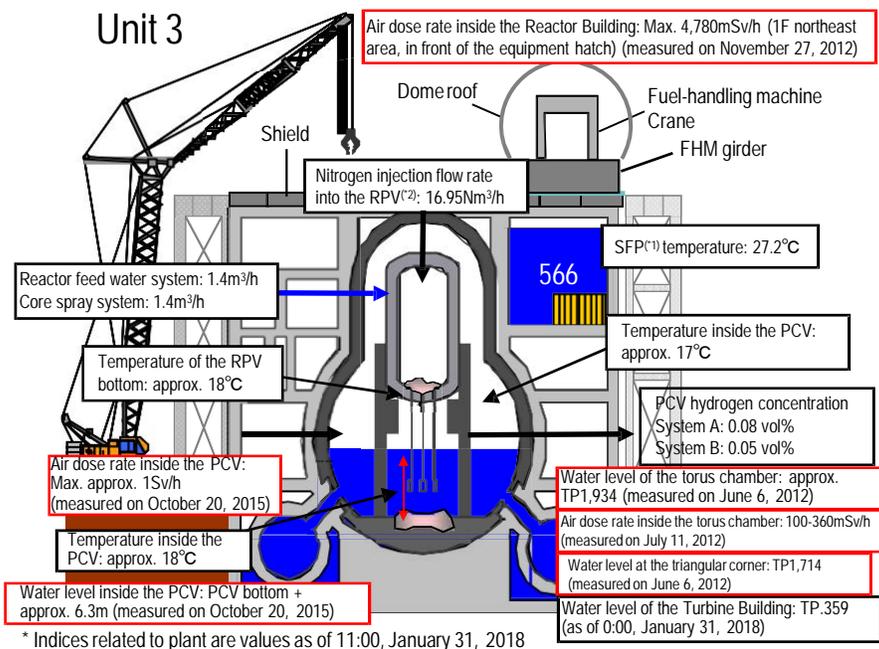
Figure 4-8. 1F3 status. (Courtesy of TEPCO Holdings [130])

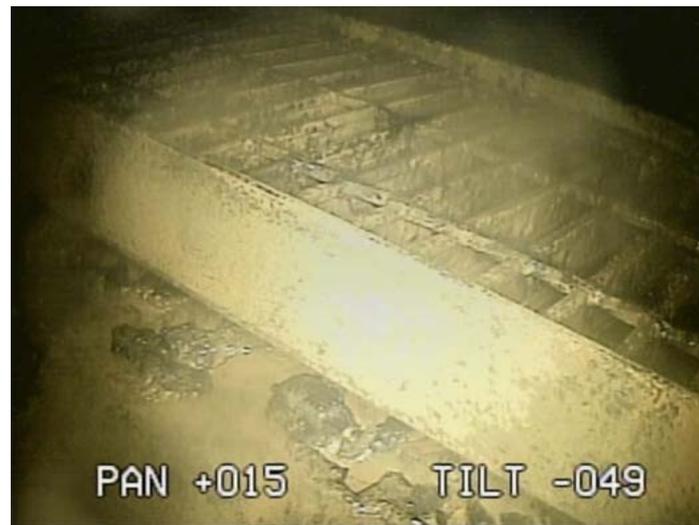
the PCV has been gained through the X-6 penetration, allowing robot access to the CRD exchange rail (Figure 5-1). The initial investigations [196-198] revealed the presence of black material laying on the surface of the exchange rail near the CRD platform (Figure 5-2). The composition of the black material has not been determined. Possibilities include melted CRD cabling insulation or core material. Thus, evaluations of this material could provide evidence of the temperatures that the below vessel structure experienced during the accident, as well as possibly confirming lower head failure if the material contains a significant amount of core debris. .

Figure 5-2. Photograph of CRD exchange rail surface near the CRD platform showing the presence of black material. (Courtesy of TEPCO Holdings [196])

Valuable data continues to emerge from 1F2 examinations [158, 160, 164] to augment the initial findings reported in late 2016 and early 2017.[196-199] Access inside the PCV has been gained through the X-6 penetration, allowing robot access to the CRD exchange rail (Figure G-12). The initial investigations [196-198] revealed the presence of black material laying on the surface of the exchange rail near the CRD platform (Figure 5-2). The composition of the black material has not been determined. Possibilities include melted CRD cabling insulation or core material. Thus, evaluations of this material could provide evidence of the temperatures that below vessel structure experienced during the accident, as well as possibly confirming lower head failure if the material contains a significant amount of core debris.

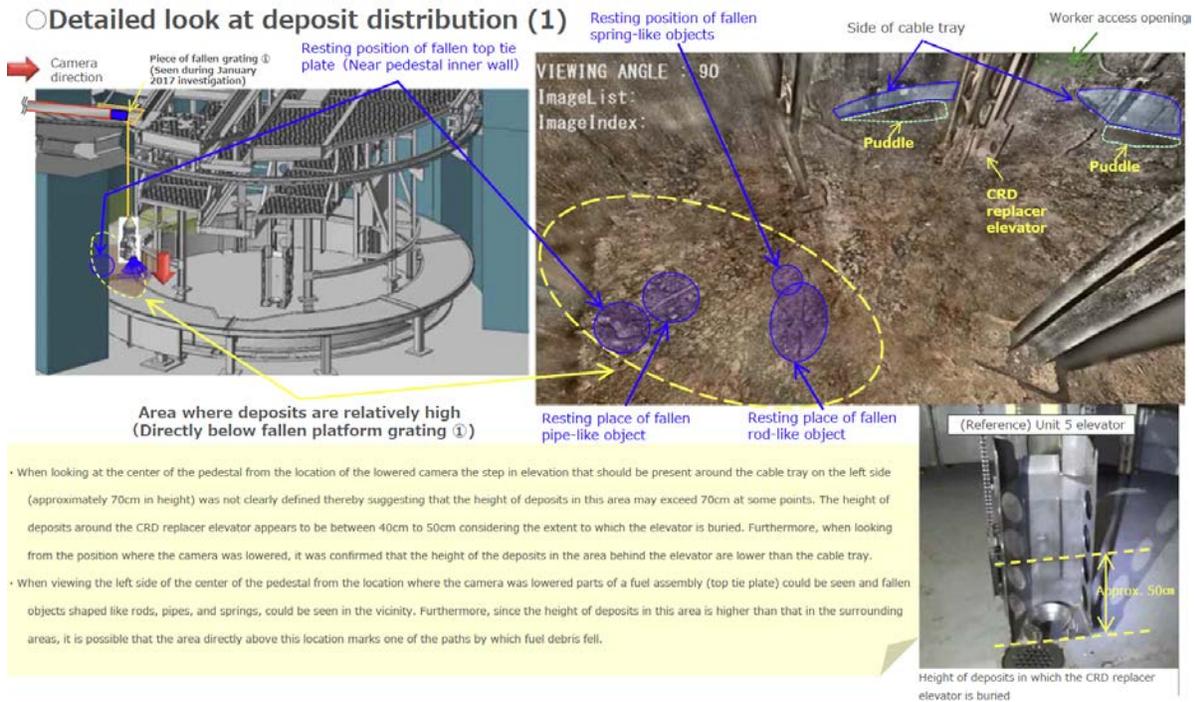
Figure 5-3. Characteristics of core debris on the floor inside the pedestal of 1F2. (Courtesy of TEPCO Holdings [160])

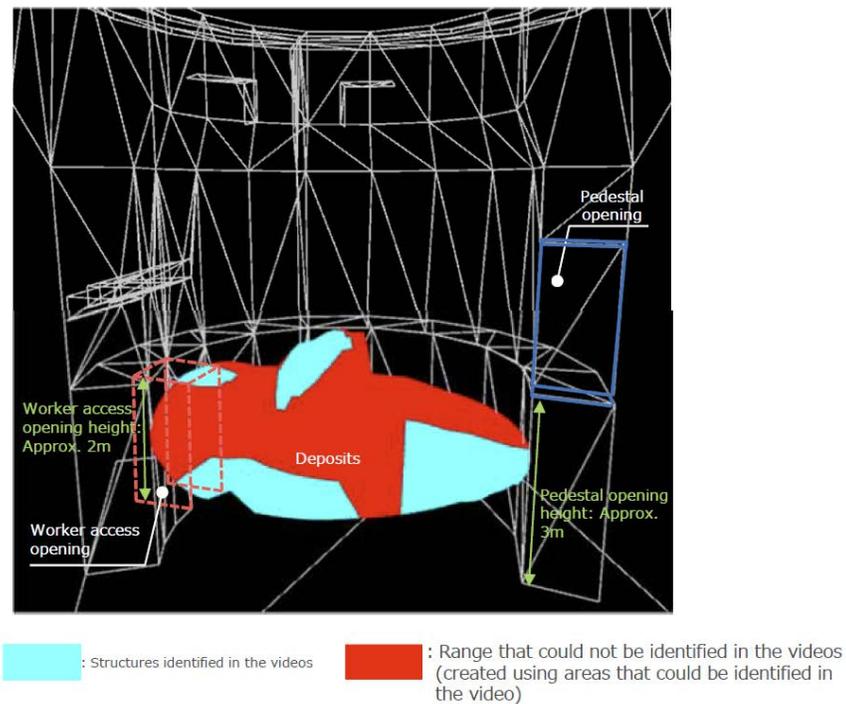
Figure 5-5. 3-D reconstruction of core debris distribution in the pedestal region of 1F3. (Courtesy of TEPCO Holdings [161])

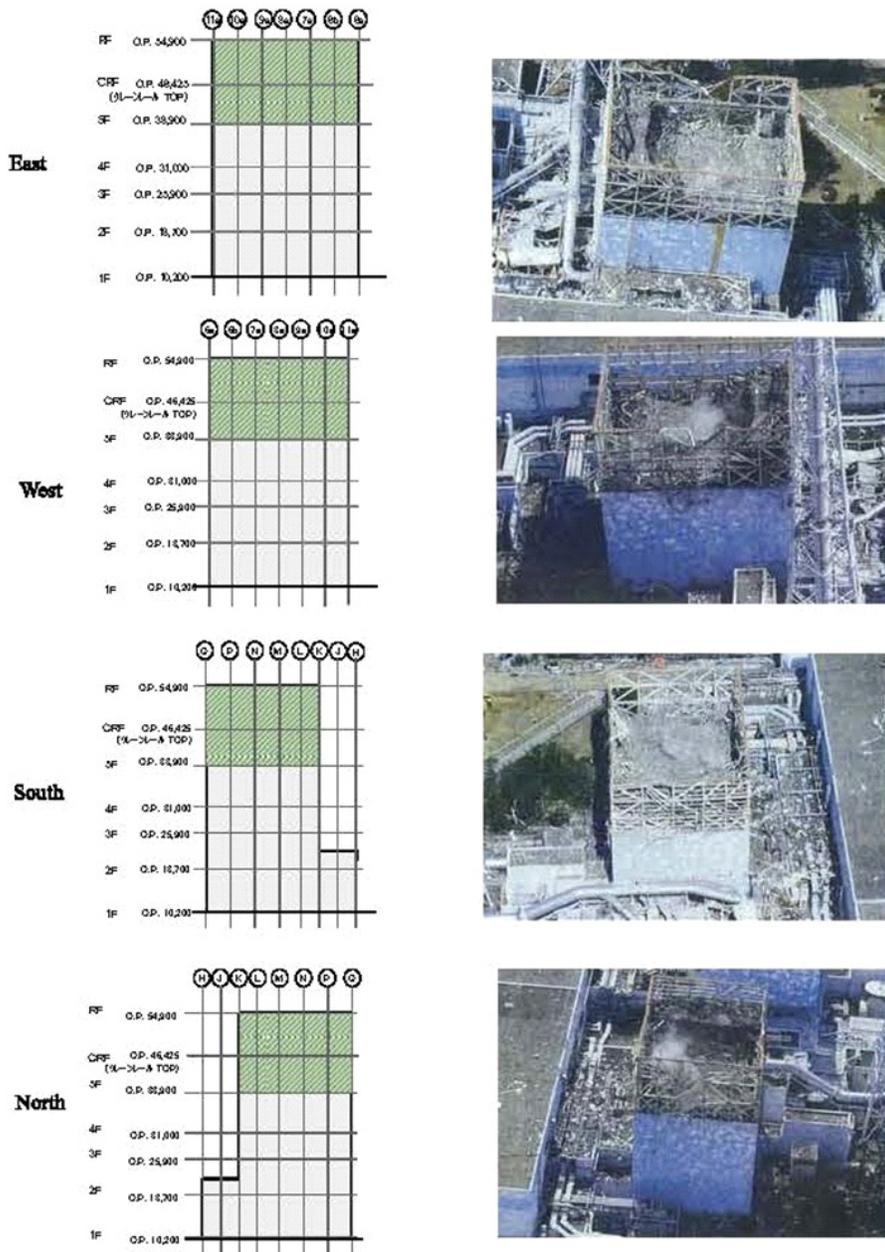
Figure 6-1. 1F1 reactor building damage following explosion. (Courtesy of TEPCO Holdings [208])

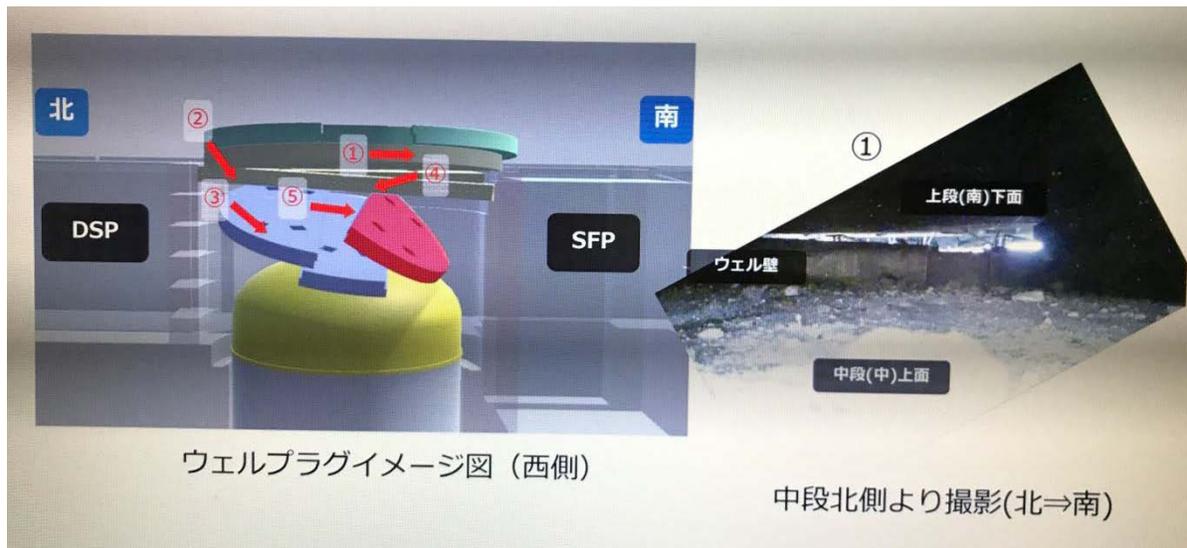
Figure 6-2. Dislocation of 1F1 drywell head shield plugs. (Courtesy of TEPCO Holdings [213])

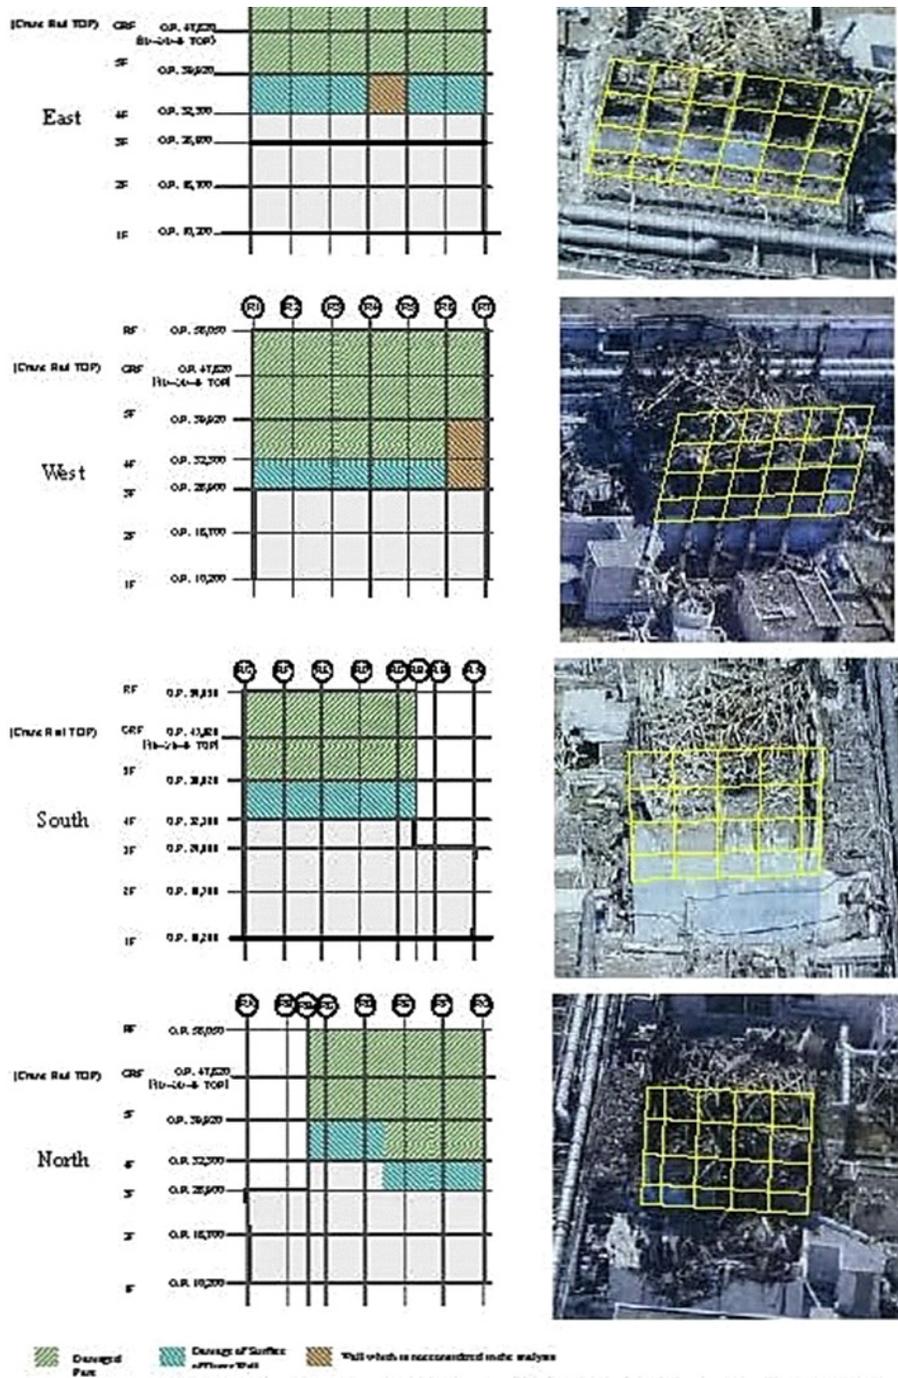
Figure 6-3. 1F3 reactor building damage following explosion. (Courtesy of TEPCO Holdings [209])

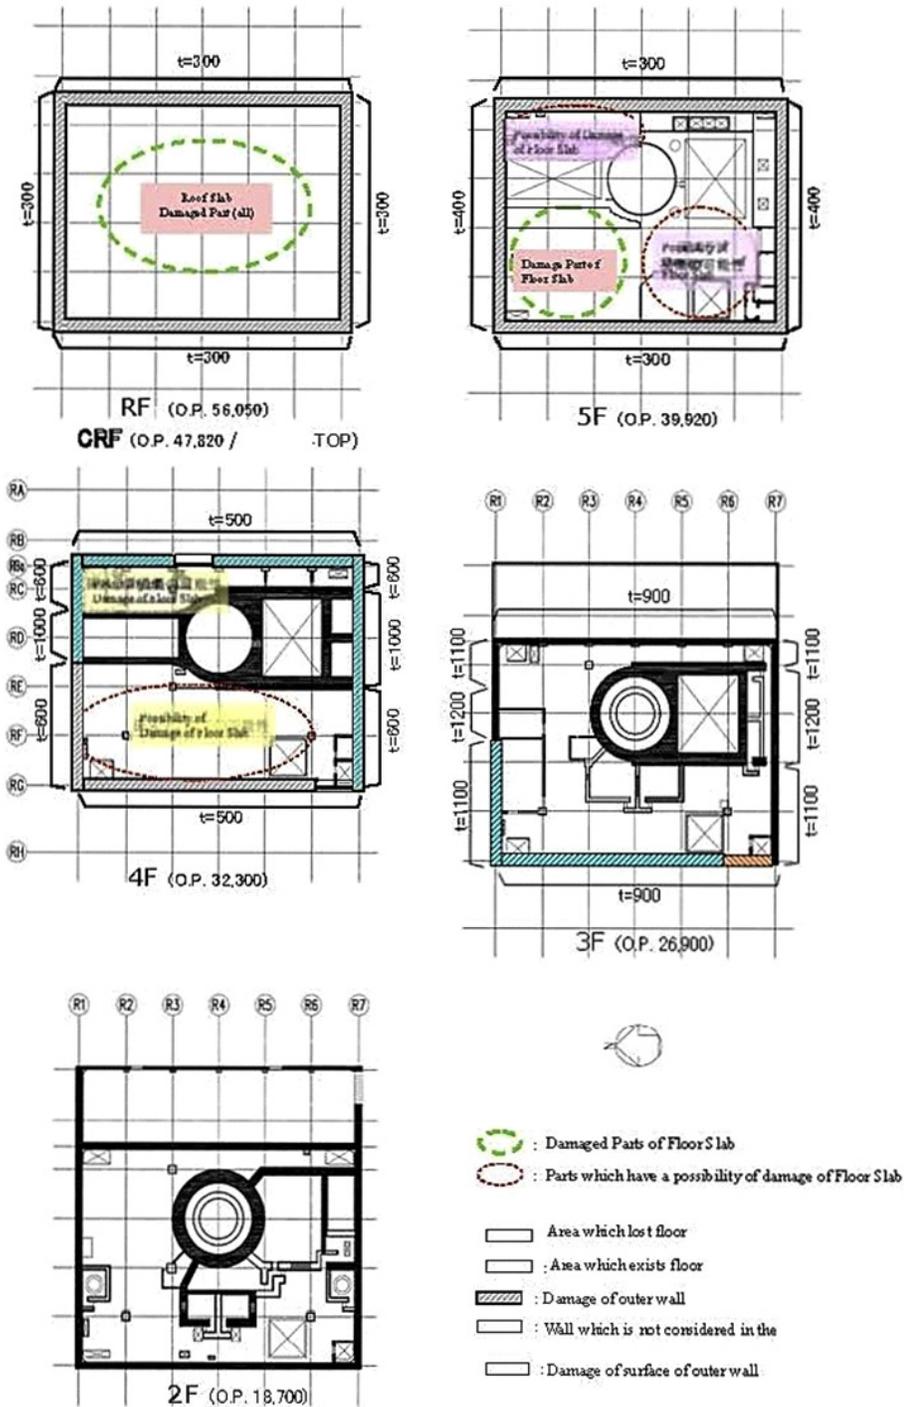
Figure 6-4. Damaged areas on 1F3 reactor building floor plan. (Courtesy of TEPCO Holdings [209])

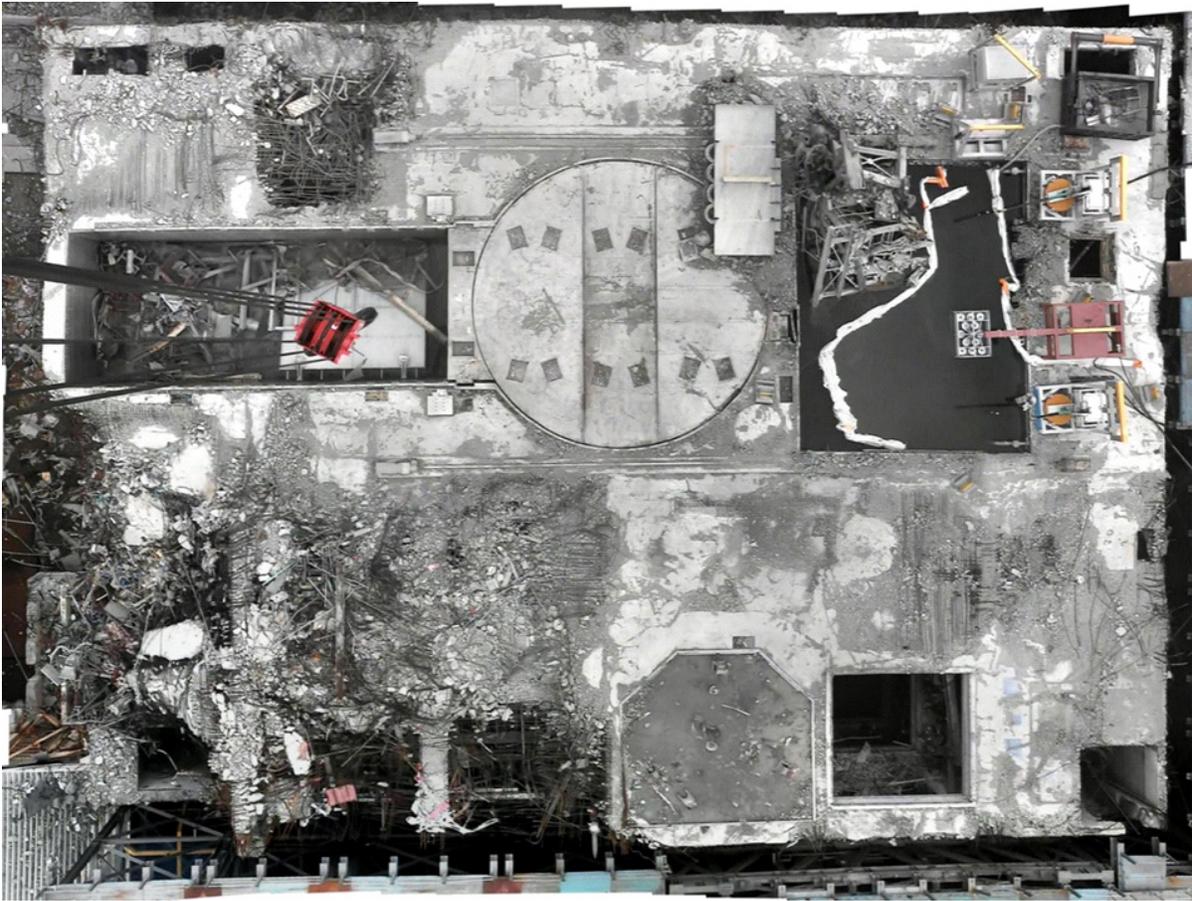
Figure 6-5. Damaged areas on 1F3 reactor building floor. (Courtesy of TEPCO Holdings [17])

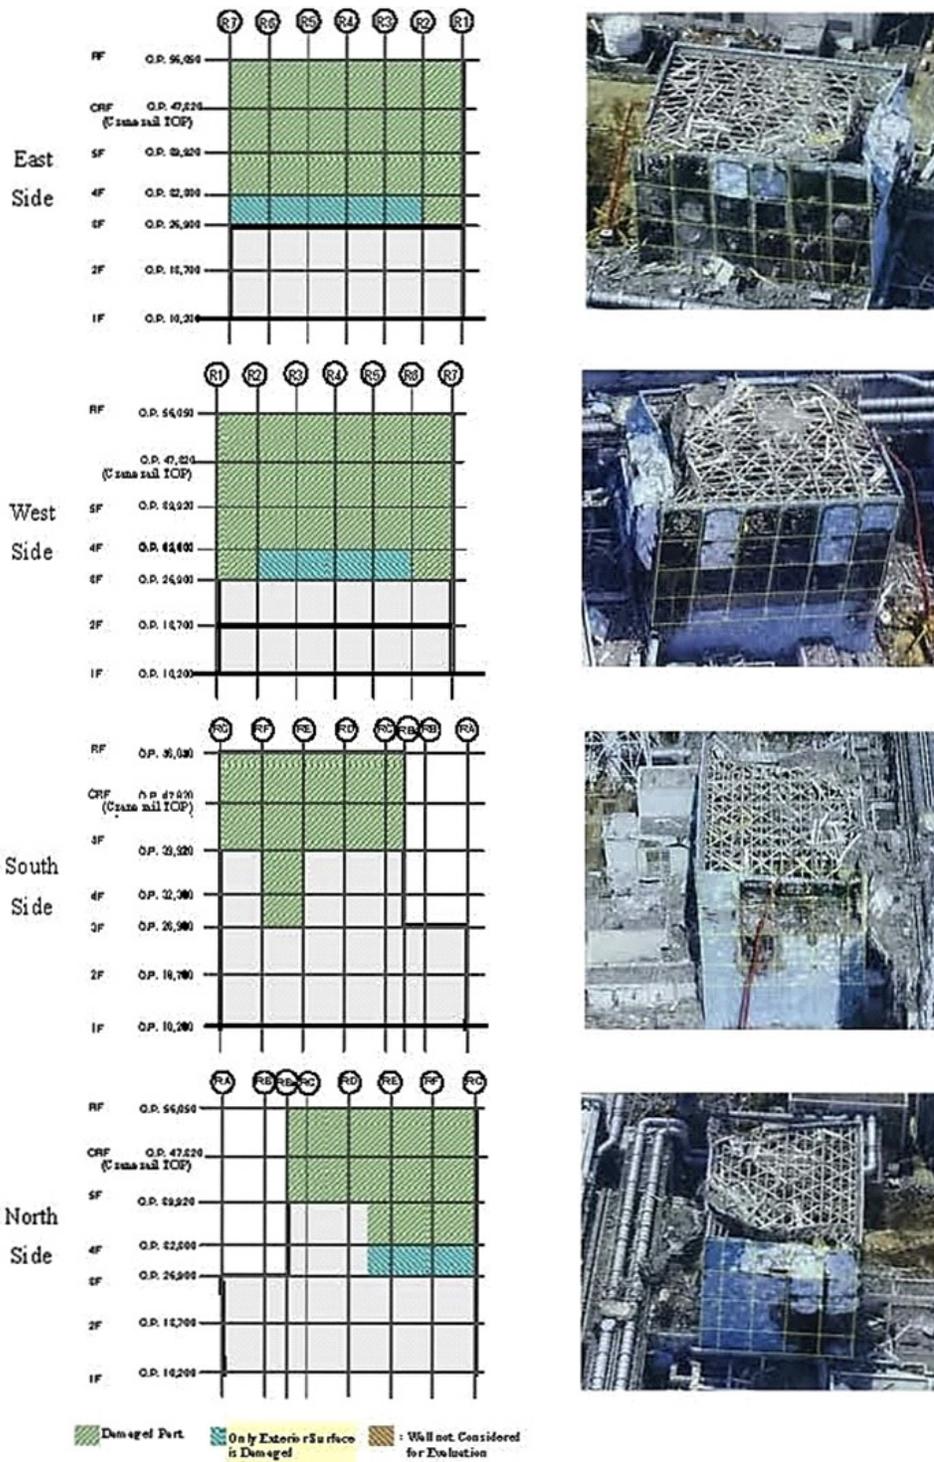
Figure 6-6. 1F4 reactor building damage following explosion. (Courtesy of TEPCO Holdings [208])

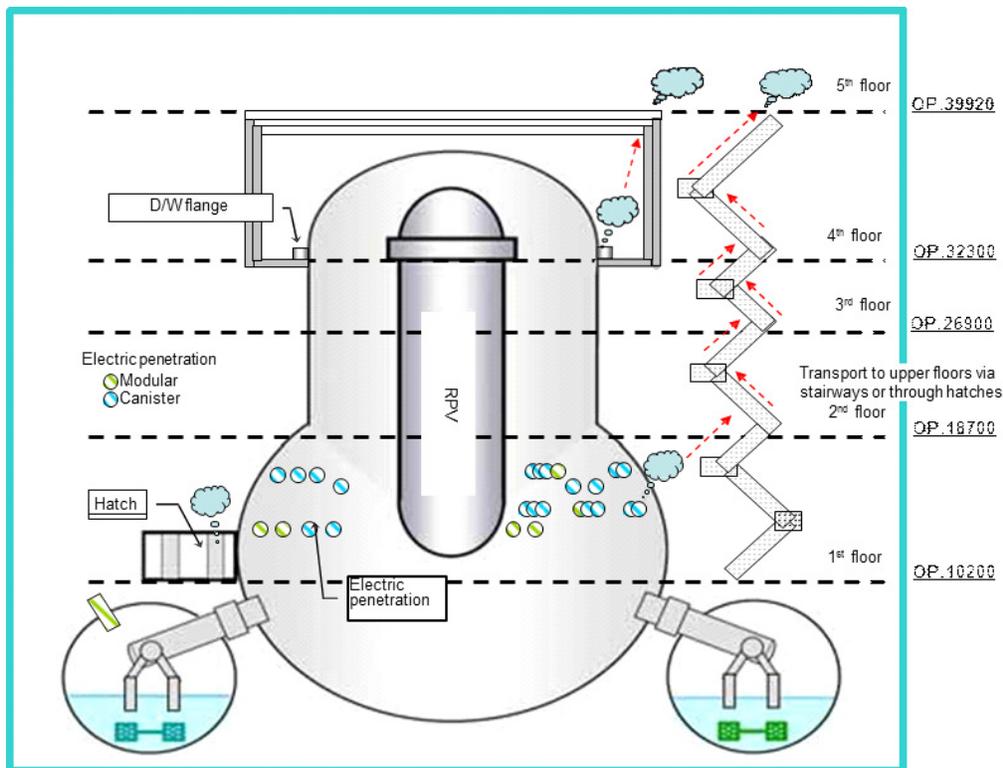
Figure 6-7. Inferred leakage paths; flow paths differ from 1F1 and 1F3 due to system configuration. (Courtesy of TEPCO Holdings [211])

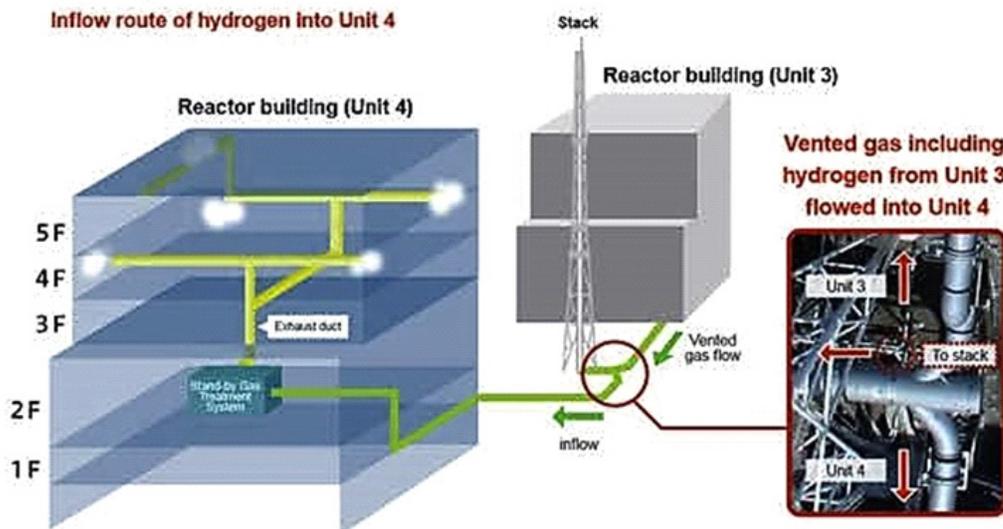
Figure 6-8. Hydrogen transport path from 1F3 to 1F4. (Courtesy of TEPCO Holdings [210])

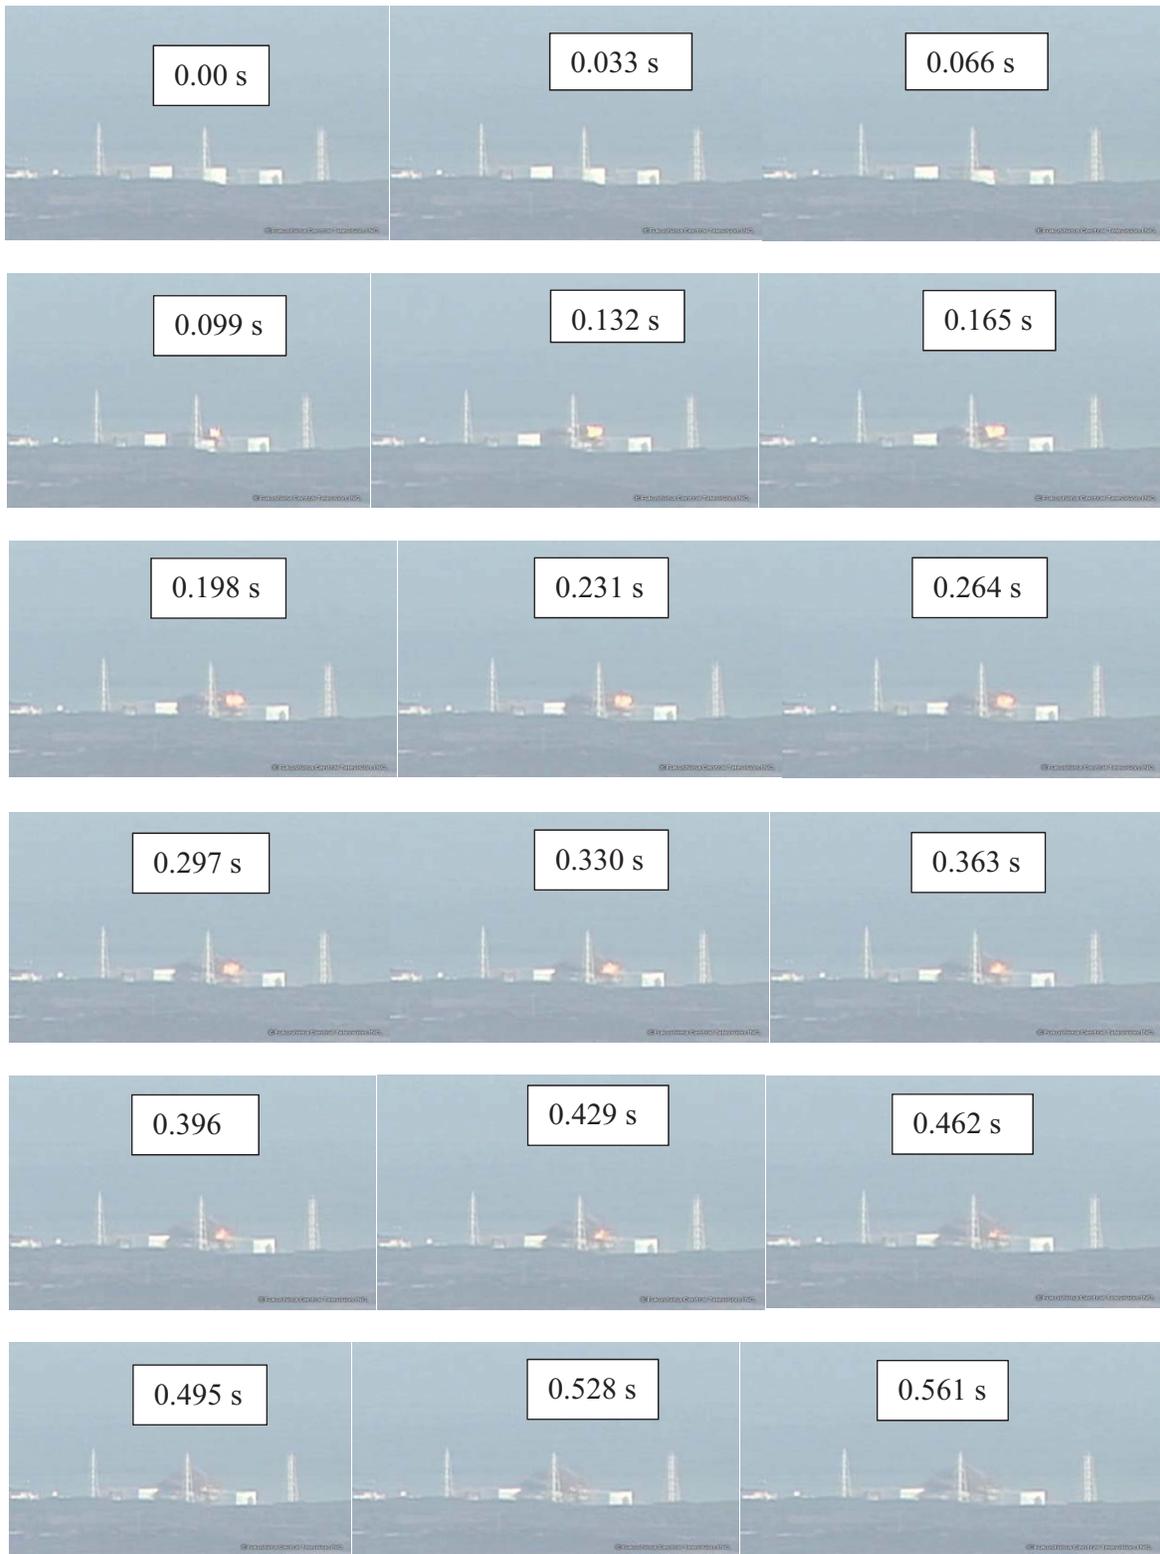
Figure 6-12. Images of 1F3 explosions during an appearance of a flash fire. (Courtesy of FCT [214])

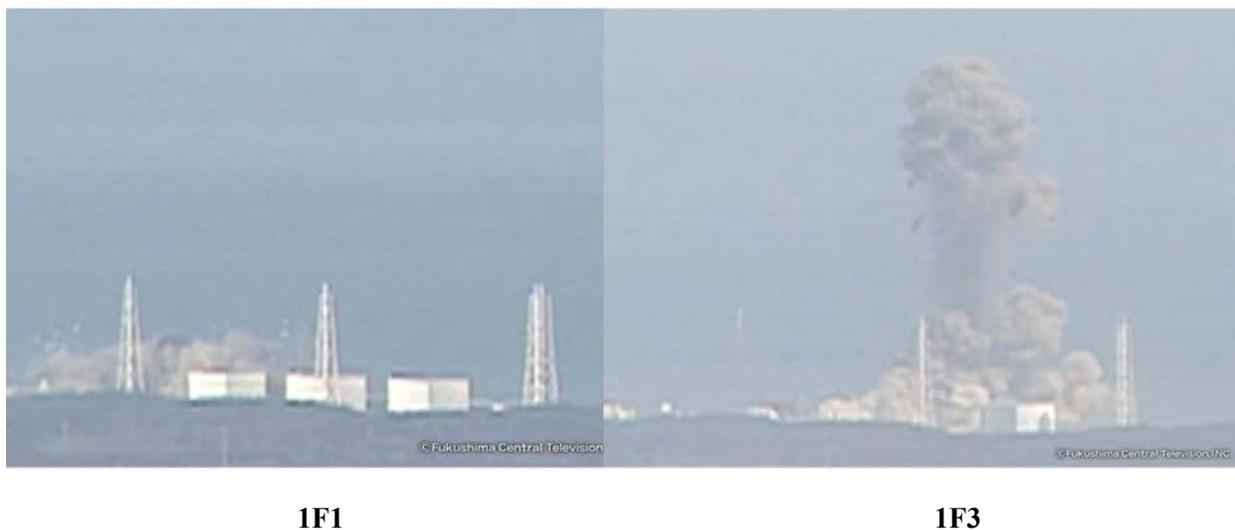
Figure 6-14. Images of 1F1 explosion compared with 1F3 explosion. (Courtesy of FCT [214])

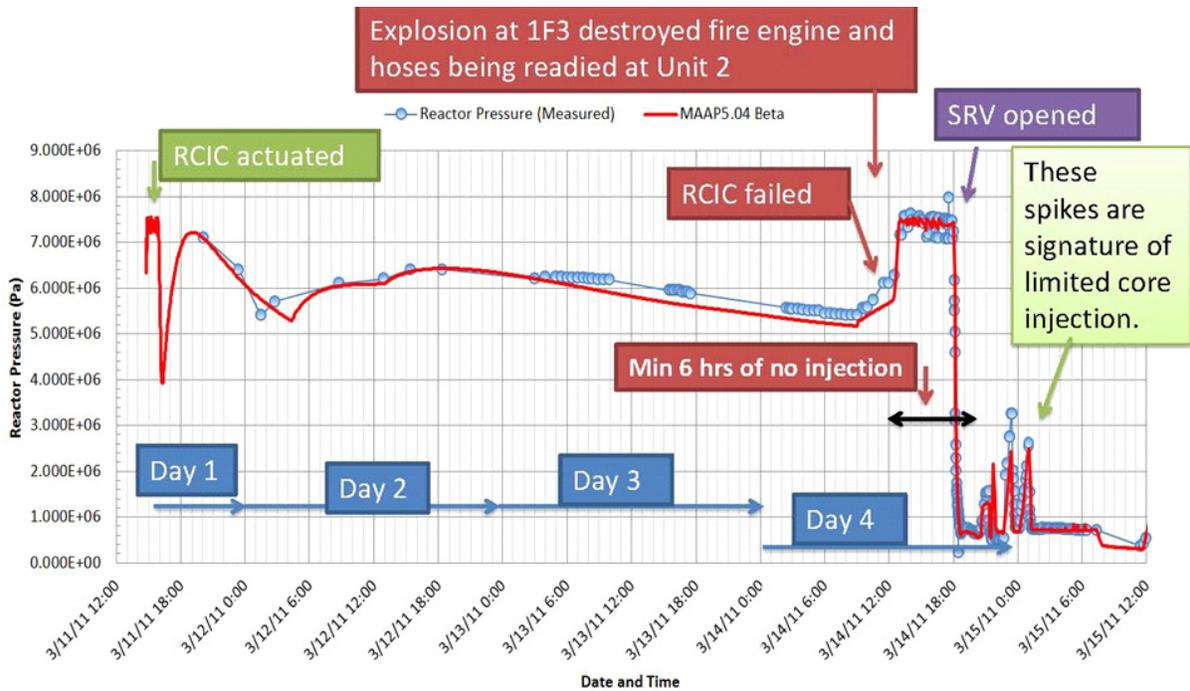
Figure 6-16. Timing of 1F2 RCIC failure and 1F3 explosion. (Data courtesy of TEPCO Holdings [10] as modified by FAI)

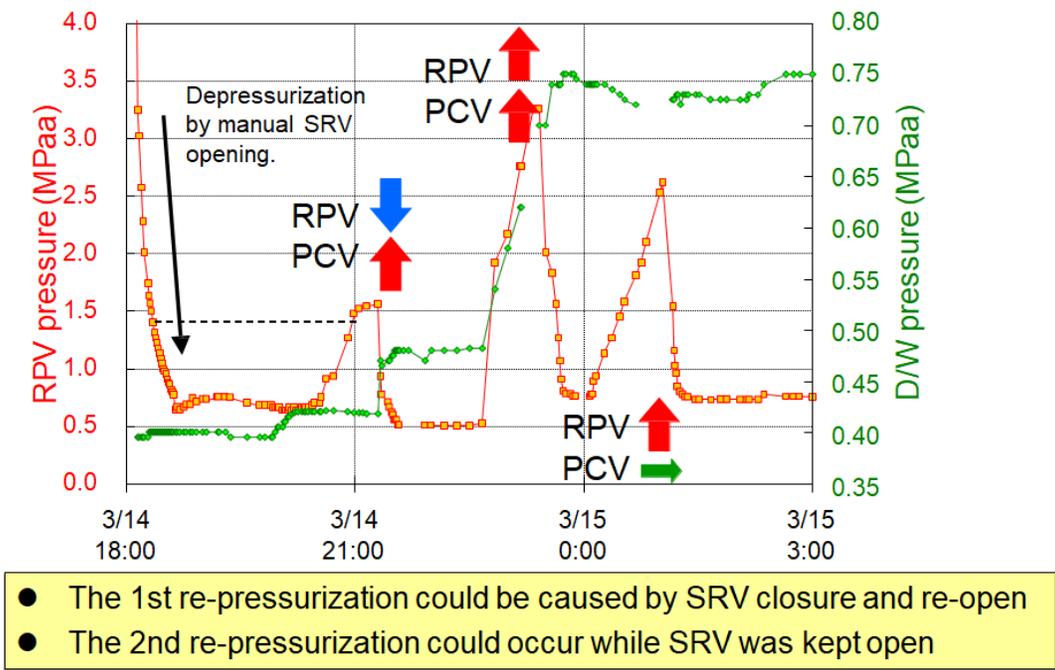
Figure 6-17. 1F2 PCV pressure trend - Rapid increase in PCV pressure coincides well with the second RPV pressure spike following the injection with fire trucks at 8:00 pm, March 14, 2011. (Courtesy of TEPCO Holdings [224])

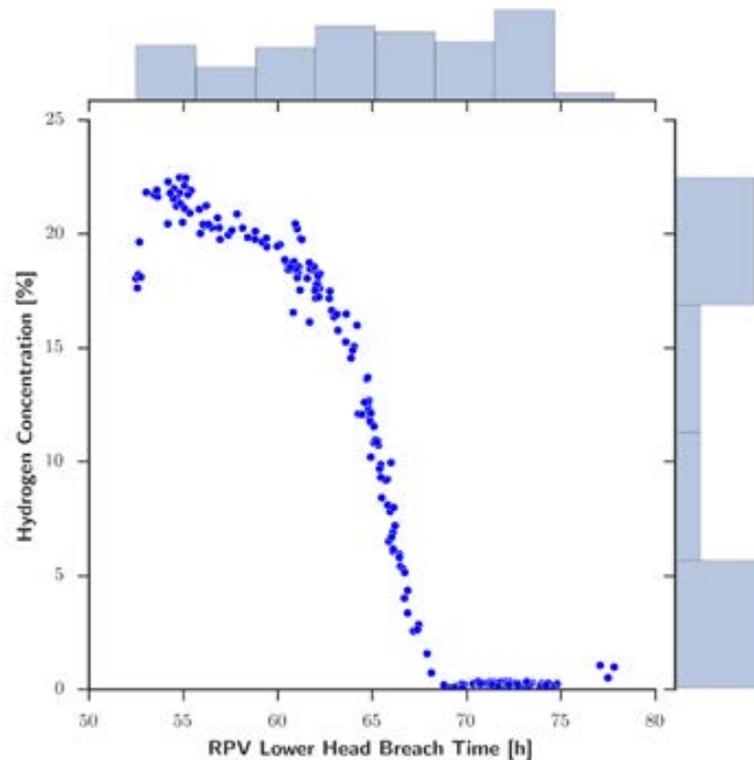
Figure 6-18. MAAP 1F3 modeling uncertainty evaluation: refueling floor hydrogen build-up at time of 1F3 reactor building explosion. (Courtesy of EPRI [72])

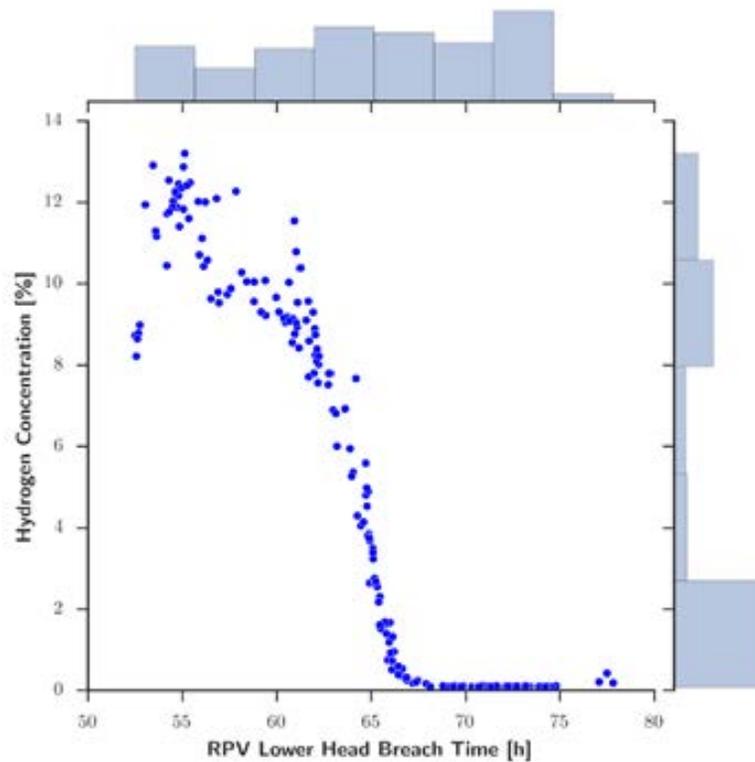
Figure 6-19. MAAP 1F3 modeling uncertainty evaluation: fourth floor hydrogen build-up at time of 1F3 reactor building explosion. (Courtesy of EPRI [72])

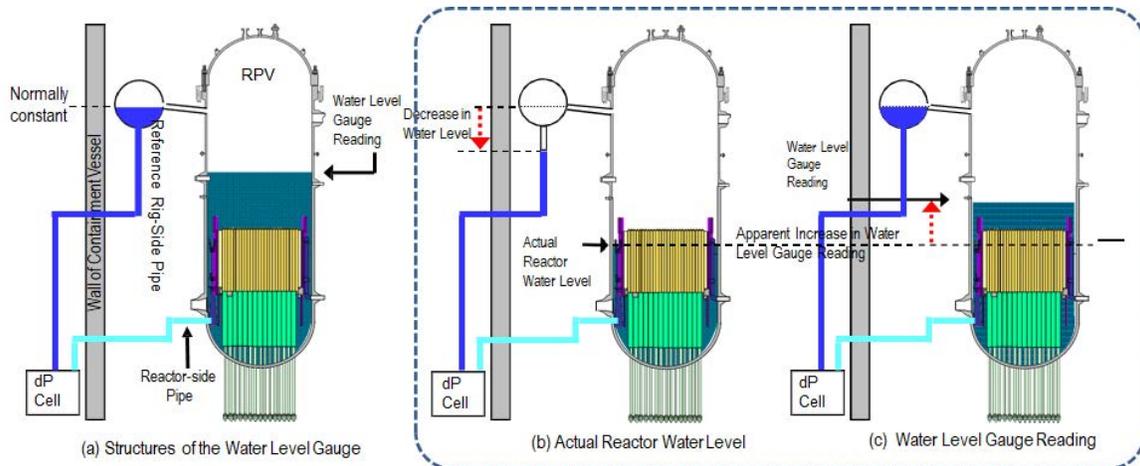
Figure 7-1. Water level instrument diagram. (Courtesy of TEPCO Holdings [53])

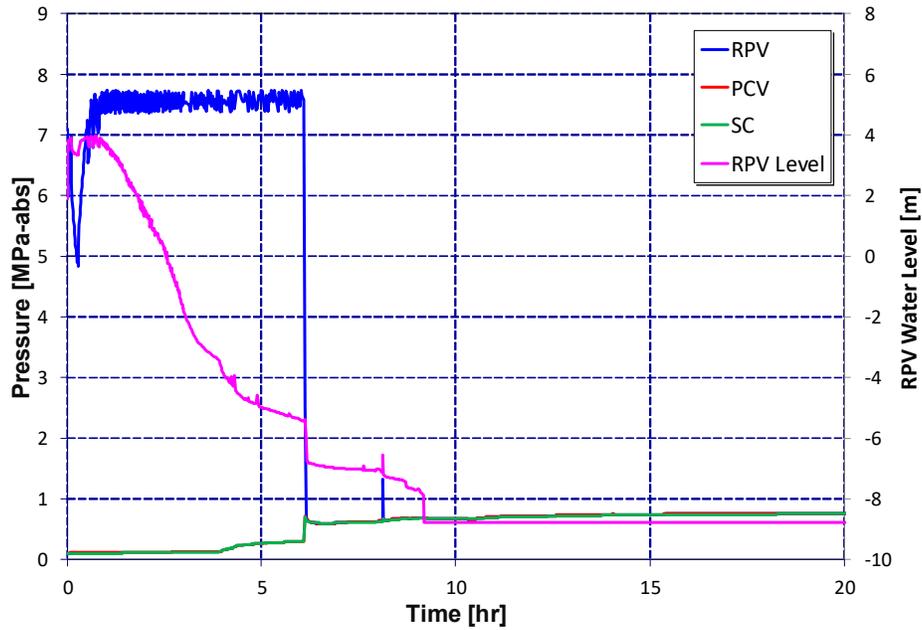
Figure 7-19. MELCOR estimates for pressure and water levels at selected 1F1 locations [t=0.0 corresponds to 14:46 on March 11, 2011; RPV water level of 0 corresponds to TAF]. (Courtesy of SNL)

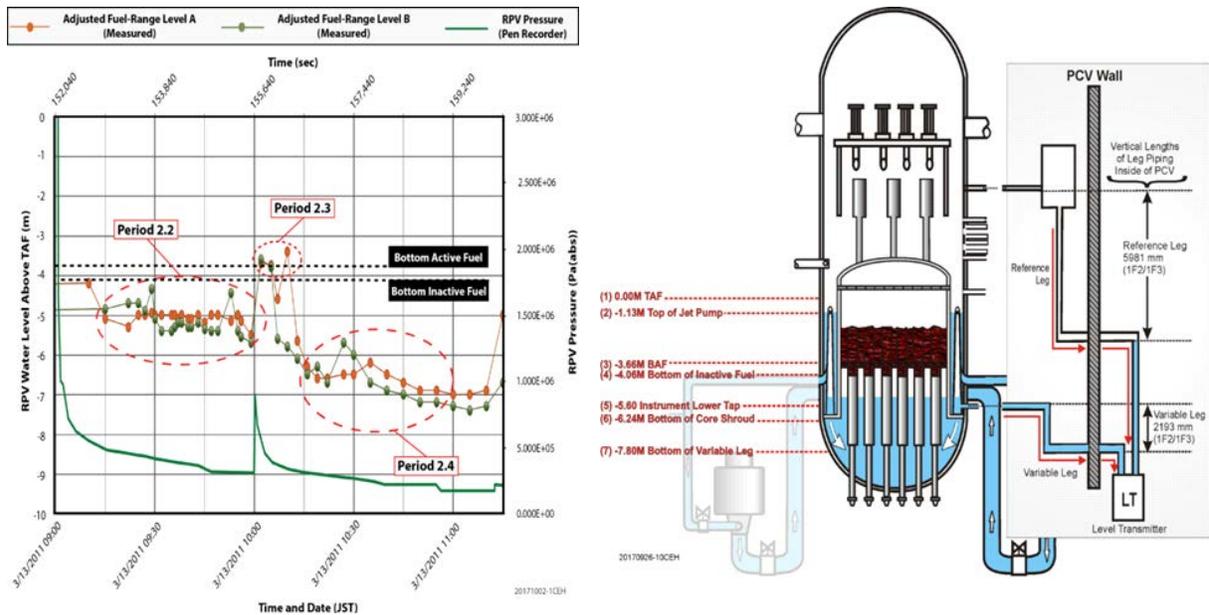
Figure 7-26. 1F3 pressure and RPV water level data for Time Periods 2.2 through 2.4 with the corresponding RPV elevation view for Time Period 2.2. (Data courtesy of TEPCO Holdings [10] as modified by EPRI [238])

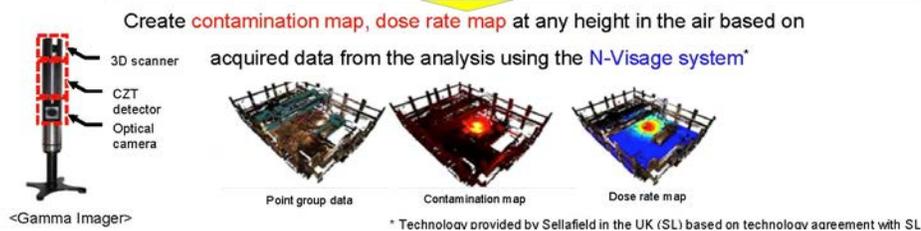
Figures 7-40 and 7-41 describe new technologies deployed at Daiichi for monitoring dose rates. As illustrated in Figure 7-40, aerial drones and gamma imagers are deployed within the site, allowing dose rate and contamination maps to be generated real time. Figure 7-41 shows a robot used to obtain radiation dose rate and contamination concentration measurements.

Figure 7-40. Drones and gamma images for generating radiation maps. (Courtesy of Ministry of Labor, Health, and Welfare [243])

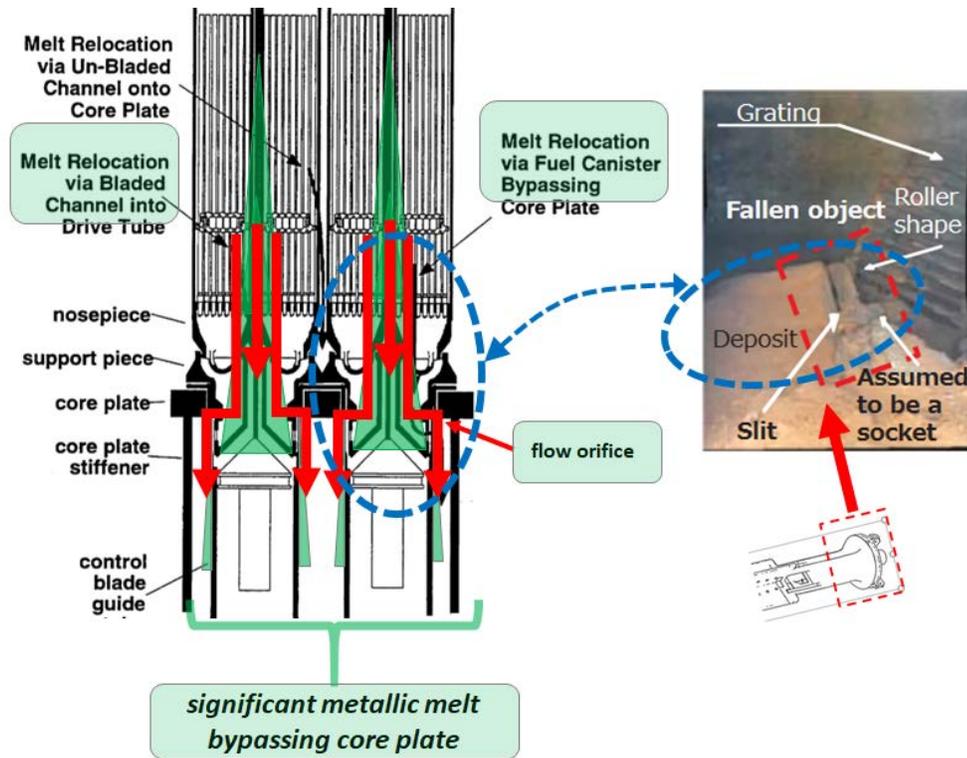
Figure 8-1. Visual representation of control blade and canister melt draining through fuel assemblies and bypass regions at 1F [Graphics courtesy of TEPCO Holdings [250] and SNL[251]
