U.S. Efforts in Support of Examinations at Fukushima Daiichi - 2019 Evaluations

Nuclear Engineering Division

U. S. Department of Energy - Office of Nuclear Energy

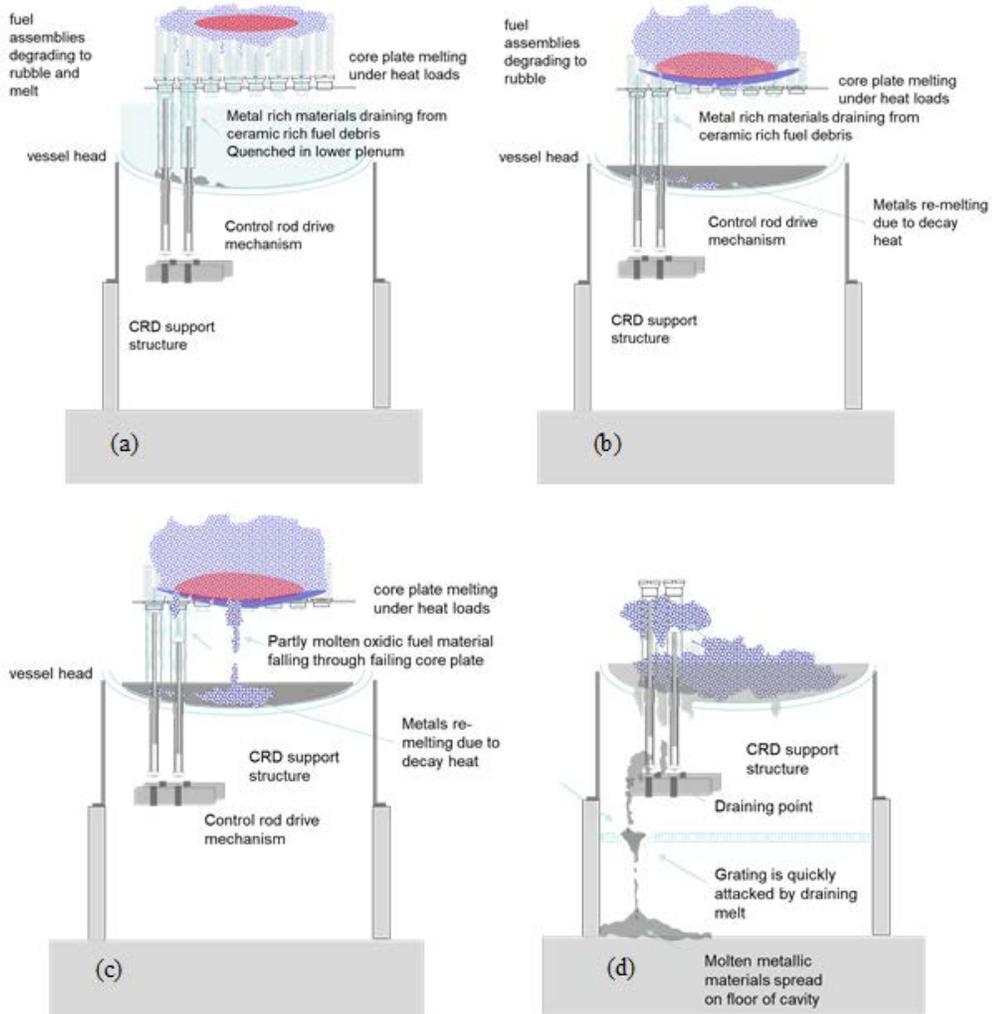
Figure 8-2. Core damage progression within the BWRs at Daiichi, progressing from fuel assemblies begin to degrade (a) to the eventual failure of the lower head and relocation ex vessel (d). [Graphics courtesy of SNL]

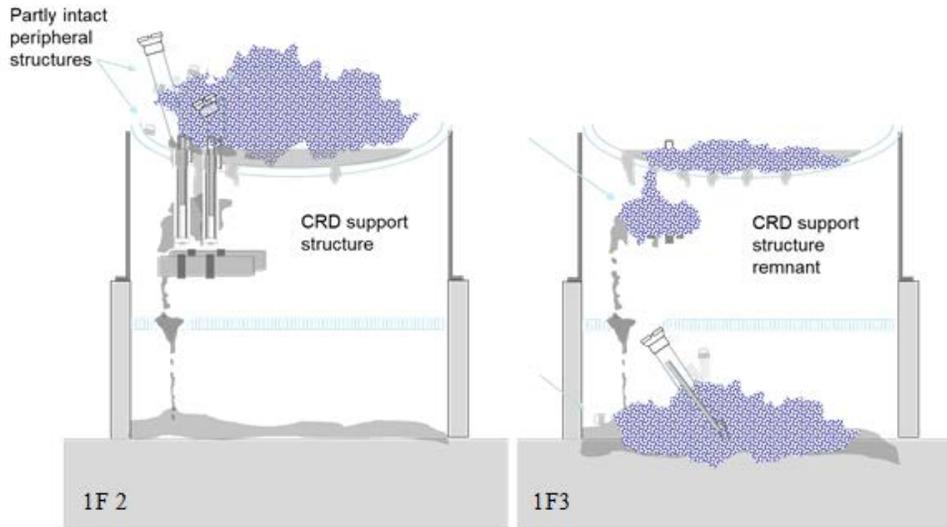
Figure 8-3. Estimated state of 1F2 and 1F3 core debris following the meltdowns of each reactor. [Graphics courtesy of SNL]

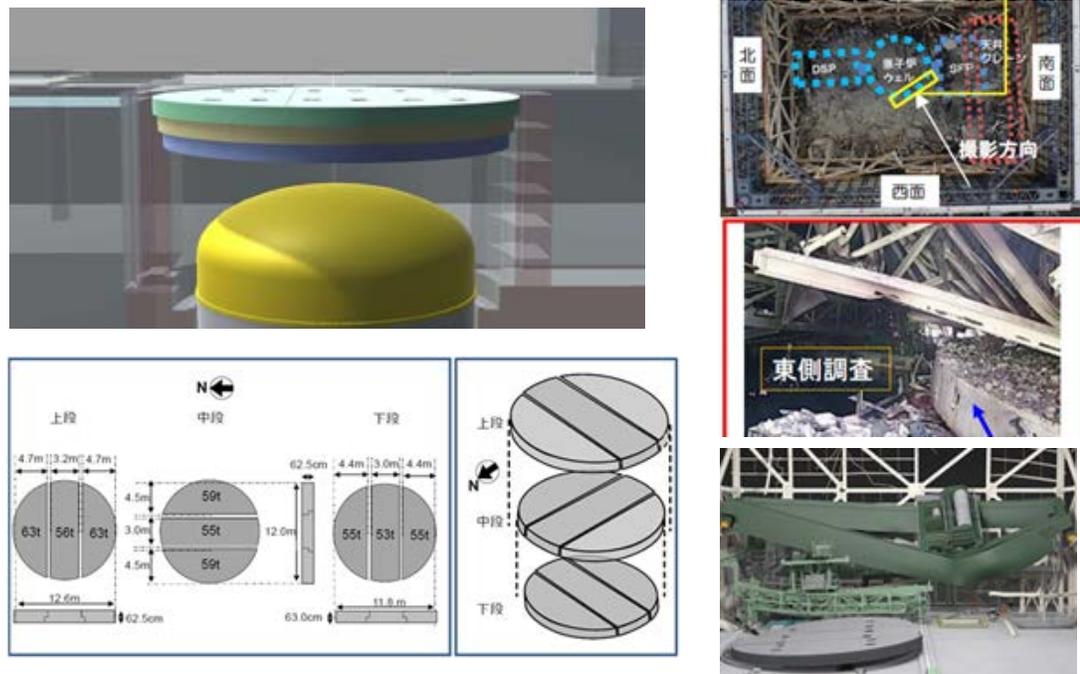
Figure E-1. Physical characteristics, photographs, and 3D images based on photographs showing the displacement of the 1F1 drywell head shield plugs. (Courtesy of TEPCO Holdings [276, 278])

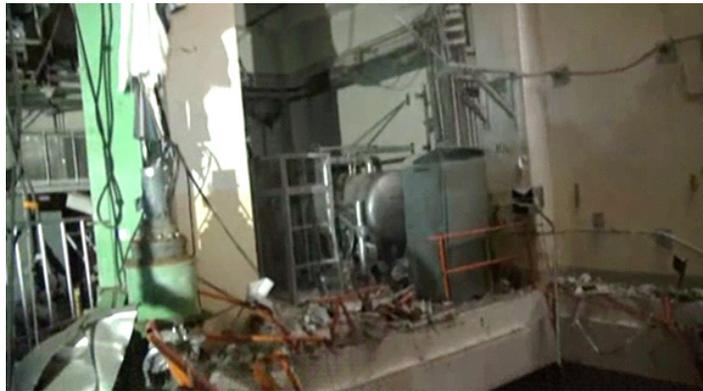
Figure E-5. 1F1 RCW surge tank. (Courtesy of TEPCO Holdings [284])

Design details of the RCW at 1F1 are not readily available. In reviewing the design for a similar BWR4 in a Mark I containment at the Browns Ferry Nuclear Power Plant (BFN), [285] the pipe size for the drywell equipment drain sump heat exchanger is 3.81 cm (1.5 inch). The rest of the RCW piping of relevance is much larger, in the 5-30.5 cm range (4-12 inch). The volume of water in the system (relevant to RCW piping, surge tank, and heat exchangers of interest) is not readily known; however, it is estimated to be on the order of several cubic meters (i.e., on the order of 1000 gallons). The RCW piping is designed for 1.14 MPa-gauge (150 psig) at BFN which exceeds available values recorded for the 1F1 drywell pressure.

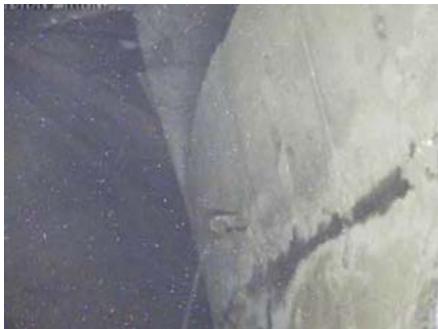
Figure F-3. Leakage out of the sand cushion drain pipes at 1F1. (Courtesy of TEPCO Holdings [179])

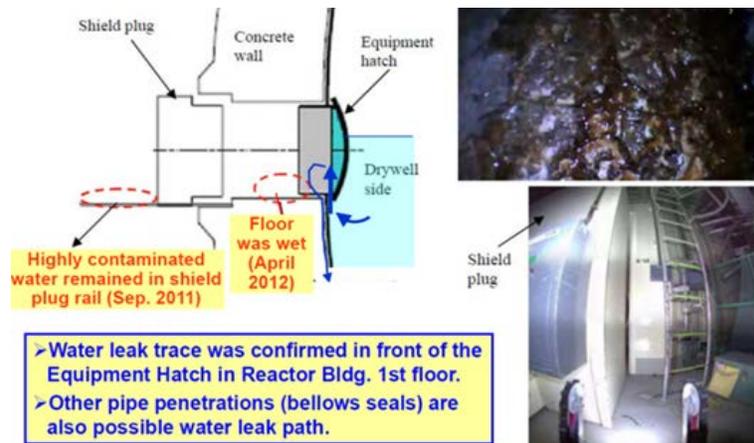
Figure F-11. Liquid-phase leakage from 1F3 equipment hatch. (Courtesy of TEPCO Holdings [177])

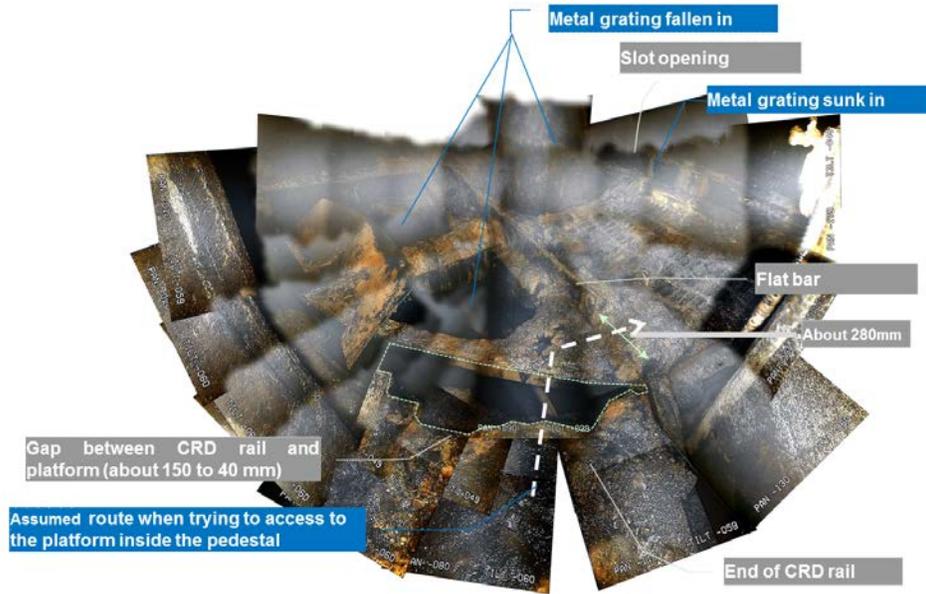
Figure G-13. Combined images from entry into 1F2 pedestal region, indicating findings. (Courtesy of TEPCO Holdings [197])

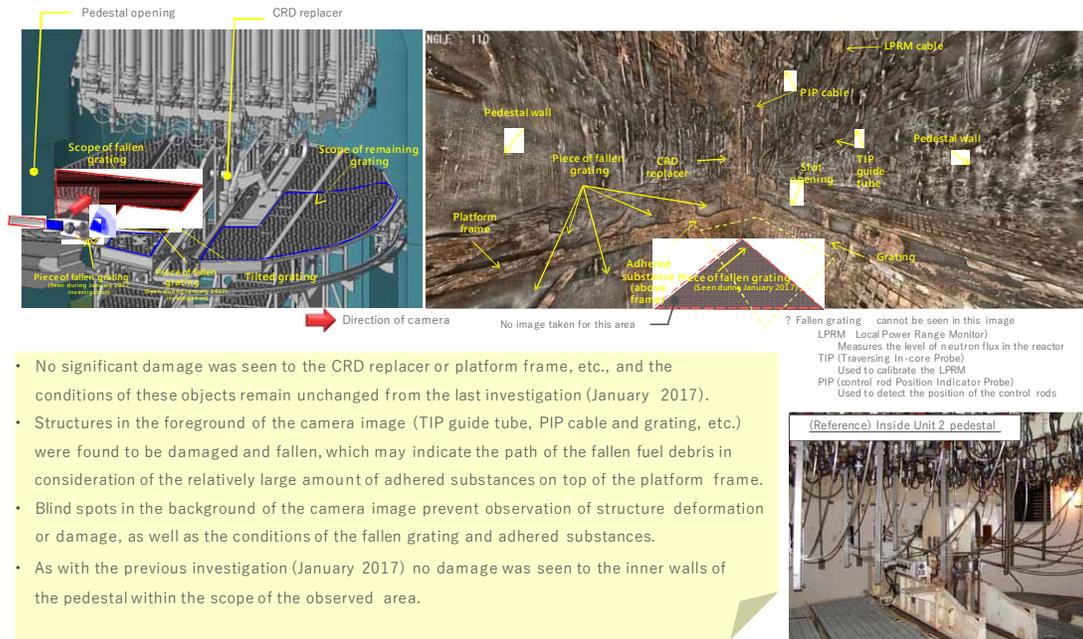
Figure G-19. Photograph of the top platform showing damage inflicted by relocating core debris. (Courtesy of TEPCO Holdings [160])

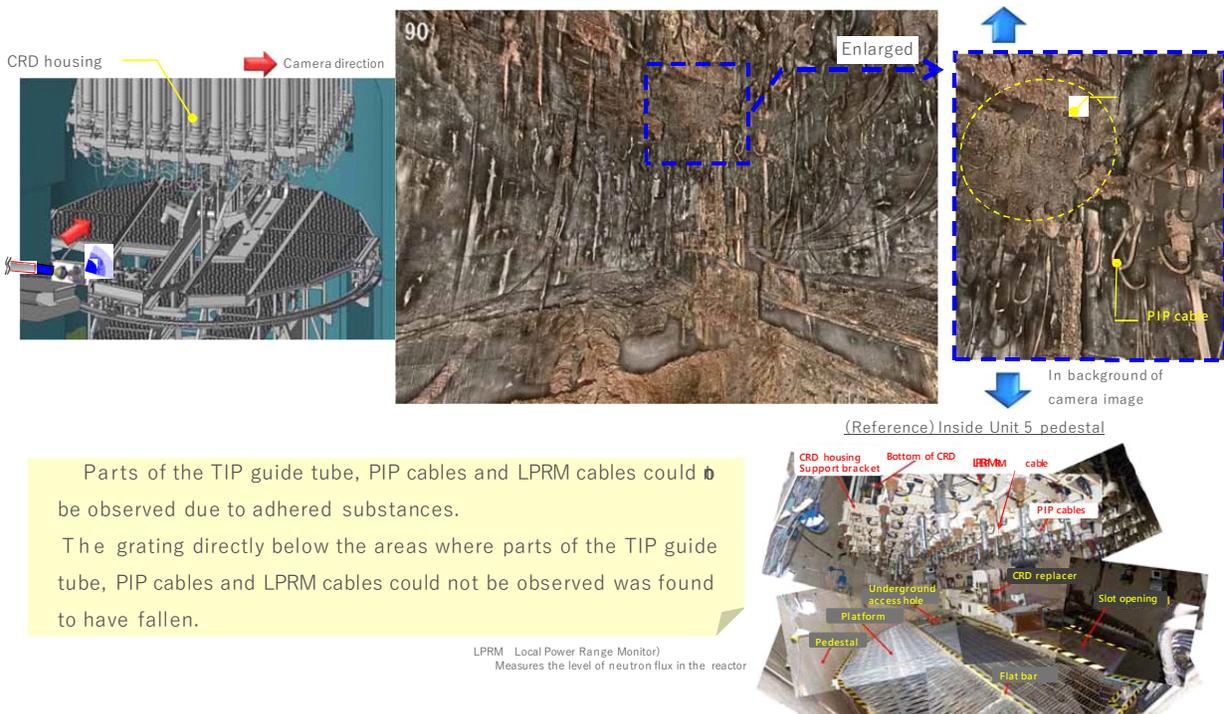
Figure G-20. Photograph of lower head showing core debris adhering to TIP guide tube and PIP and LPRM cables in the region where platform grating has failed. (Courtesy of TEPCO Holdings [160])

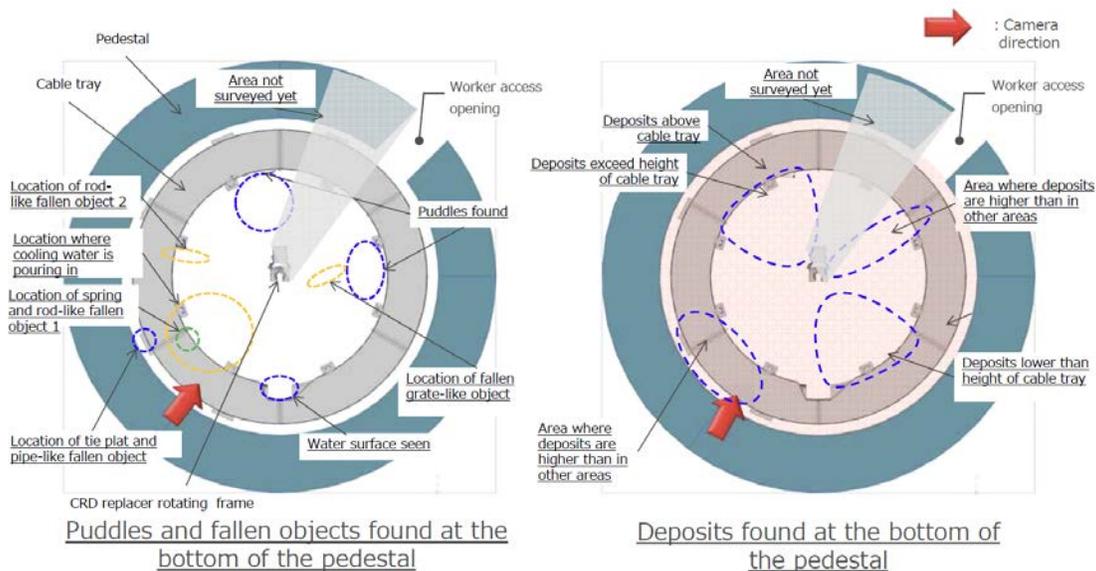
Figure G-23. Details of core debris surface characteristics for 1F2. (Courtesy of TEPCO Holdings [160])

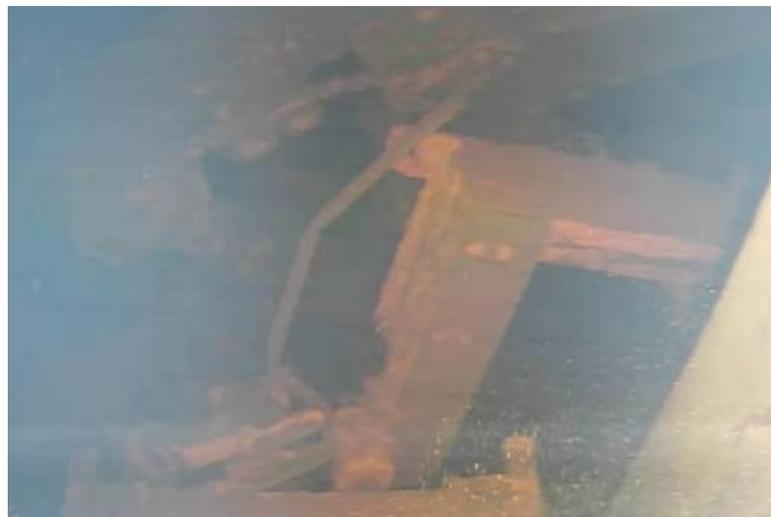
Figure G-25. Image of relocated CRD rail on the 1F3 platform with no grating; obtained on July 19, 2017. (Courtesy of TEPCO Holdings [201])

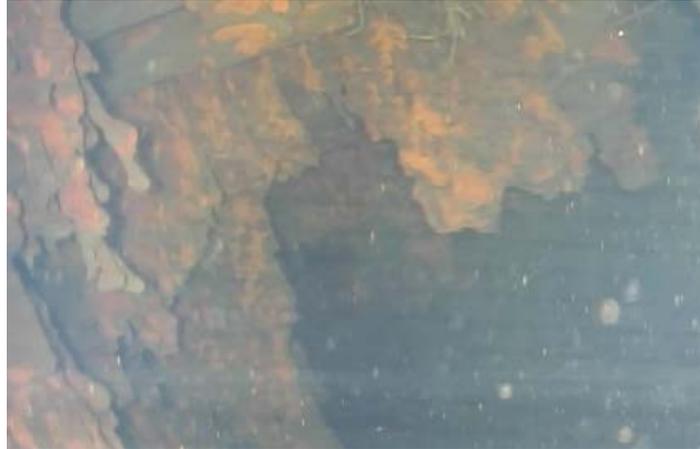
Figure G-26. Image of relocated material adhered to remaining 1F3 CRD housing and cable structures; obtained on July 21, 2017. (Courtesy of TEPCO Holdings [202])

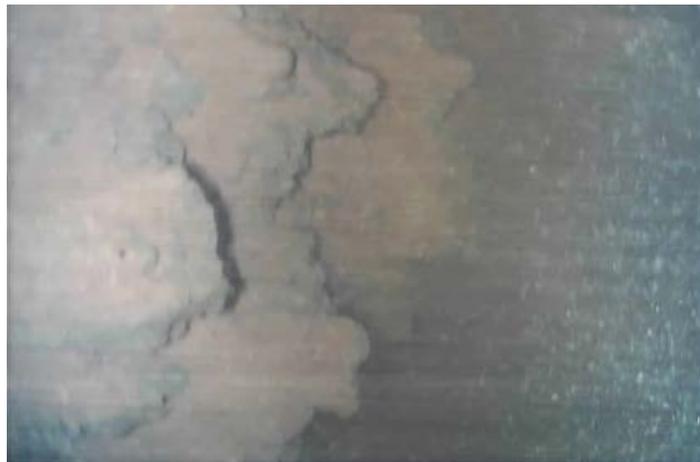
Figure G-27. Image of material that had relocated beneath the 1F3 platform into the pedestal area; obtained on July 22, 2017. (Courtesy of TEPCO Holdings [203])

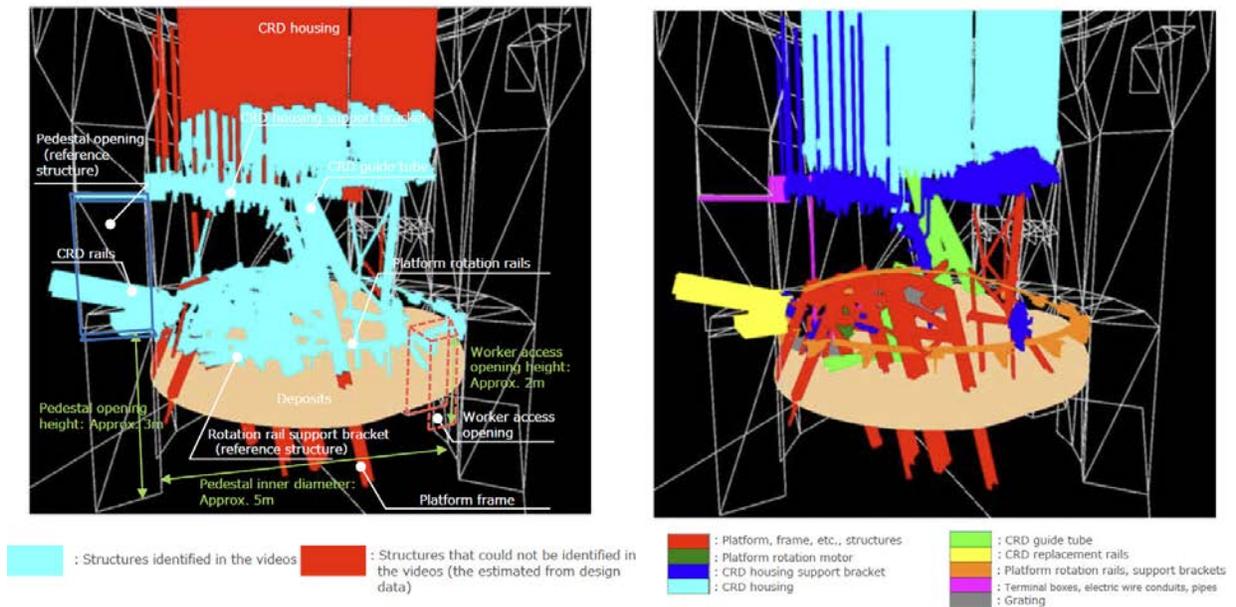
Figure G-28. 3-D reconstruction of structures located in the pedestal region for 1F3. (Courtesy of TEPCO Holdings [161])

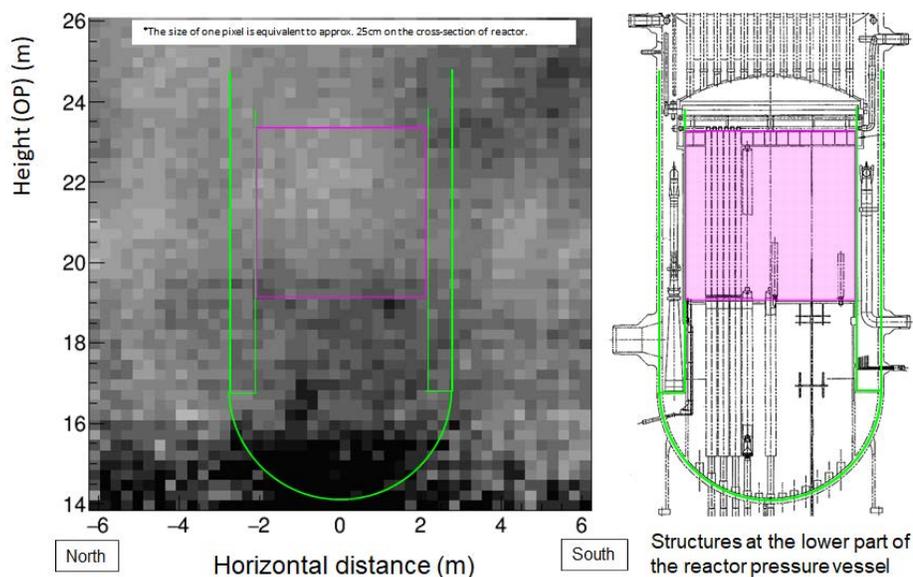
Figure G-33. Images of 1F2 obtained using muon tomography with scintillation detectors. (Courtesy of TEPCO Holdings [19])
