**All Auto Shredding: Evaluation of Automotive Shredder Residue Generated by Shredding
Only Vehicles**

Argonne National Laboratory

July 11th, 2011

ANL/ES-C0201801

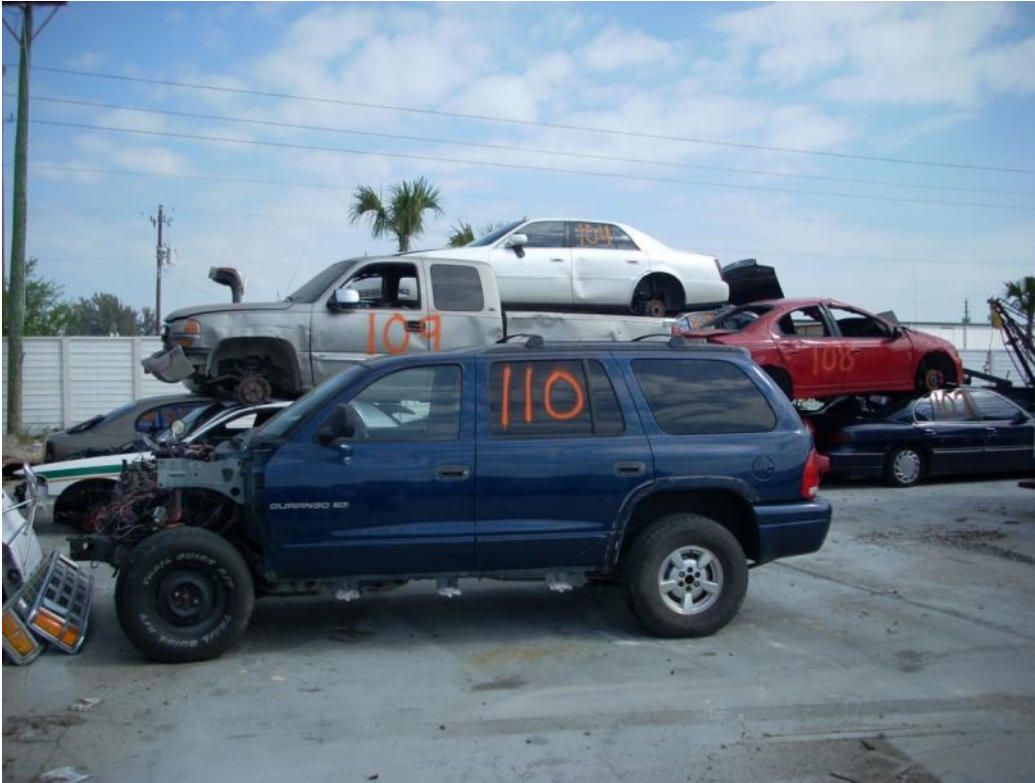
Figure 1. Vehicle Storage Area before the Test. Note the minimal damage to the vehicles.

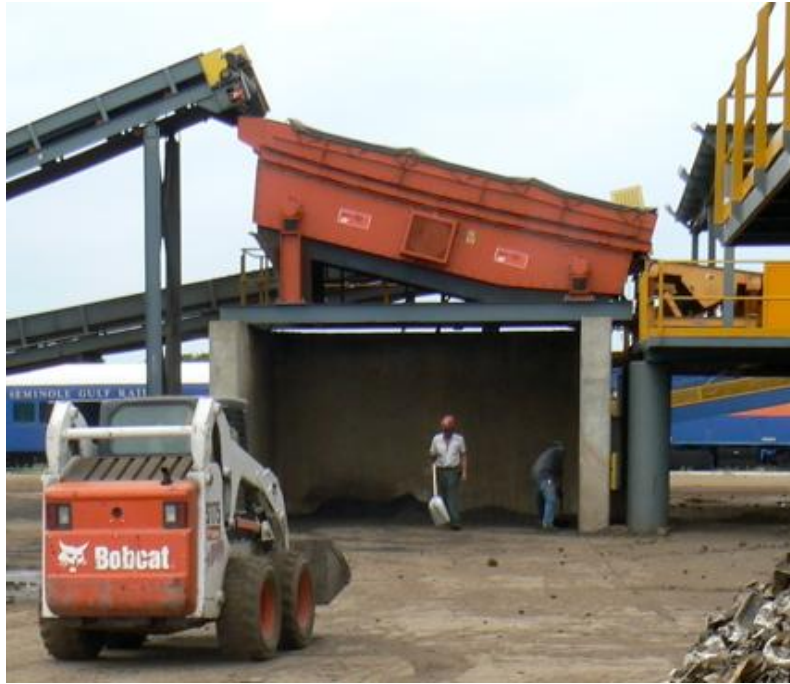
The fines fraction was generated using a Bivi-tec screener with a 12 mm perforated screen. A picture of the screener is shown in Figure 3. This fraction was sent to Energy Anew, Inc. for processing, and ultimately for determination of its material composition. A separate report was generated by Energy Anew, Inc. The information here was taken from that report.

Figure 3. Picture of the Bivi-tec Screener Utilizing a 12 mm Perforated Screen

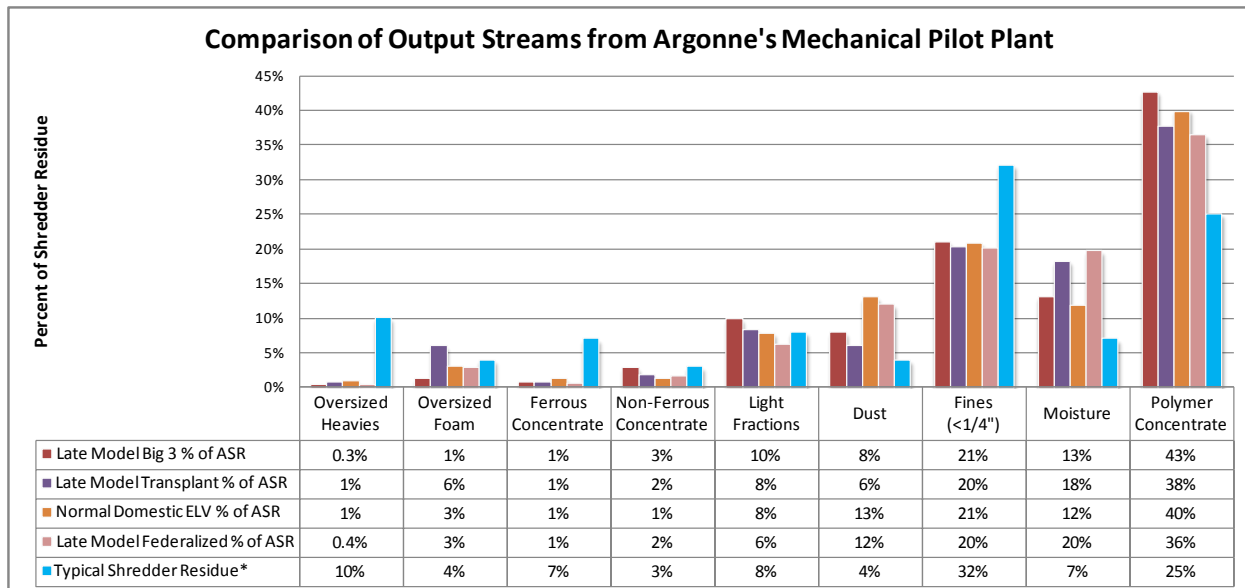
All four categories of vehicles were processed through the mechanical system. The output fractions of each category are summarized in Figure 4. The “Oversized Heavies” fraction shown in Figure 4 was hand-picked and contained large pieces of metal and other hard objects which would potentially damage downstream equipment. The “Oversized Foam” was hand-picked as well. This material was seat foam and was removed due to its tendency to slow the throughput of the installed shredder. The “Ferrous Concentrate” was separated using a magnetic head pulley and contained about 90% ferrous metal. The “Non-Ferrous Concentrate” was recovered using an eddy current separator. This material, which is predominately aluminum, varied from 23% metal content in the Late Model Transplant category to 62% in the Normal Domestic ELV category. Typically, the ferrous fraction was 1% of the shredder residue by weight and the non-ferrous was about 2% on average. A little less than 10% of the shredder residue reported as a “Light Fraction”. This fraction includes materials such as foam and fiber. Dust collectors were emptied at the end of processing each category and this material was about 10% of the shredder residue in each of the categories. The moisture content of the shredder residue was determined by moisture loss through heating 10 to 15 gallon samples of the as-received residues in a large oven set to 200 °F.

A <1/4 inch fines fraction consistently accounted for about 20% of the shredder residue. The largest quantity of the shredder residue from each category reported to the “Polymer Concentrate” fraction. This fraction, amounting to roughly 40% of the coarse residue fed to the system, contains many different types of polymers, including different plastics and elastomers. It also contains small amounts of glass, rock, wood, foam, metal, and other materials. Though there is a slight difference in weight percent between the categories, the amount of polymer concentrate is roughly the same.

* - Moisture and dust were recorded together as a loss for the typical shredder residue data. To better compare the five categories the loss of 11% was therefore separated into dust and moisture in a proportion equal to the average of the four vehicle categories.

Figure 4. Output Streams from Argonne’s Mechanical Pilot Plant

The shredder residue compositions of the four categories generated in Argonne’s pilot plant are only slightly different from that of “typical” shredder residues processed through the same pilot plant. The fractions showing the most difference were the Polymer Concentrates, Oversized Heavies, Ferrous Concentrates and Fines. The Polymer Concentrate generated from strictly automotive residues was on the higher end of percentages seen from “typical” shredder residues. This is due to the fact that automobiles contain a high percentage of polymers compared to most other metal bearing scrap that is fed to a shredder. The decrease seen in the Oversized Heavies and Ferrous Concentrates are likely due to the larger sized metal chunks generated by industrial metal scrap. It is typical to see large knuckles and gears in “typical” shredder residue because it is difficult for magnets to suspend the large pieces due to their large mass and spherical type shapes. The average percentages of the Oversized Heavies and Ferrous Concentrates in “typical” shredder residues processed through Argonne’s pilot plant are 9% and 8%, respectively. The larger percentage of Fines in the “typical” shredder residue, averaging 32%, is because of two factors. One being that the <12 mm fraction is present in the typical shredder residue while it is absent for the vehicle categories. The other is that the feed material typically seen by shredders usually contains dirt, rock, and gravel while the vehicles used for this test were relatively clean and free of this type of material

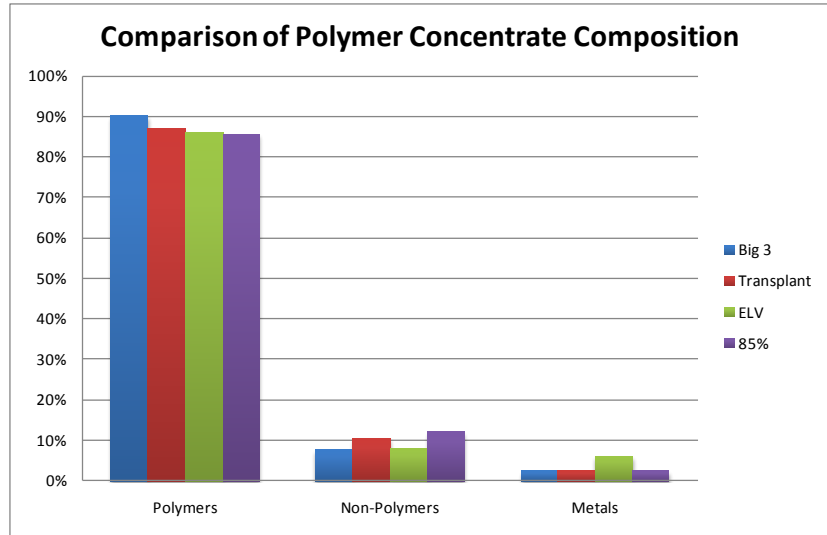
Analysis of the polymer concentrate was performed on all four categories. Figure 5 shows that the relative amount of polymer, non-polymer, and metal is about the same among the categories. Polymer concentrates generated in Argonne's pilot plant using "typical" shredder residue contained the same ranges of materials. One hundred pieces of polymer were randomly chosen from each category and scanned using FTIR analysis. The results are shown in the second chart of Figure 4.

Figure 5. Composition of the Polymer Concentrate and Polymers in the Polymer Concentrate Generated from each of the Four Categories

The polymer concentrates generated in Argonne's pilot plant while processing "typical" shredder residues contained the same polymers as the auto-only polymer concentrate. The most notable differences in quantities were in the amount of rubber and polypropylene. The "typical" shredder residues generally contain between 20% and 40% rubber while the polymer concentrates from this test contained from 7% to 17%. The tires for this test, which generally account for 3-5% of a car's mass, were removed. The large increase in polypropylene with the auto-only polymer concentrates is because these are very commonly used plastics in vehicles. In fact, polypropylene, primarily filled polypropylene, is replacing other polymers in newer vehicle applications. Typical shredder residue polymer concentrates produced in Argonne's pilot plant contain an average of 11% polypropylene.

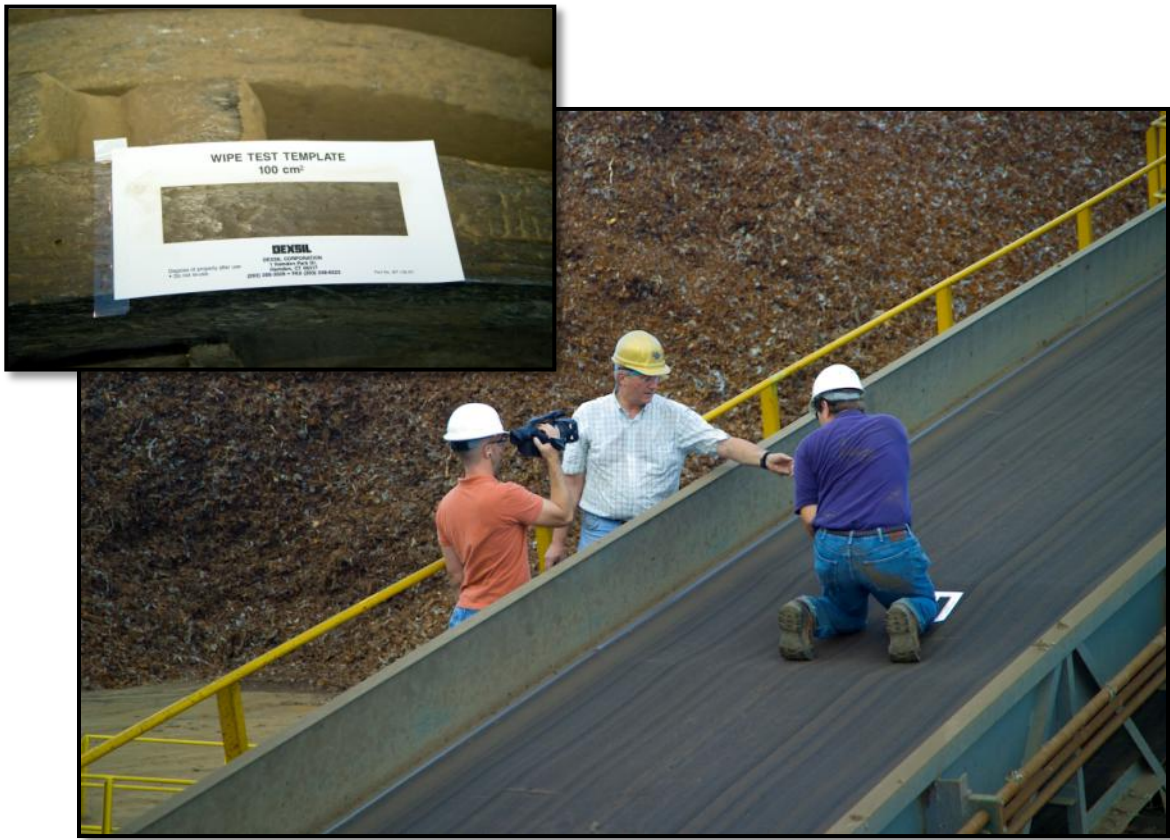
Before any of the testing began W.Z. Baumgartner & Associates (WZB) performed swipe tests from various locations at the shredder site. This was done to verify that the shredder plant did not contain significant PCB contamination. A picture of the swipe sample template and an example of a swipe test location are shown in Figure 9. A list of all the swipe test locations is shown in Appendix C. In addition to equipment being tested for surface contamination, the dismantling area and several bumpers from vehicles to be shredded during the test were swipe tested as well.

Figure 9. A Picture of the Sample Size Template for a Swipe Test and an Example Location of this Type of Sample

The results are presented in Appendix D. The samples were analyzed per EPA method 8082. For reference, e-CFR §761.79 indicates that decontamination of non-porous surfaces for unrestricted use was successful if measured below 10 µg/wipe. All swipe tests of the vehicles to be shredded and the dismantling area reported as non-detects with a detection limit of 5.00 µg/wipe. Of all the 42 swipes that were taken on shredder plant belts and feeders, eight of them contained detectable levels of PCBs. Of these eight, two of them were above 10 µg/wipe, 10.8 µg/wipe and 16.6 µg/wipe.

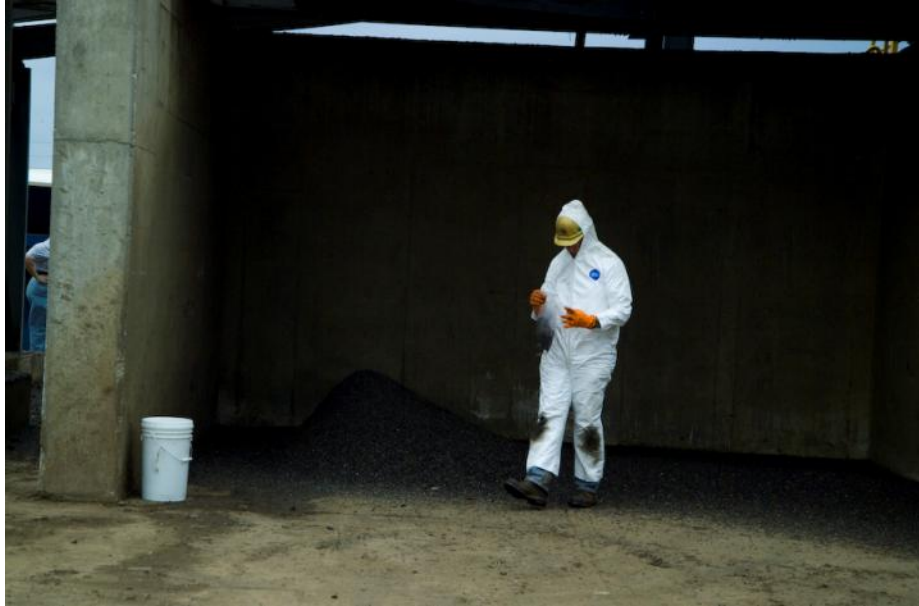
Figure 10. Sampling location for the <12 mm fines residue.

Ten samples of the <12 mm fines and 10 samples of the coarse shredder residue were obtained from each of the four categories of vehicles. Of these, three from each group were randomly selected for analysis and then an average concentration was determined. Figures 10 and 11 show the sample location fine and coarse shredder residues, respectively. The results are presented in Appendix E. Many of the samples contained non-detectable amounts of PCBs (detection limit of 0.3 ppm). Only one <12 mm fines sample contained a detectable level of PCBs (1.77 ppm). This sample was from the Late Model Big 3 category. Only one coarse shredder residue sample contained a detectable level of PCBs (2.17 ppm). This sample was from the Late Model Transplant category. The EPA limit for PCBs is 50 ppm before the waste is considered hazardous. For comparison, a study found that shredder residues from seven different facilities in California contained 16-82 ppm (Boughton, 2006).

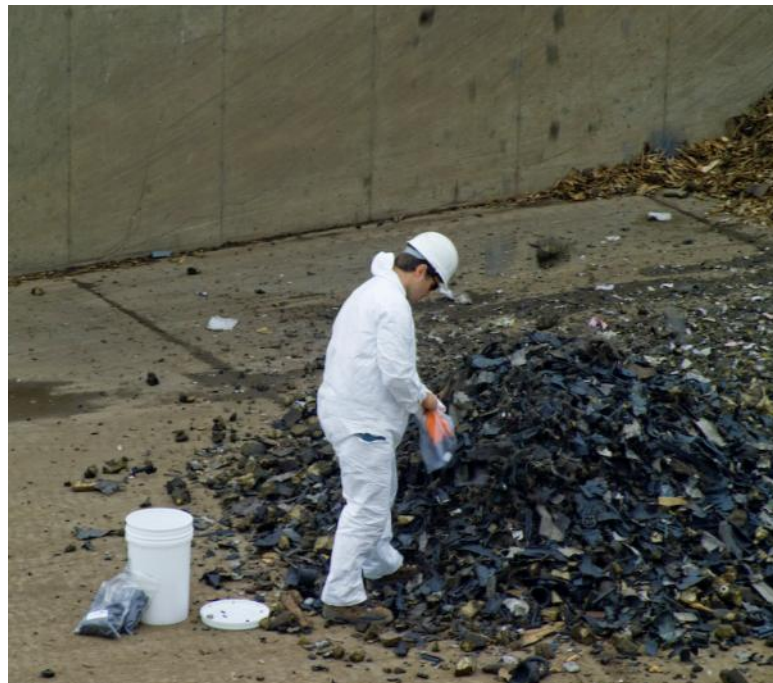
Figure 11. Sampling location for the coarse shredder residue.
