## **Gear Test Assembly – Status Report for FY2019**

**Nuclear Sciences and Engineering Division**

**E. Kent, H. Belch, D. Kultgen, M. Weathered, C. Grandy**

September 2019

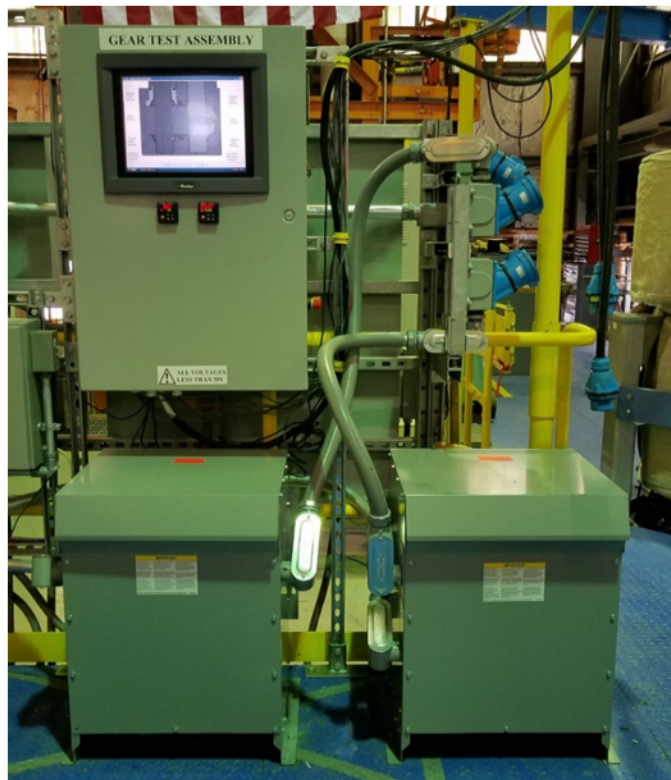
**Figure 6: GTA Electrical 1/3 – 480 VAC Transformers (bottom), GTA I&C Panel (top-left), and 480 VAC Meltric Receptacles for Motors (top-right).**

All the electrical hardware that supports the GTA was moved from Building 206 and installed in Building 308. QEW2 trained staff performed all of the electrical work. **Error! Reference source not found.** shows the 480VAC transformers, 480VAC Meltric switch-rated receptacles, and the 24VDC I&C Panel for the GTA project. The 480VAC transformers are fed with the building's 480VAC 3-phase Delta and output the 480VAC 3-phase WYE required by the motors. The Meltric receptacles provide cord-and-plug control for the motor controllers. The I&C Panel includes the following hardware:

- Parker ACR Programmable Motor Controller
- Parker EPX2 HMI
- NI cDAQ-9188XT
  - NI9428 Analog Output Card –SSR and Solenoid Valve Control
  - NI9208 4-20mA Input Card – Pressure Transducer and Torque Sensor Input
  - NI9213 Thermocouple Card – Temperature Input
  - NI9234 Voltage Input Card – Vibration Sensor Input
- Watlow EZ-Zone RM Integrated Controllers
- Watlow EZ-Zone Remote User Interface Modules.
- Futek Torque Sensor Amplifier
- 24VDC SSRs
- Ethernet Switch

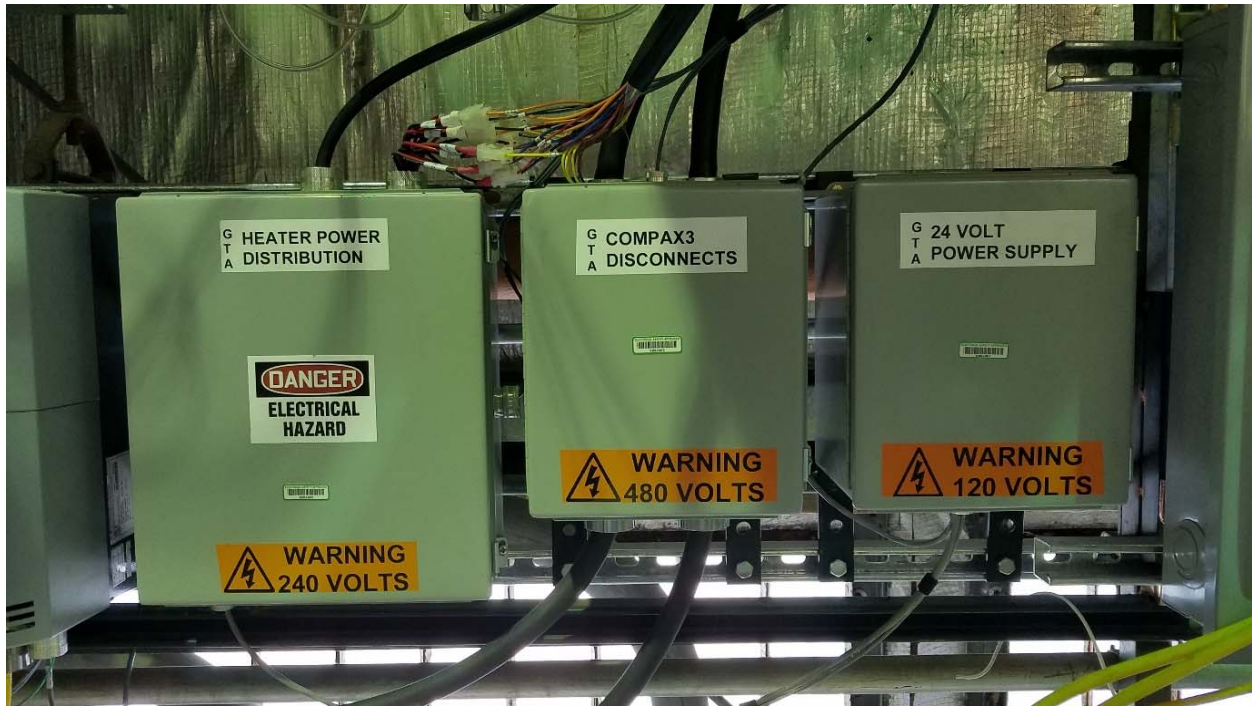
**Figure 7: GTA Electrical 2/3 – Heater Power Panel (left), 480 VAC Remote Disconnect Panel (middle), DC Power Panel (right).**

The I&C Panel is fed with 24VDC from a DC Power Panel that houses a 480W 24VDC power supply. Separating the power supply from the I&C Panel removes any hazardous electrical energy from the I&C Panel, thereby allowing safer access for troubleshooting. A 480VAC Remote Disconnect Box is located between the 480VAC Meltric receptacles and the Compax3 Motor Controllers. This allows the operator to control remotely the power supplied to the motors by opening or closing 480VAC solid-state relays. The Heater Power Panel supplies 240VAC to two heater zones on the GTA. Each zone consists of several

heaters fed from distribution blocks within the panel. Each zone is controlled using a 240VAC SSR that operates off PID parameters set by the Watlow EZ-Zone hardware located in the I&C Panel. The main feed to the Heater Power Panel is controlled using another 240VAC SSR that can be remotely switched by the operator. All three panels are single energy source, cord-and-plug controlled, and are DEEI approved. Figure 7 shows these three panels mounted on the north wall of the Building 308 high bay.

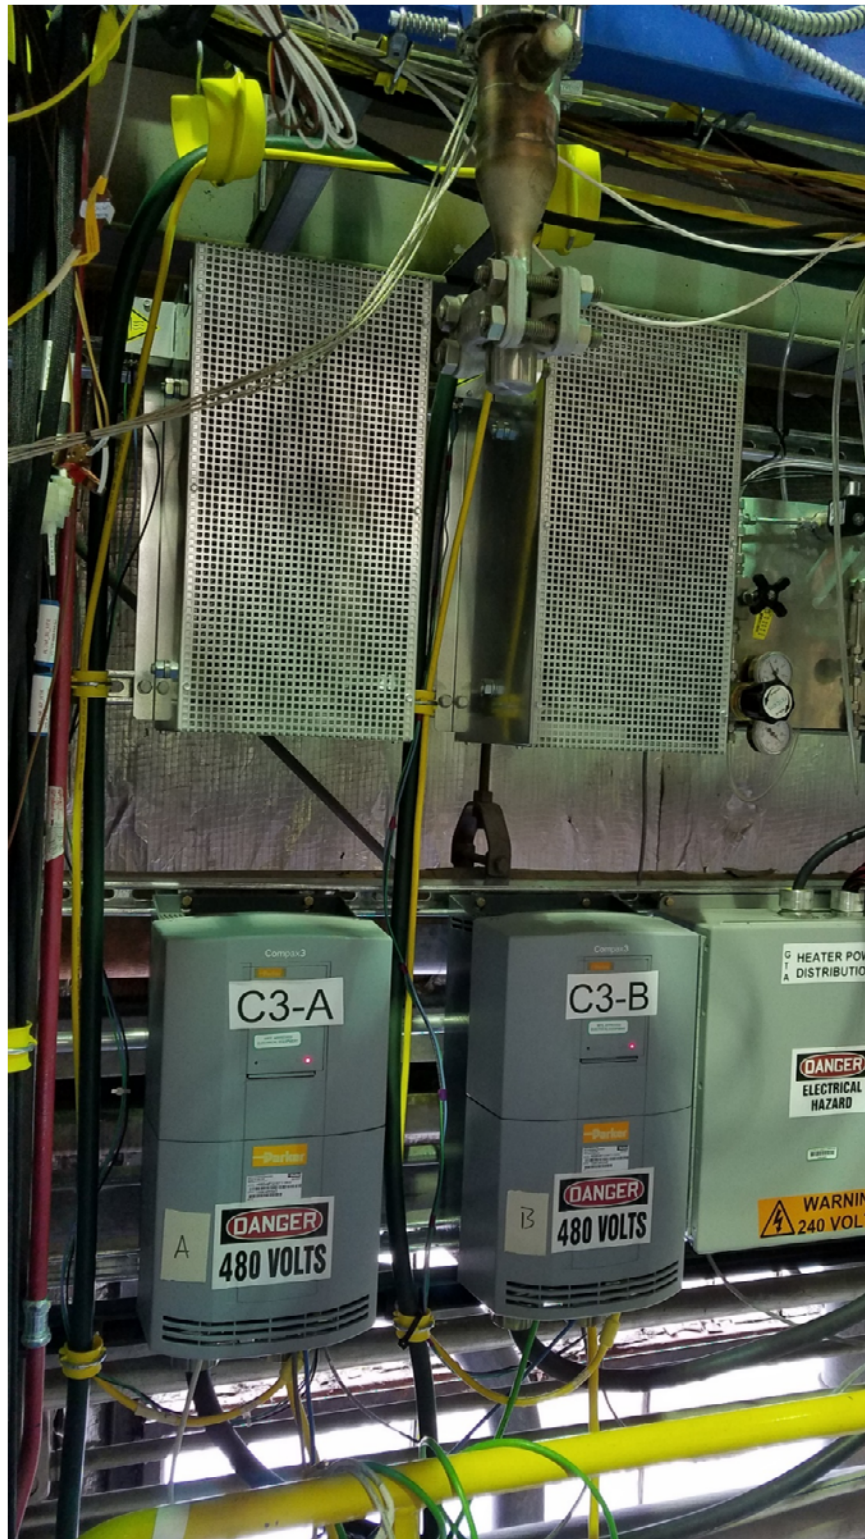
**Figure 8: GTA Electrical 3/3 – Compax3 Motor Controllers (bottom) and Motor Braking Resistors (top)**

The GTA uses two Parker servomotors to rotate the shafts and provide the torque to load the gears. These motors are powered from Parker brand Compax3 Motor Controllers that include individual braking resistors. Each Compax3 can be used to operate an individual servomotor, and coordinated motion is achieved using the Parker brand ACR Motor Controller located in the I&C Panel. Figure 8 shows the two Compax3 Motor Controllers and their associated braking resistors.

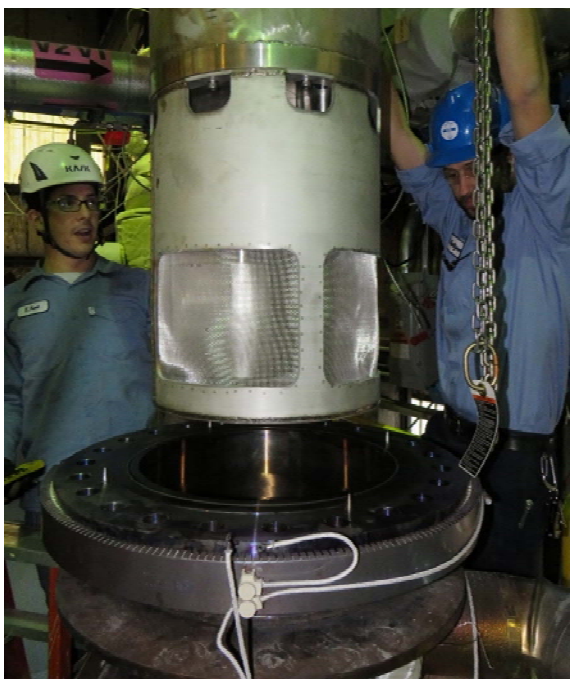
**Figure 13: GTA being lowered into V1.**

The GTA was moved to Test Vessel 1 and lined up with the center axis of the vessel using the overhead crane controls. Test Vessel 1 was allowed to cool to room temperature in preparation for the article installation. Test Vessel 1 had not yet seen sodium from METL, so the cover flange could be removed without concern of exposing sodium to the high bay atmosphere. Care was taken to protect the metal c-ring seal and seal surfaces during this procedure, as well as to prevent any debris from falling into the open test vessel. Once the article was aligned properly with the test vessel, the chain fall was used to lower slowly the article into place. Figure 12 and Figure 13 show the process of lowering the GTA into Test Vessel 1.

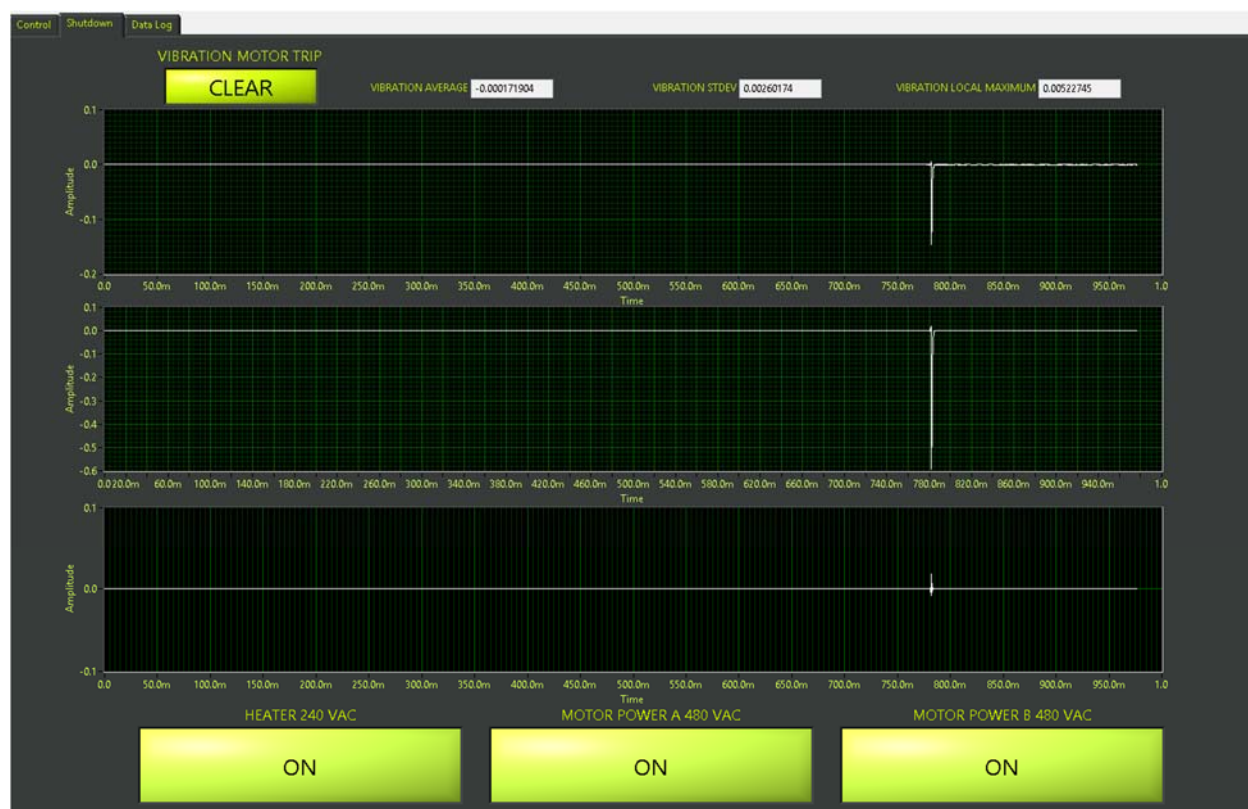
**Figure 16: GTA LabVIEW Program – Vibration and Shutdown Panel.**

Figure 16 shows the Vibration and Shutdown Panel of the LabVIEW VI. This presents readings from the three vibration sensor mounted on the GTA that monitor the system's health. Two sensors were out of the sodium and mounted to the upper gearboxes. The third sensor was submerged in the sodium and mounted to the test gearbox. These sensors provided the primary means of monitoring the gear and bearing health in the system. Measurements were made shortly after starting the GTA to record baseline vibration readings used to indicate normal performance. The vibration readings were continuously monitored and the motors

set to trip should the local maximum or the standard deviation exceed the baseline by a factor of two. This panel also has the controls used to trip the remote SSR disconnects for the 240VAC and 480VAC.

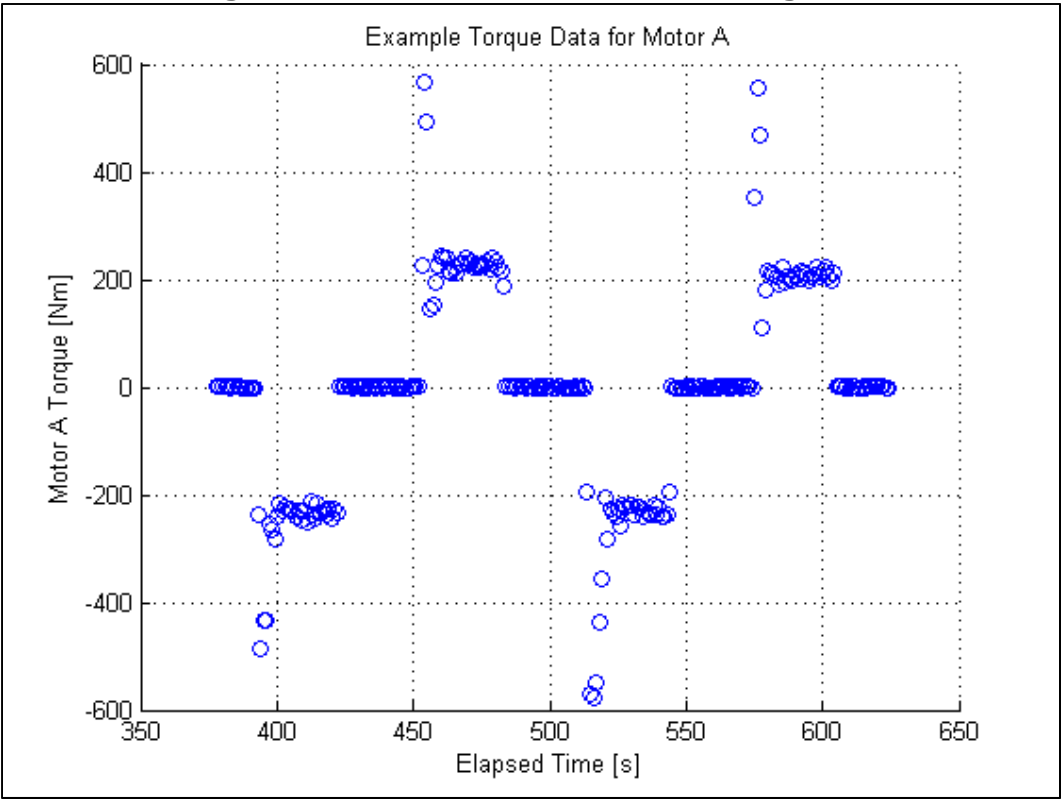
Figure 18: Example torque data collected for Motor A.

Figure 18 displays an example of the torque data collected during normal operation.

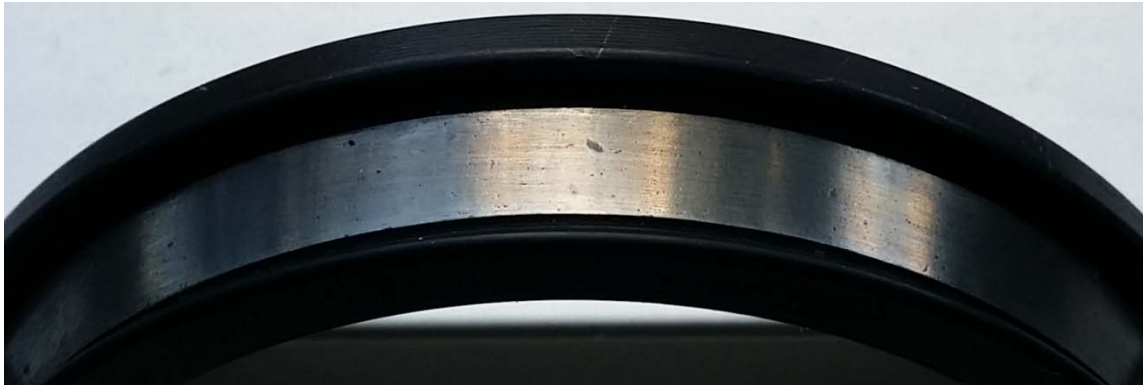
**Figure 20: Inner race shows bore polishing due to excessive preload and lack of lubrication.**

An issue with the external gearboxes was encountered during the experimental operations. The external gearboxes were an “open” design that did not trap grease inside the gearboxes. There was a concern that over packing these gearboxes would cause them to bind up over time. A consequence of this was a reduction in lubrication from the grease and an increase in friction experienced by the bearings used in these gearboxes. After one week of continuous operation, a bearing failed in one of the upper gearboxes. This required a temporary shutdown to disassemble the upper gearboxes and replace the bearing. It was determined that the preload of the bearings in the external gearboxes was excessively high due to the omission of some shims during GTA assembly as well as inadequate lubrication which caused the early failure.

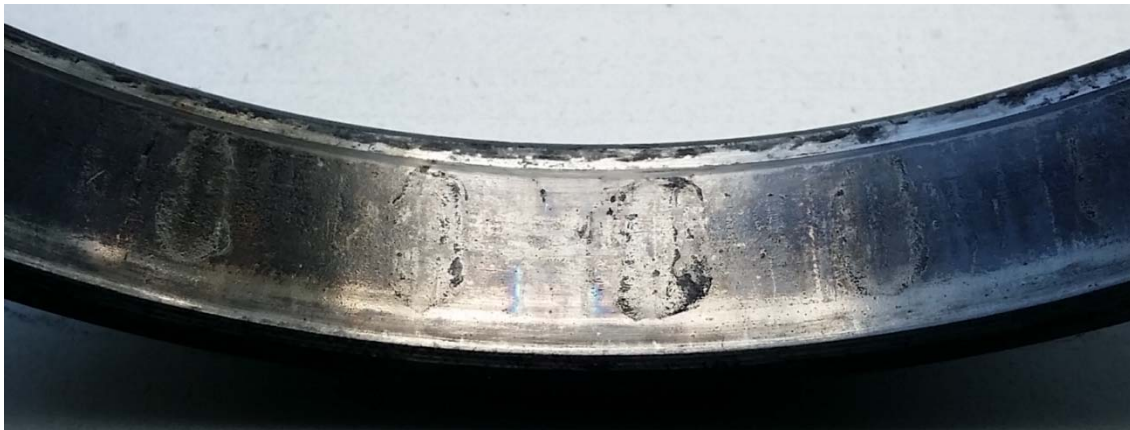
**Figure 21: Outer race shows wear and deformation due to excessive preload and lack of lubrication.**

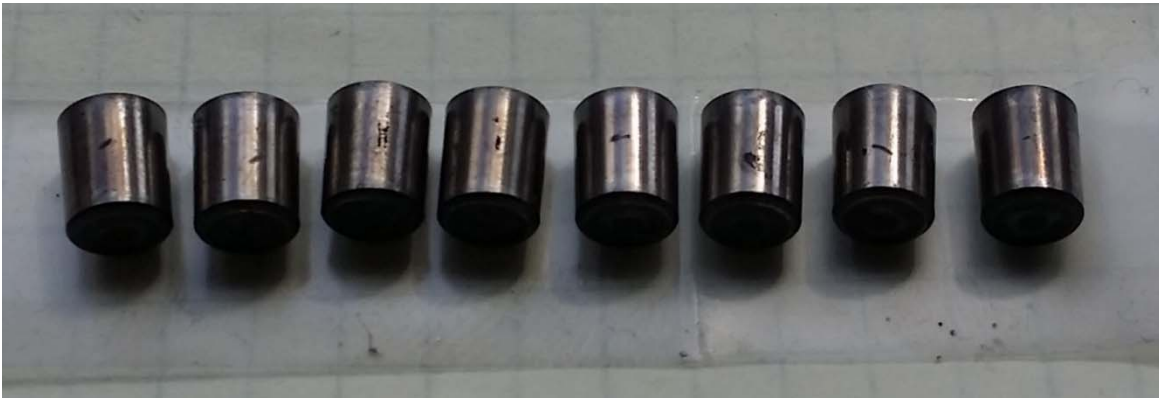
**Figure 22: Tapered rollers show signs of pitting due to excessive preload and lack of lubrication.**

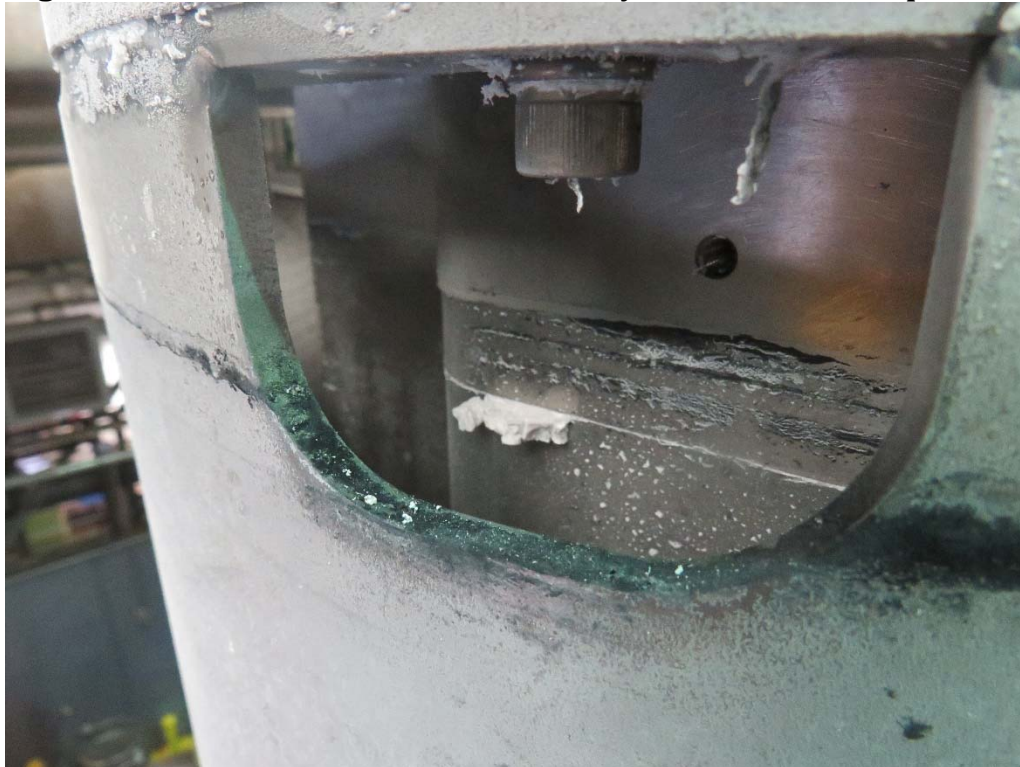
**Figure 35: Sodium bicarbonate production and expansion on GTA.**
