## Gear Test Assembly – Experimental Testing and Gear Analysis – FY2022

Nuclear Science and Engineering Division

prepared by  
E. Kent, H. Belch, C. Grandy  
Nuclear Science and Engineering Division, Argonne National Laboratory

June 2022

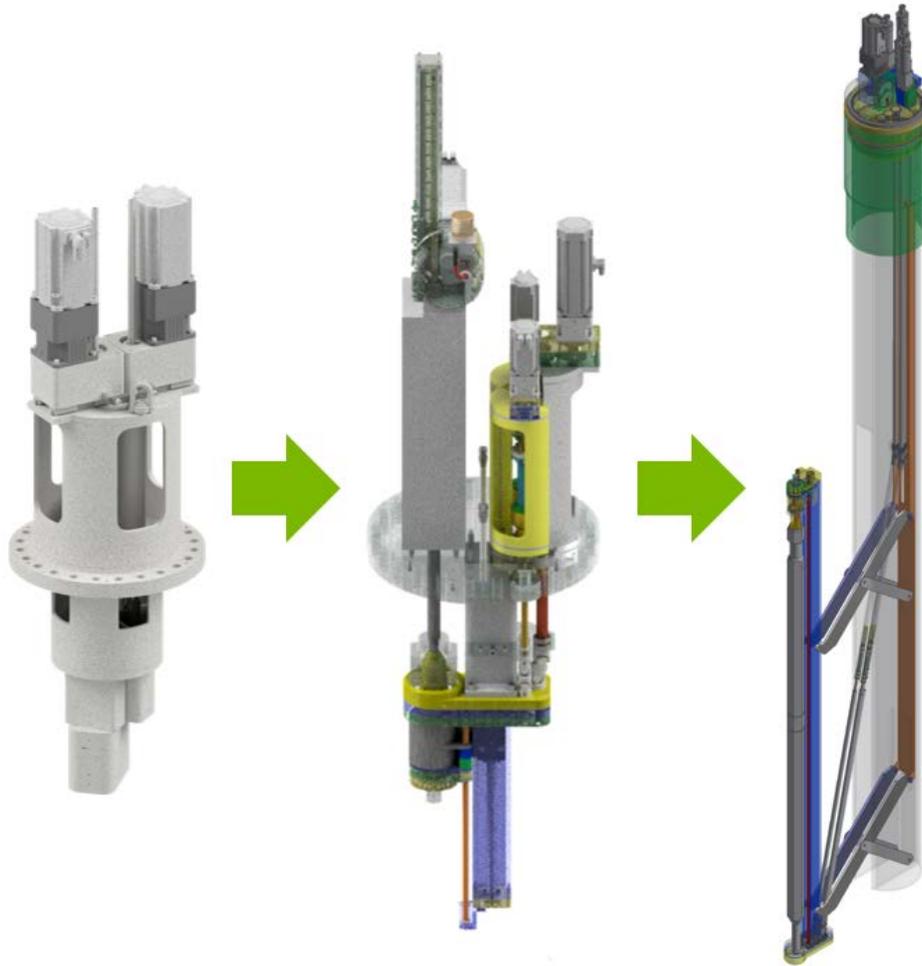
**Figure 1: Progressive experimental plan for the development of a compact fuel handling mechanism. Gear Test Assembly (left), Gripper Test Assembly (mid), Fuel Handling Mechanism (right)**

The performance of the gears and bearings in the GTA has informed the design of the Gripper Test Assembly (GrTA). The GrTA is an experimental assembly that will evaluate the performance of a fuel assembly gripper head that is driven using mechanical components that are submerged in liquid sodium. The GrTA design has been completed and the project is currently in the fabrication phase. Figure 1 shows CAD representations of the GTA, the GrTA, and the final ANL FHM.

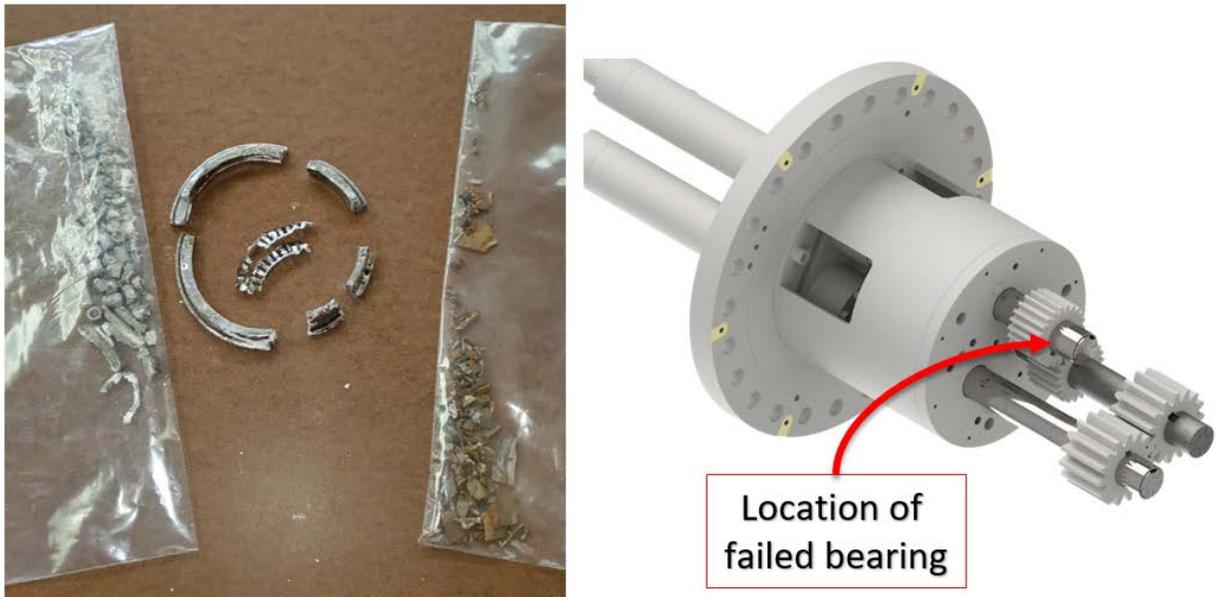
Following cleaning and disassembly of the GTA, a failed tapered roller bearing was found below gear T1BT (Figure 6). The bearing fragmented in the gearbox, causing visible damage to both the gearbox and the shaft (Figure 7). The shaft collar on which the gear and bearings were located was damaged so significantly that it needed to be cut off and replaced (Figure 8).

**Figure 6: Remains of failed tapered roller bearing (left) and location of failed bearing (right) from Experimental Campaign #2.**

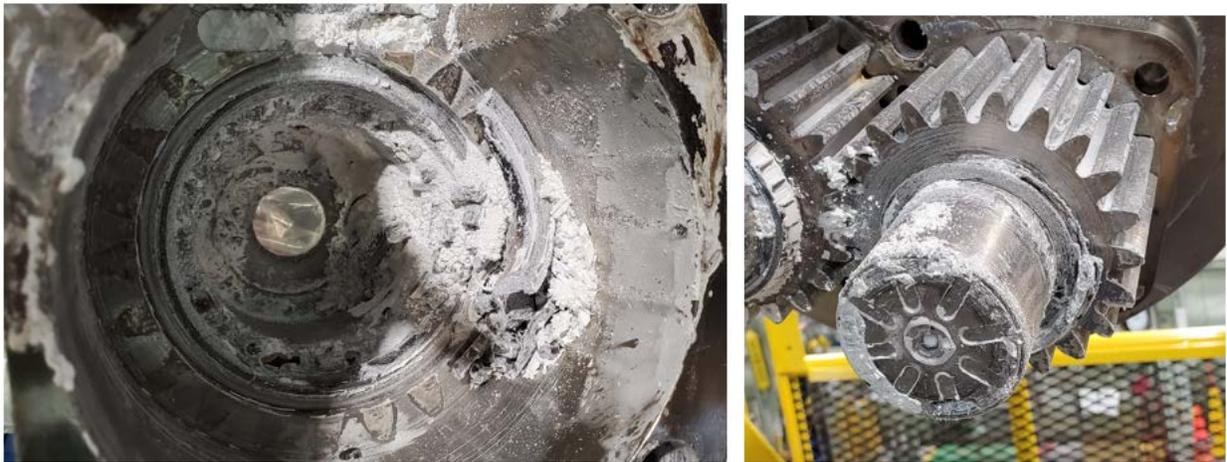
**Figure 7: Remains of bearing in gearbox (left) and on shaft (right).**

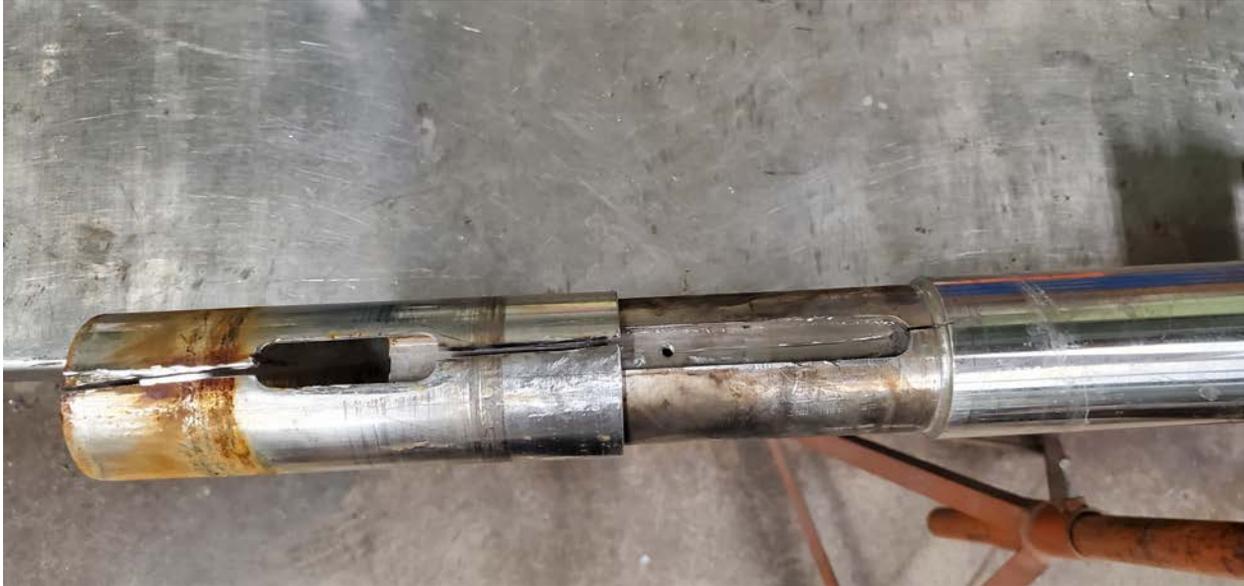
**Figure 8: Damaged shaft sleeve following Experimental Campaign #2.**

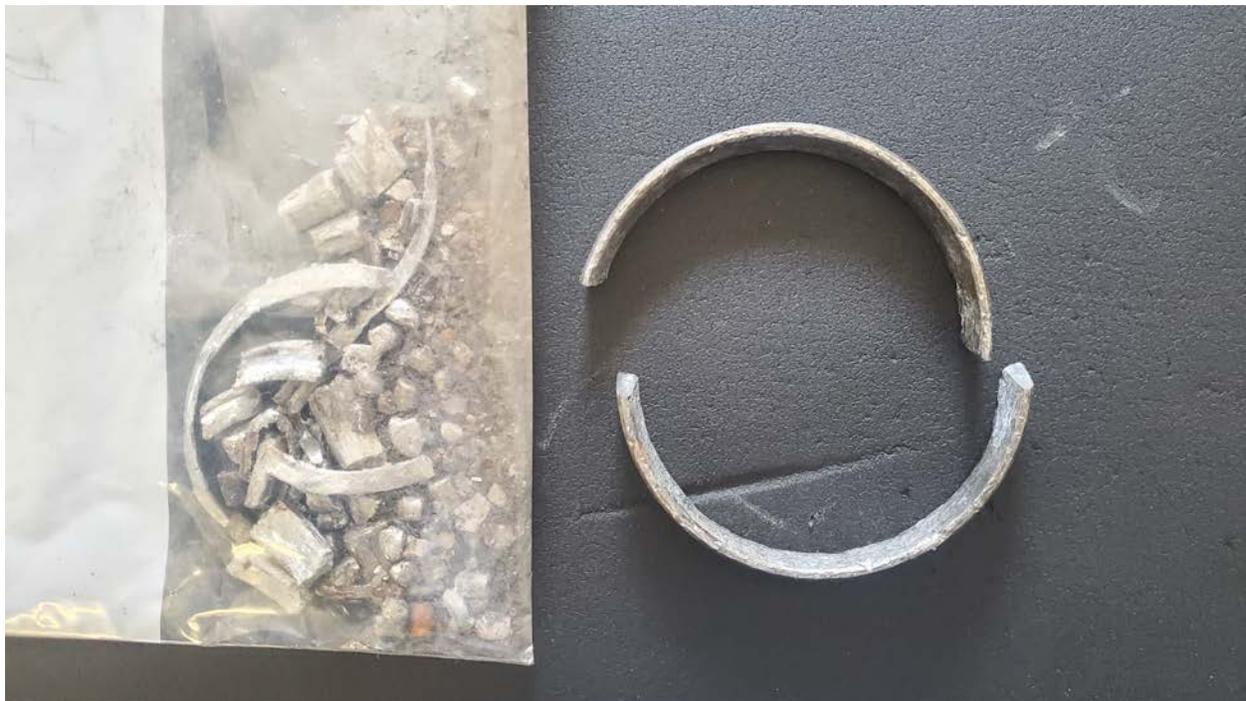
Following cleaning and disassembly of the GTA, a failed tapered roller bearing was found above gear L1IT that had fragmented significantly (Figure 10). An additional failure was found above gear T1BT, but the failure was much less severe (Figure 11). The locations of these failures are indicated in Figure 12.

**Figure 10: Remains of the fragmented tapered roller bearing from Experimental Campaign #4.**

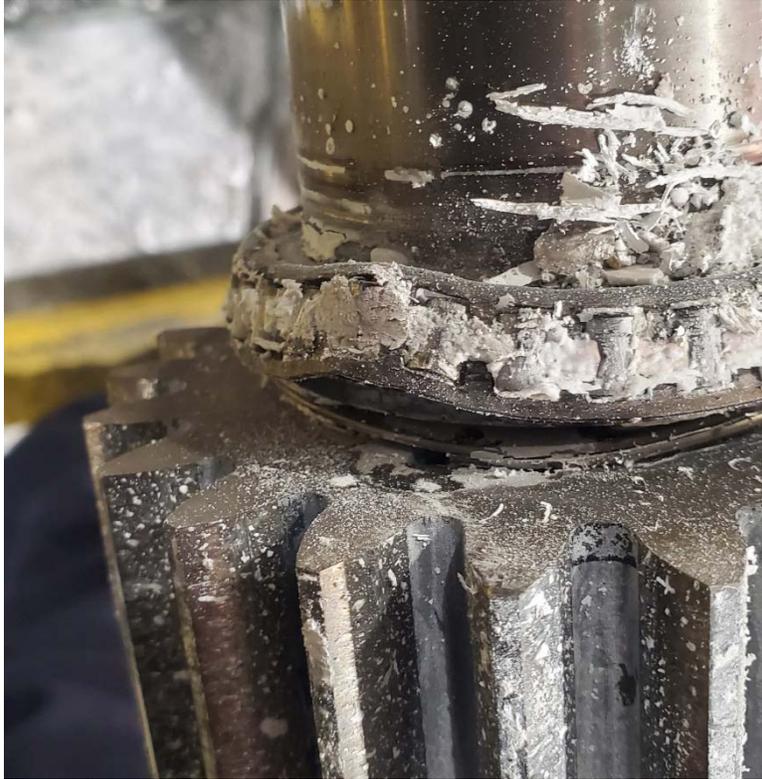
**Figure 11: Damaged tapered roller bearing from Experimental Campaign #4.**

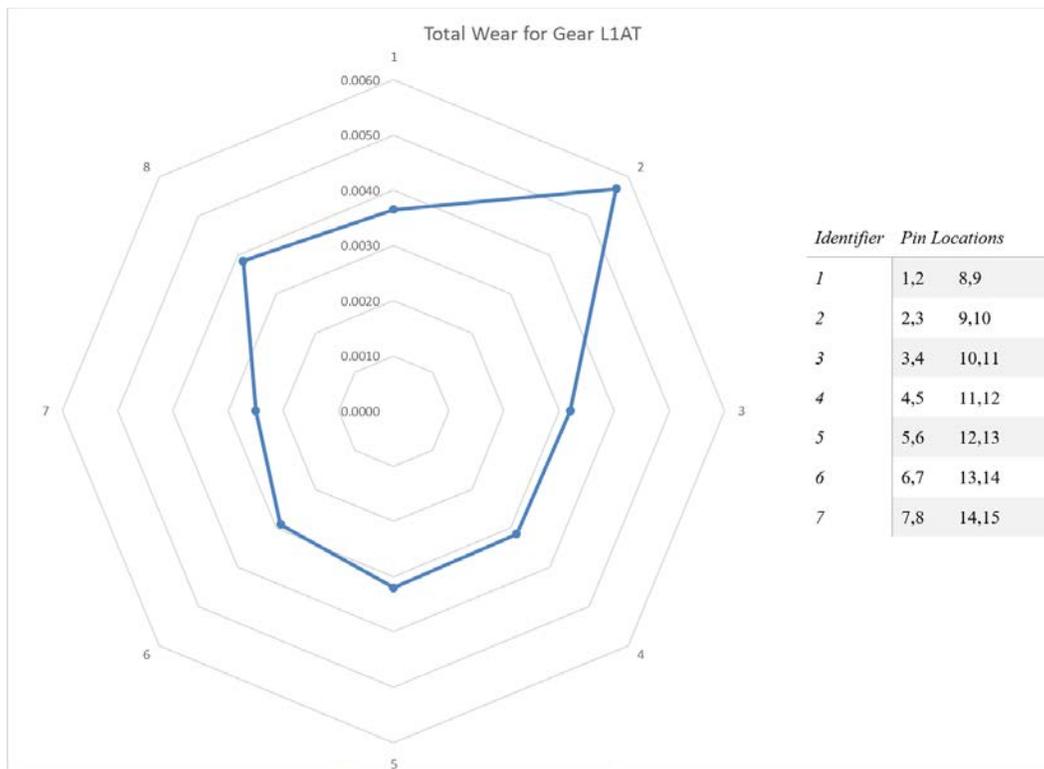
Figure 16, Figure 17, Figure 18, and Figure 19 present polar plots of the change in over-pin dimensions between the initial measurement and the most recent measurement following Experimental Campaign #4. This provides a view of how the gears are wearing across each individual tooth. Gears L1AT, L1IT, and T1IT show fairly uniform wear across all teeth, as what would be expected. Gear T1BT shows rather non-uniform wear, with low changes at Identifier #2, #9, #10, and #11, then large changes at Identifier #1, #4, and #5. One possible explanation is the presence of burrs on the gear teeth that would provide high spots that were not previously measured. Further measurements are needed to determine the cause. A complete record of all over-pin dimensions is provided in the Appendix of this report.

**Figure 16: Total wear measurements for gear L1AT made by taking the difference in over-pin dimensions [inches].**

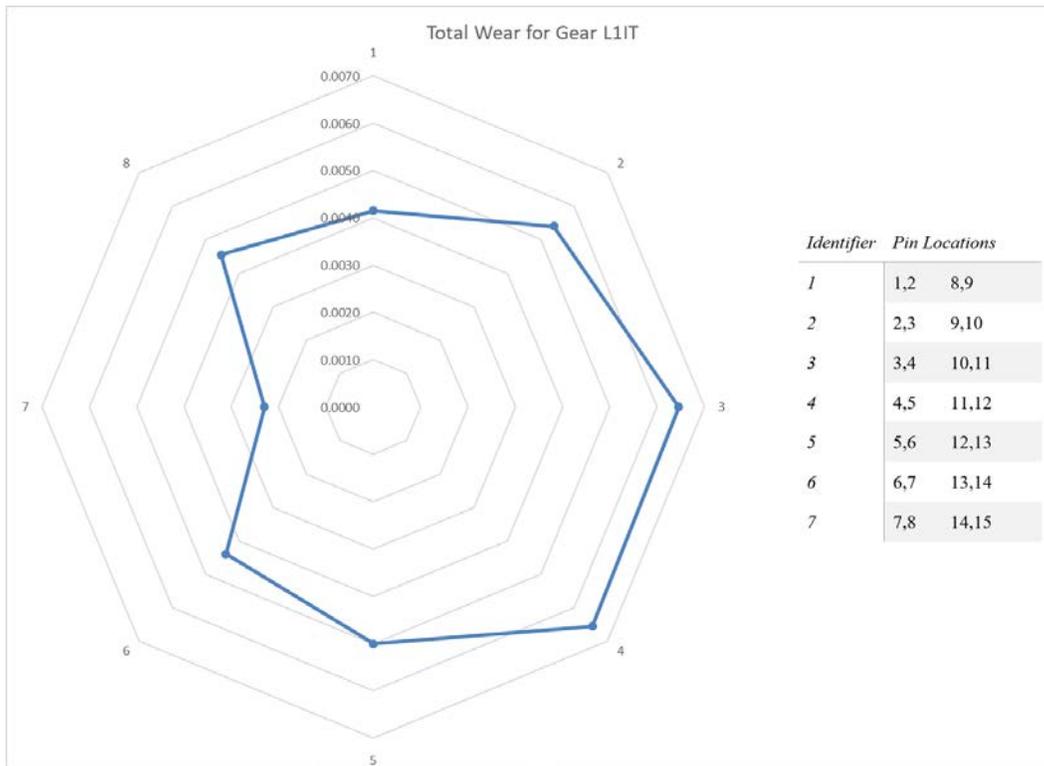
**Figure 17: Total wear measurements for gear L1IT made by taking the difference in over-pin dimensions [inches].**
