# **U.S. Efforts in Support of Examinations at Fukushima Daiichi - November 2022 Meeting Notes and Information Request Status**

**Nuclear Engineering Division**

# U.S. Effort Support to Examinations at Fukushima - November 2022 Meeting Notes Meeting Notes and Information Request Status

April 2023

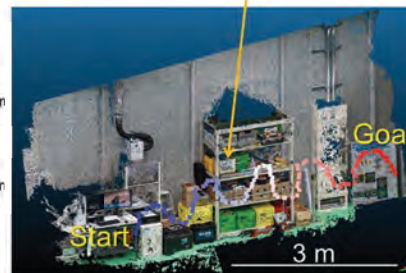
**Self-position and posture information of the moving Compton camera is estimated by SfM.**

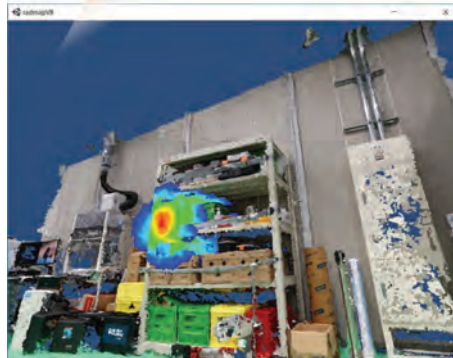
- HMD: Meta Rift S, Meta Quest 2
- **Unity** was used as VR engine

- Experience the work environment from any location using **commercially available VR-HMD**.
- The location of the radiation source can be grasped **inside the VR space**.

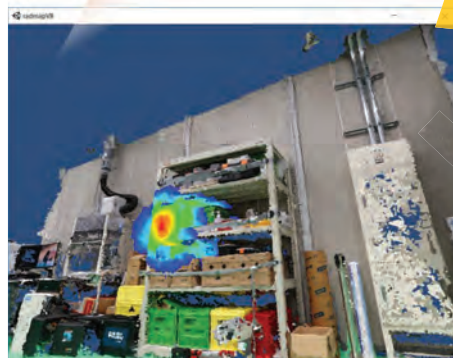
- HMD: Meta Rift S, Meta Quest 2
- **Unity** was used as VR engine

- Experience the work environment from any location using **commercially available VR-HMD**.
- The location of the radiation source can be grasped **inside the VR space**.

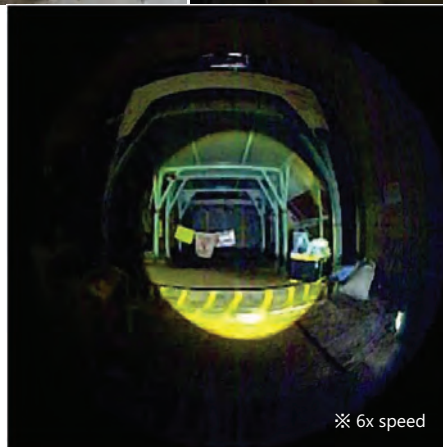
◆Air dose rate in the test area: 5 mSv/h or higher.

◆Measurement was **performed remotely from the Main Anti-Earthquake Building** of FDNPS.

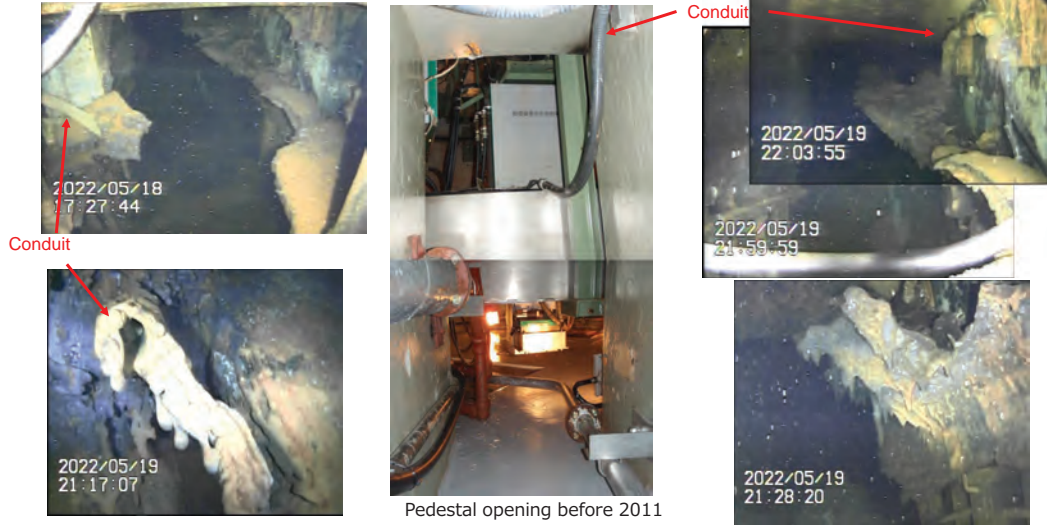
- No significant damage to the upper part of concrete
- Deposits shelves on the right side of the wall increasing in height towards pedestal
- “lavacicles” on bottom surface of the shelves

Free space without water existed below shelves when “lavacicles” formed

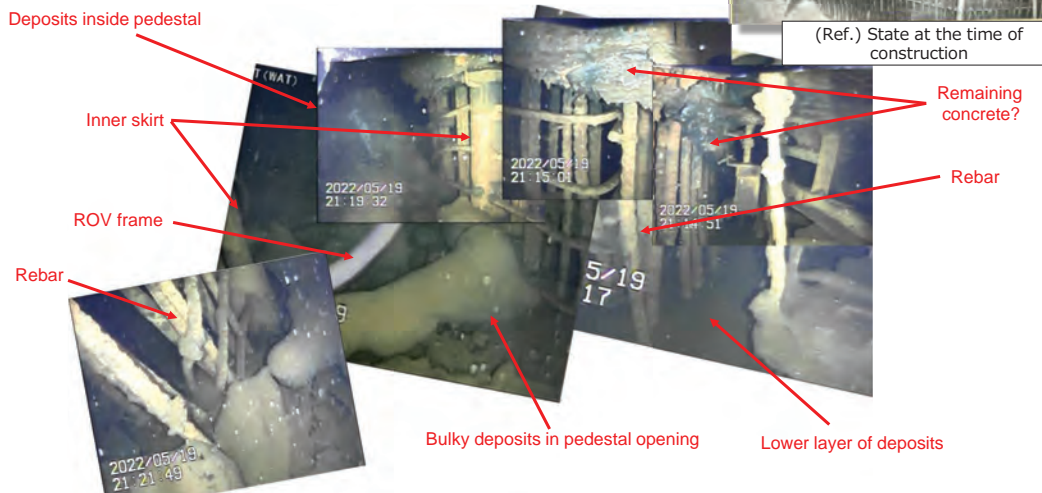
- Concrete degraded up to ~1 m from the floor
- No significant deformation of inner skirt
- Minor deformation of rebar (embossed pattern still visible)
- Height of the deposits inside the pedestal ~1 m

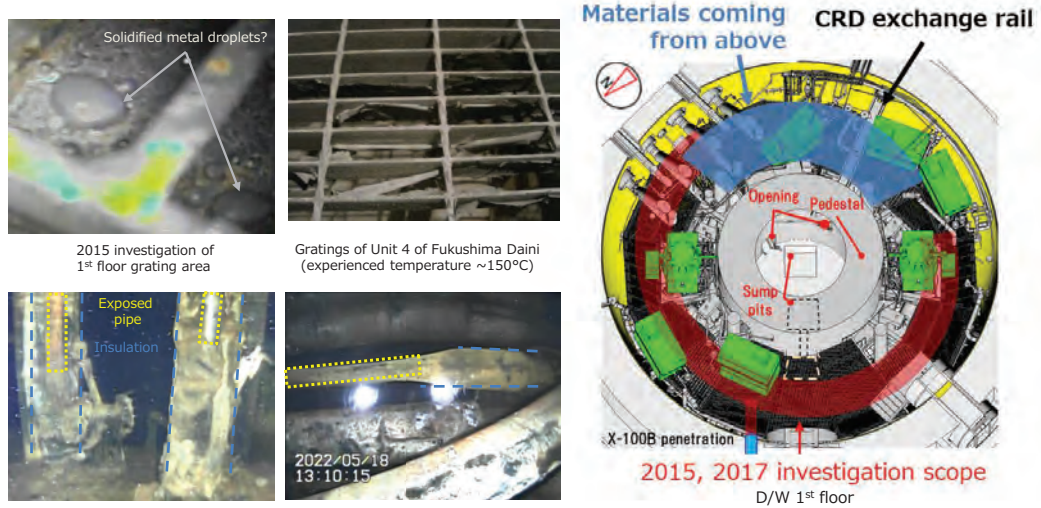
- Lead shielding and Zn galvanized grating from all D/W area (relatively small amount)
- Piping insulation materials? Paints?
- Materials coming from inside the pedestal area through the 1<sup>st</sup> floor CRD exchange rail opening?

RCW piping near equipment drain sump pump (under water)  
©Tokyo Electric Power Company Holdings, Inc. All Rights Reserved.

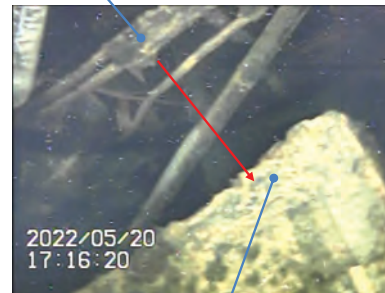
Deposits suspended on structures in water (shielding of equipment drain sump pump)

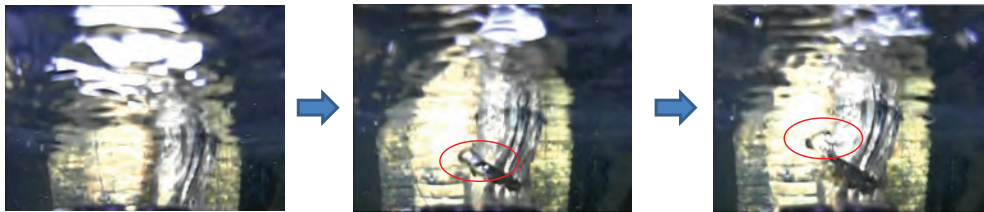
After contact with ROV, fragment of suspended deposit under water level broke away  
A gas bubble emerging from the broken deposit and raising towards the water surface was observed.

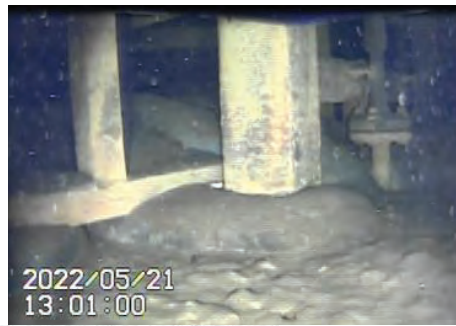
## Locally rising bulky deposits

- Found mainly in the vicinity of PLR piping
- Locally increasing in height even with increasing distance from the pedestal opening
- Considered to be coming mainly from the lead wool blankets shielding
- Lead wool blanket connecting pieces often found in the vicinity or on top of these deposits
- Measured temperature inside PCV on 3/20: ~400°C\*  
\*close to the maximum scale of the instruments
- Lead melting point: 327.5°C
- Local height maximums near the support structures

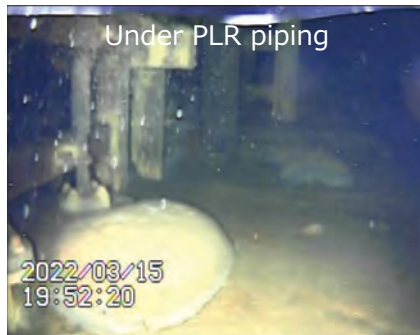
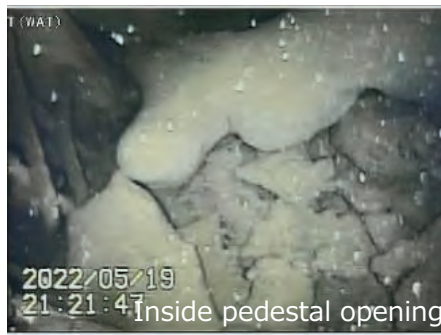
## Bulky deposits

- Found loosely distributed inside the pedestal opening (deposits height minimum)
- Location overlaps with the expected distribution of relocated lead materials
- Difficult to distinguish whether these deposits were relocated from inside or outside of the pedestal
- Appearance (size, smooth surface, etc.) resembles deposits in the vicinity of PLR piping
- Future investigation inside the pedestal area should provide more information about their origin

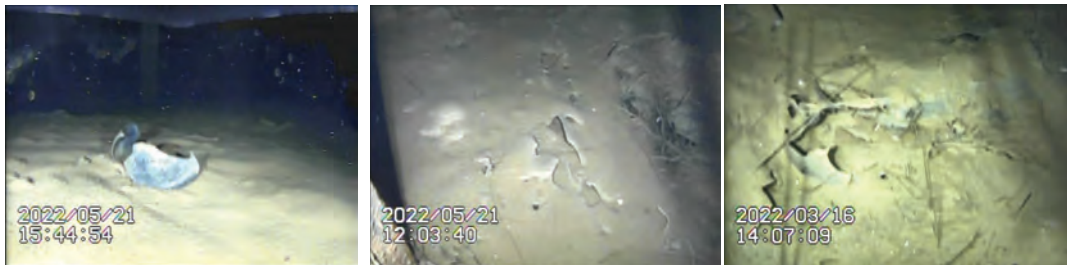
## Eggshell-like deposits

- Found mainly near the pedestal opening
- Similar thin crust objects found in other areas too (mainly overlapping with other materials coming from upper floors), but not forming egg-like shapes

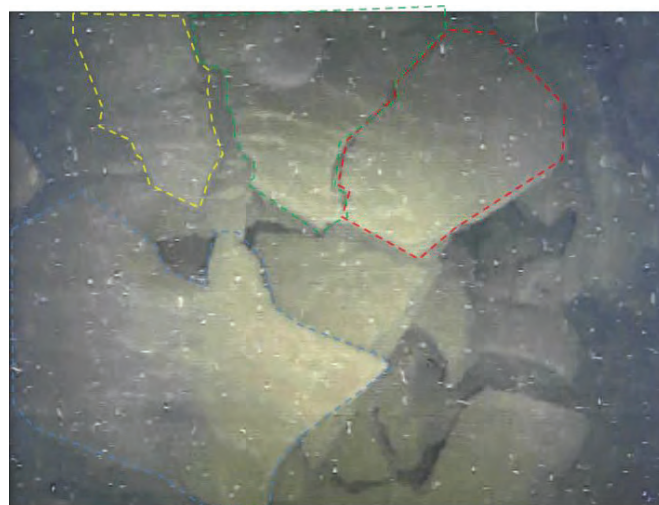
Collapsed shelves

- Shapes of neighboring deposits matching each other in a puzzle-like manner

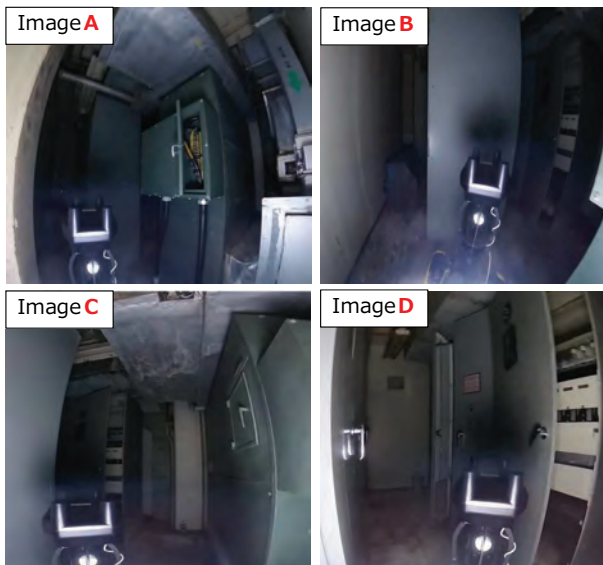
1<sup>st</sup> floor

- no major damage to walls, ceiling, floor, or equipment.
- Maximum dose rate: 28.0 mSv/h (point ①).

- : SPOT path
- ①~⑥ : Survey point (measured on 8/1)
- A~D : Image capture point (captured on 7/25)

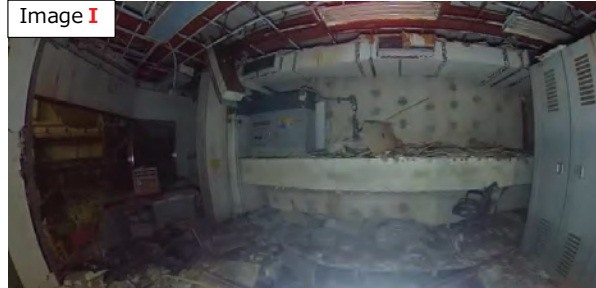
- Gypsum boards fallen from the ceiling
- OA floor plates came off
- Maximum dose rate: 76.1 mSv/h (point 15).

Point	γ dose rate [mSv/h]
⑧	50.5 <sup>※1</sup>
⑨	58.8 <sup>※1</sup>
⑩	50.2 <sup>※1</sup>
⑪	57.3 <sup>※1</sup>
⑫	75.2 <sup>※1</sup>
⑬	60.1 <sup>※1</sup>
⑭	66.8 <sup>※1</sup>
⑮	76.1 <sup>※1</sup>
⑯	73.8 <sup>※1</sup>
⑰	53.2 <sup>※2</sup>

- : SPOT path
- : OA floor plate came off under SPOT's weight
- ⑧~⑰ : Survey point (measured on 8/29)
- I~K : Image capture point (captured on 8/29)

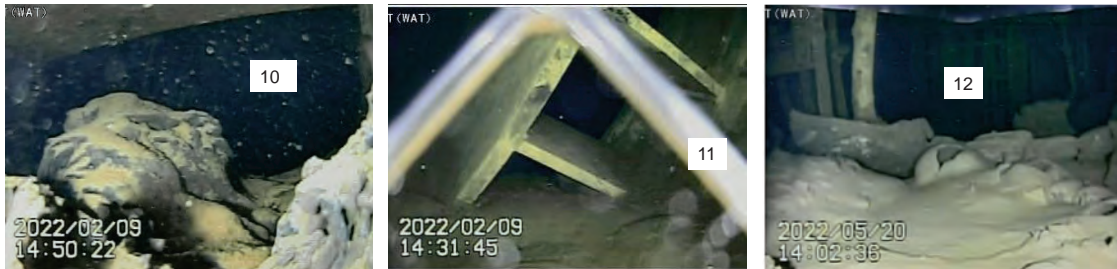
10. Large bubble-like “Crust” exists under the opening ceiling.  
(The thickness is not known.)
11. No Damage is found out at the outer walls of the PCV.
12. Bubble-like image is observed on the surface of debris or crust on the PCV floor.
13. Exact situation of the PCV floor is not known.

(source) Photos are captured from videos taken by TEPCO 7

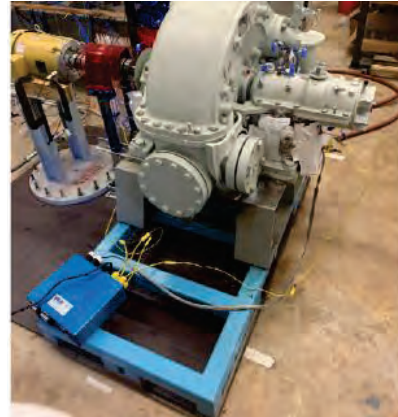
- BWROG-led Terry™ Turbine Expanded Operating Band Project (TTEXOB) expanded and defined actual operating limitations of Terry™ turbine systems (i.e., RCIC/TDAFW)
- Concluded the 1F3 RCIC operation based on available plant instrumentation data is repeatable based on insights from bi-lateral Japan/U.S. Terry™ turbine testing program
- Provided information for RCIC system Terry™ turbine and HPCI system performance models
- New RCIC models benchmarked using Tennessee Valley Authority data in which RCIC system ran on April 27, 2011 after a tornado
- Provided data on no impact on performance for higher bearing oil temperatures
- Provided data to support basis of relaxing the low pressure start up test for Terry™ turbines (eminent submittal for BWROG topical report)

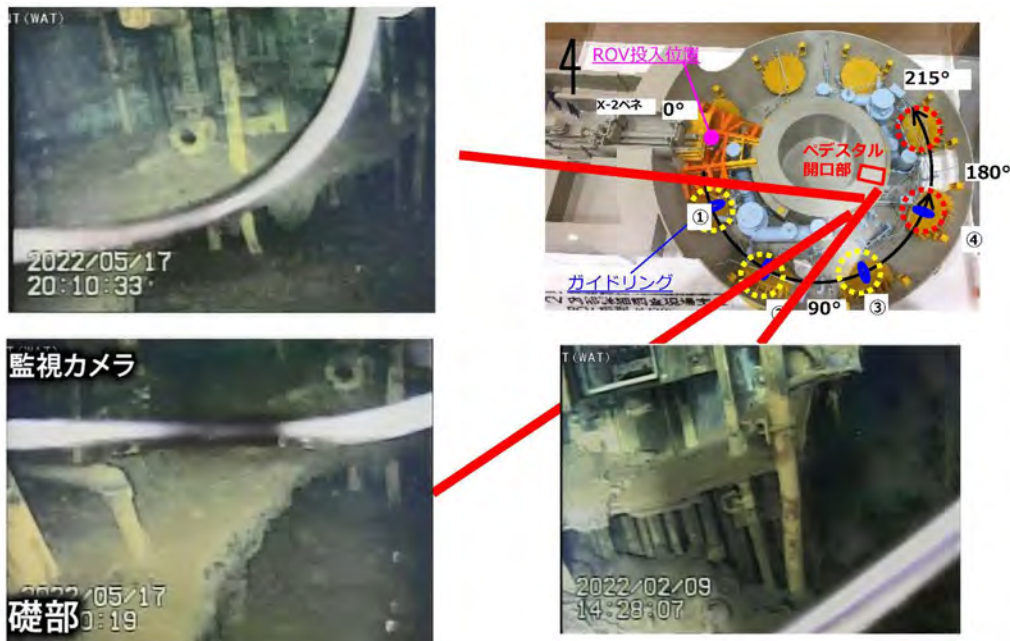
**Figure D-1.** Debris state in drywell near pedestal doorway; upper surface of the crust material is at ~ 1 meter elevation (Courtesy of TEPCO Holdings, [112])

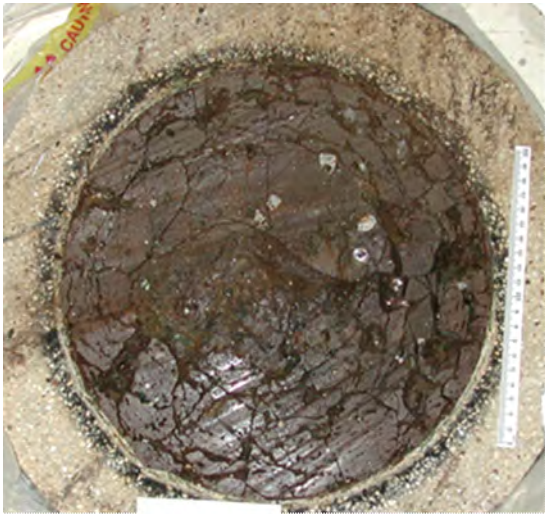
**Figure D-8.** Corium slab (30 cm outside diameter, 5 cm thick) sectioned from SSWICS post-test corium ingot (left); loading device for measurement of crust tensile strength (right)

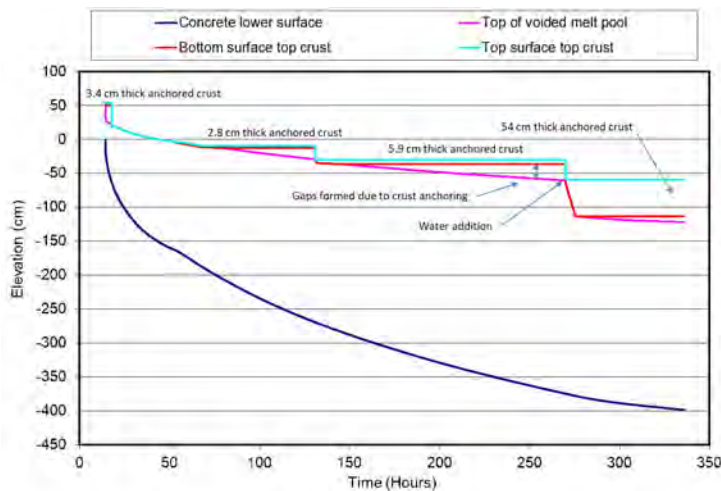
**Figure D-16.** Predicted surface elevation evolutions in the drywell annulus for 1f1 over the first 14 days of the accident.
