Inspection Status Report of Site A/Plot M

Report for 2023

2023 Inspection Status Report of Site A/Plot M

September 2023

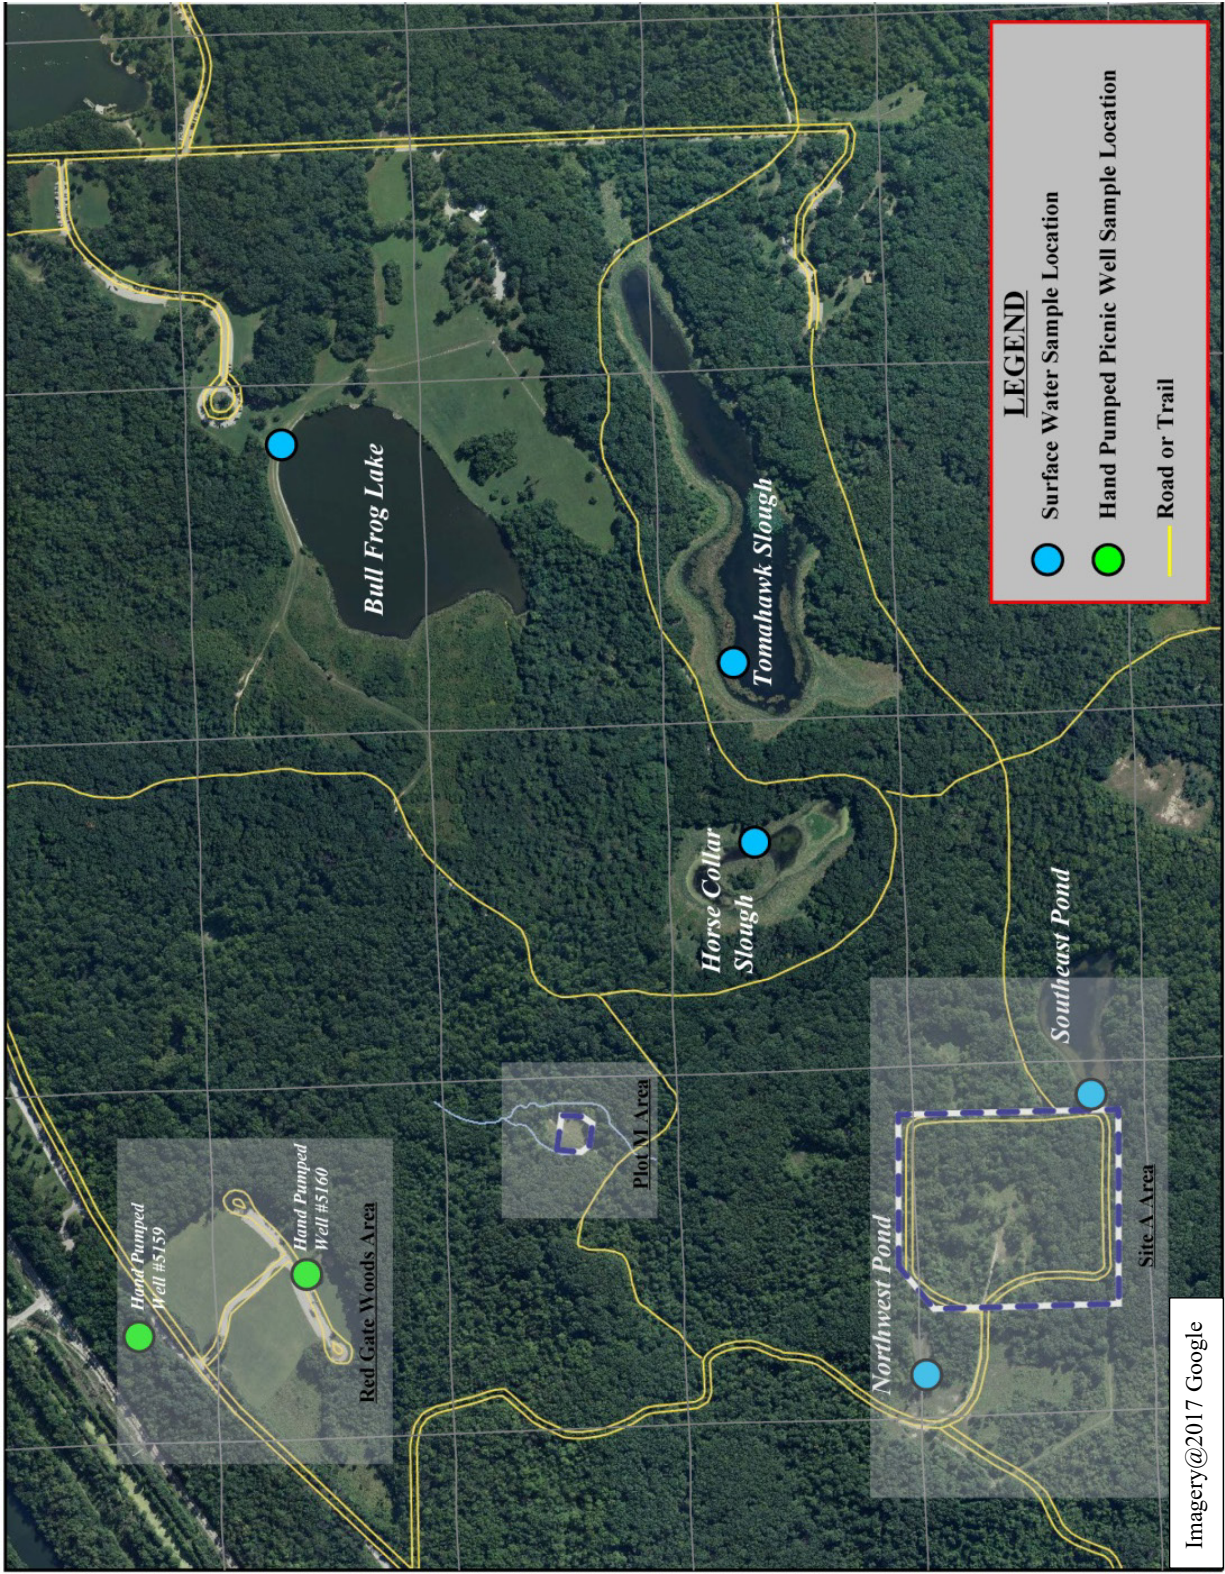
Figure 2-2 Site A/Plot M Area Map

Site A is a 19-acre area that contained experimental laboratories and nuclear reactor facilities; Plot M, is a 150 ft x 140 ft area used for the burial of radioactive waste. Operations at Site A began in 1943 and ceased in 1954. Among the research programs carried out at Site A were reactor physics studies, fission product separations, hydrogen-3 recovery from irradiated lithium, and work related to the metabolism of radionuclides in laboratory animals. Radioactive waste and radioactively contaminated laboratory articles from these studies were buried at Plot M. At the termination of the programs, the reactor fuel and heavy water, used for neutron moderation and reactor cooling, were removed and shipped to Oak Ridge National Laboratory. The biological shield for the CP-3 reactor located at Site A, together with various pipes, valves, and building debris, was buried in place in 1956. Currently at Site A, the only structures visible are the stone monument, information signage, a remnant of the original chain-link fence, fence post sections, and the remaining two groundwater monitoring wells.

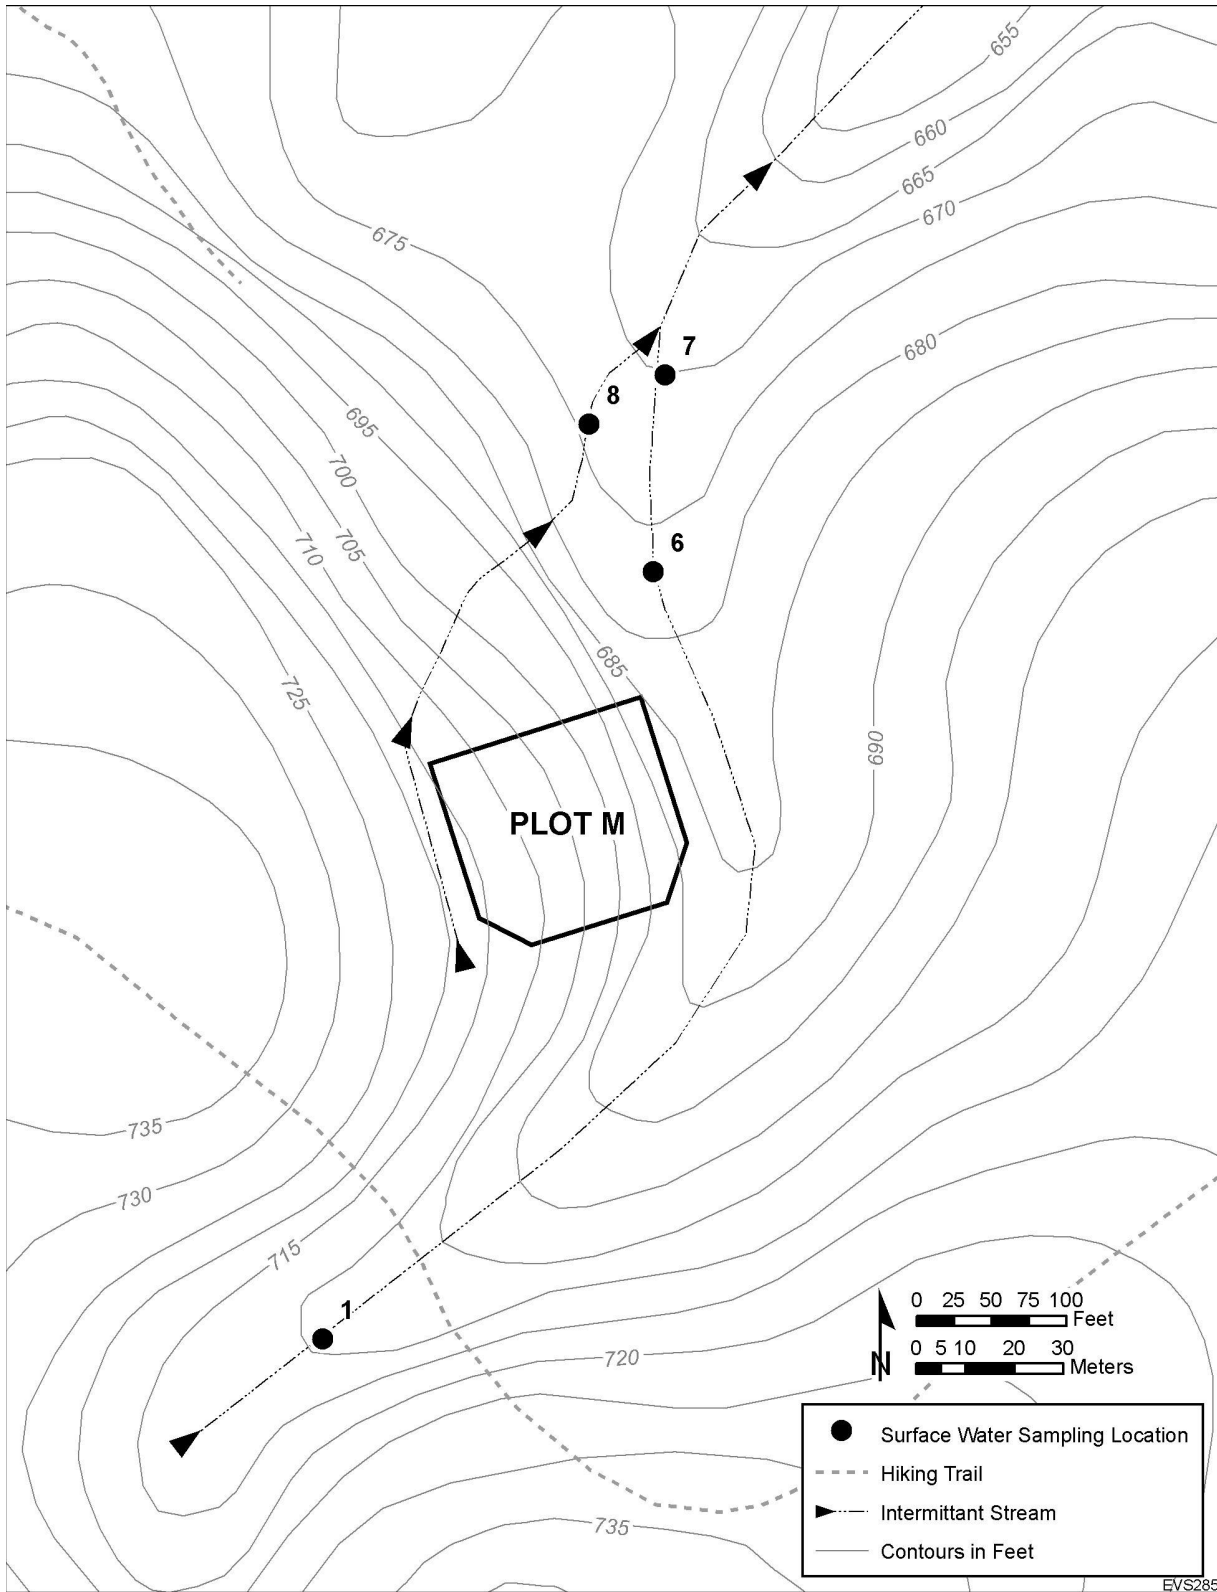
Figure 4-2 Stream Sampling Locations Near Plot M

During the time of the inspection, Plot M surface water flow was nonexistent from the four sampling locations along the two stream beds that flow around Plot M, shown in Figure 4.1. Location 1 is upstream of the Plot M area. Locations 6, 7, and 8 are immediately north and downstream of Plot M.

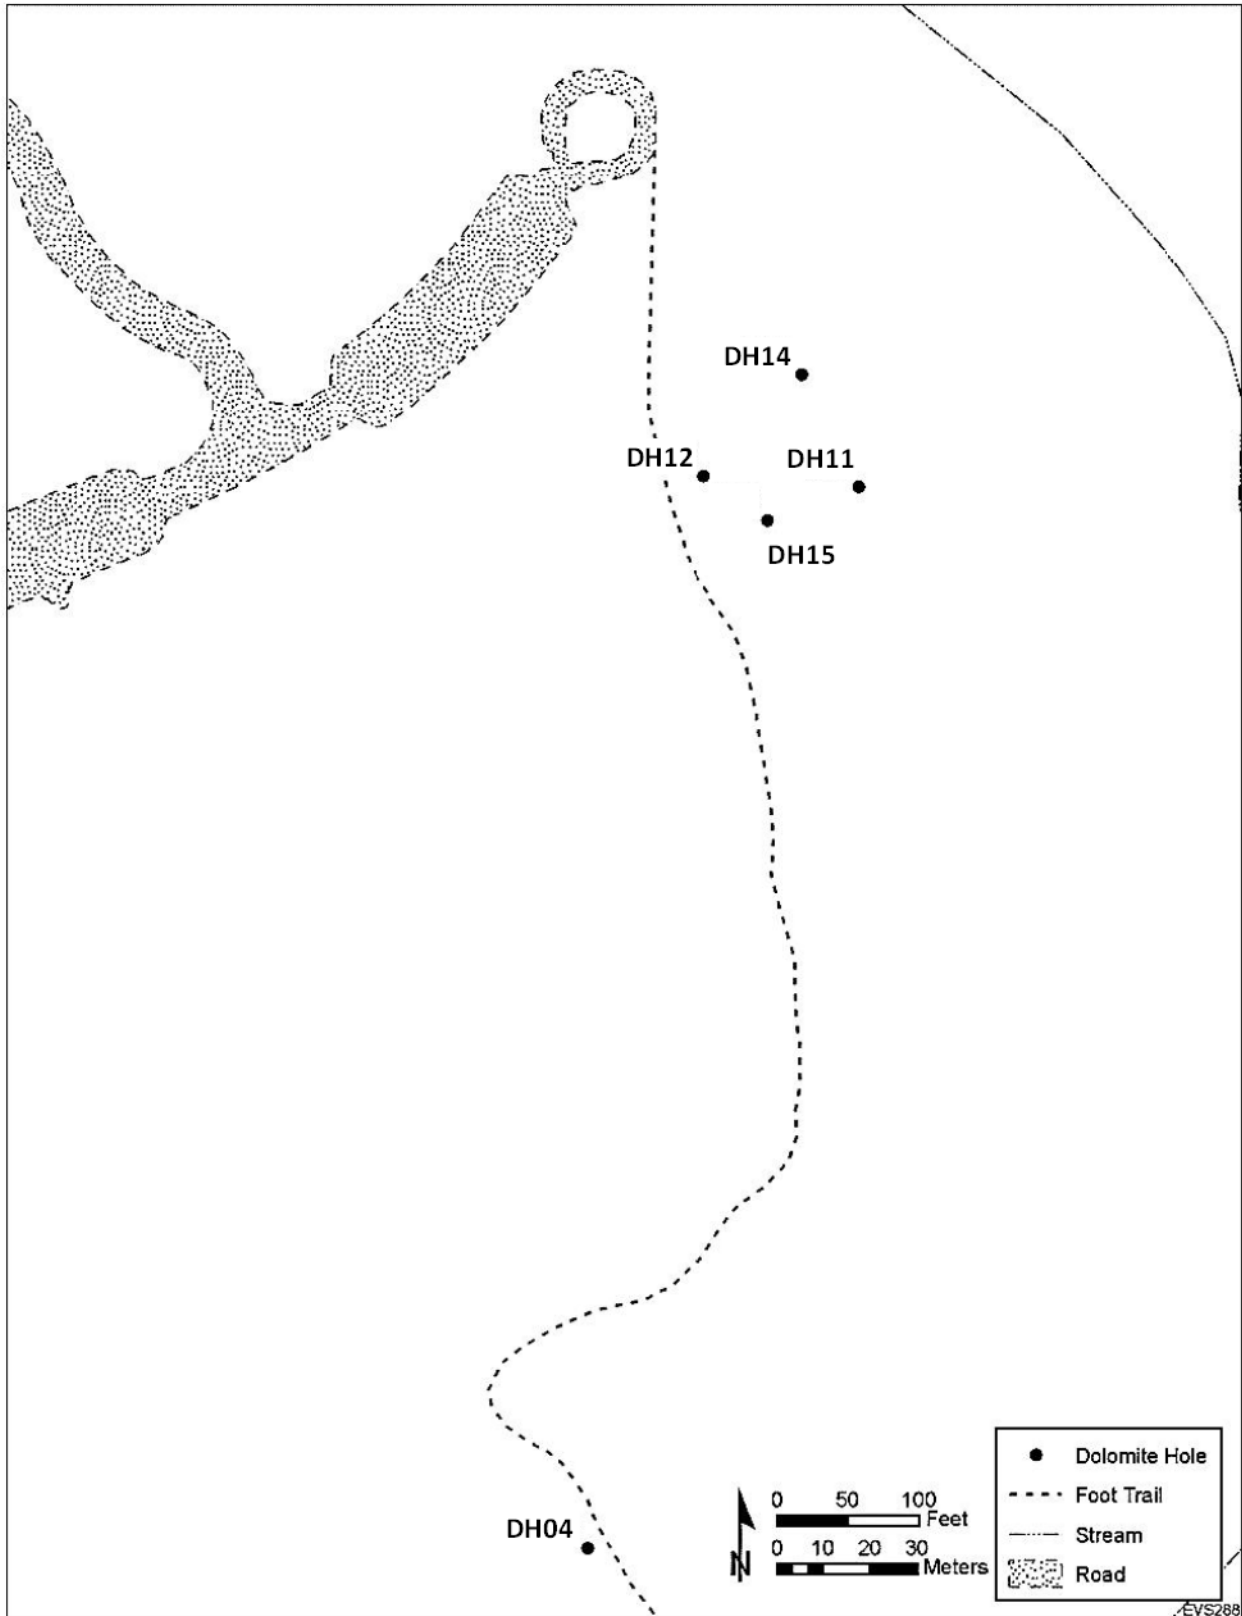
Figure 4-5 Locations of Dolomite Wells North of Plot M

Six wells cased into the dolomite bedrock are located downgradient of Plot M. One of the dolomite wells is located near Plot M, and five are located north of Plot M in the Red Gate Woods area, as shown in Figure 4.5. The two dolomite wells, DH03 and DH04, are located close to and downgradient of Plot M. All six of these wells are shown in photographs P12 through P17.

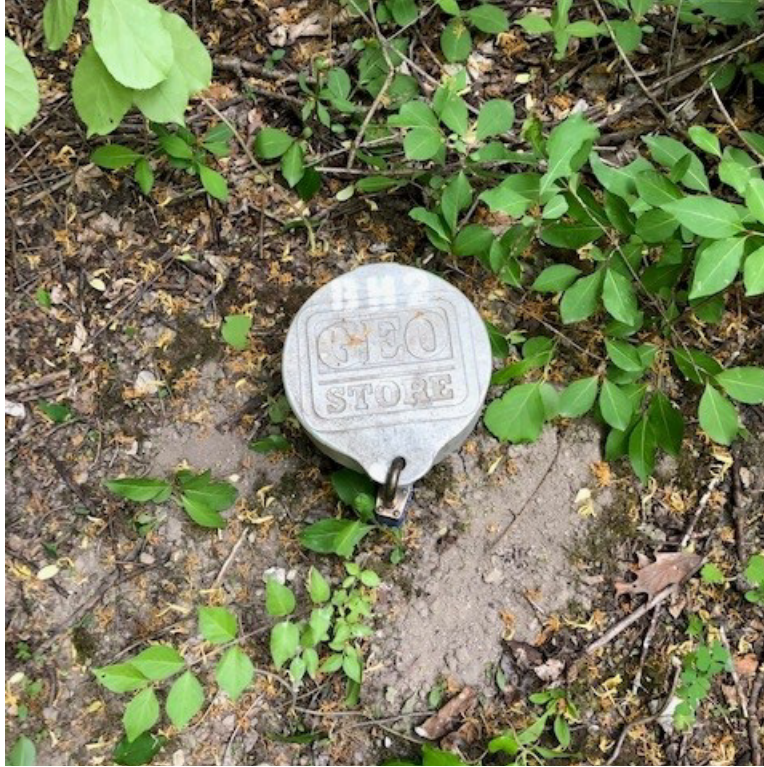
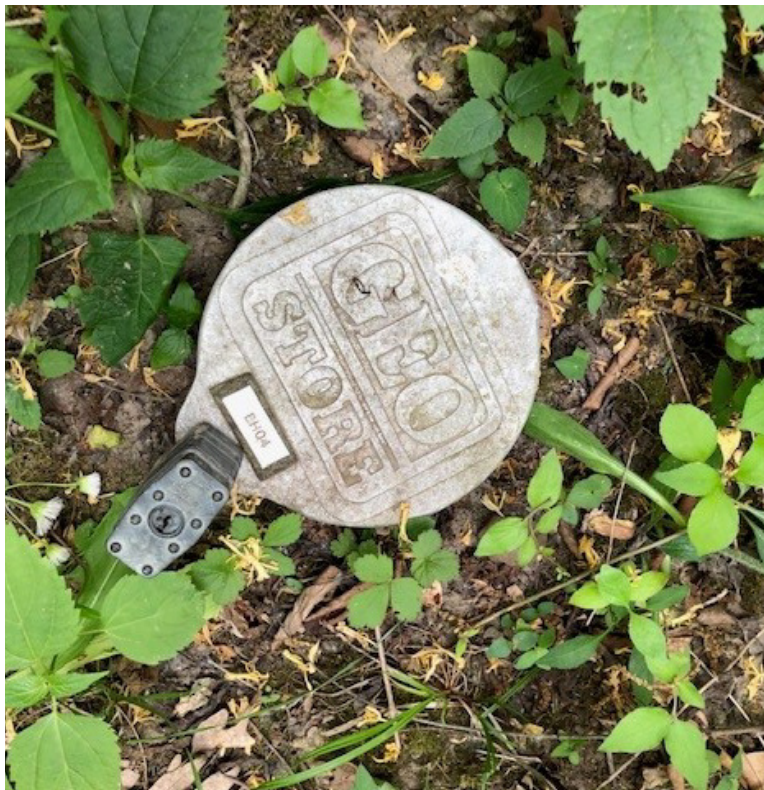
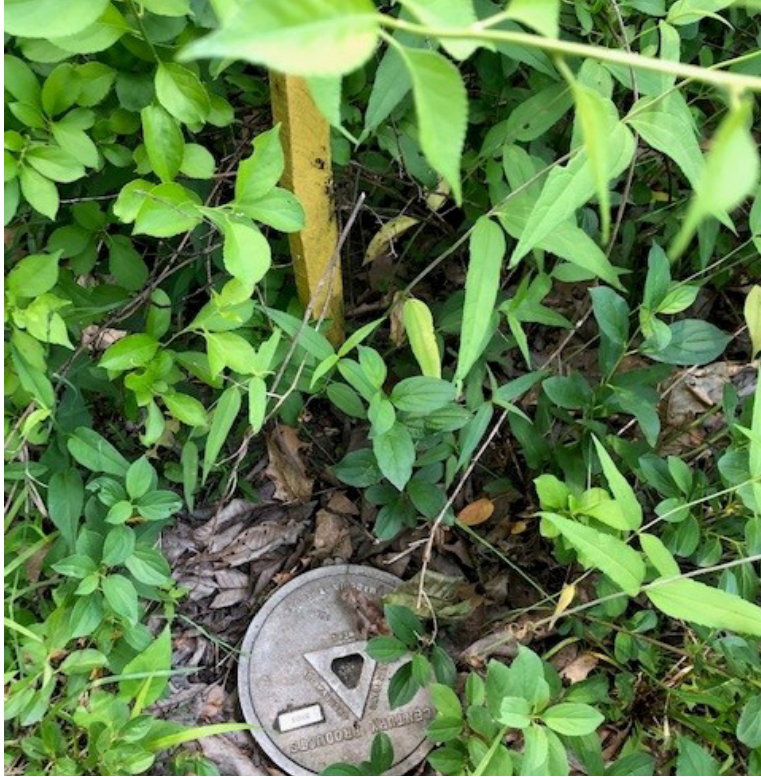
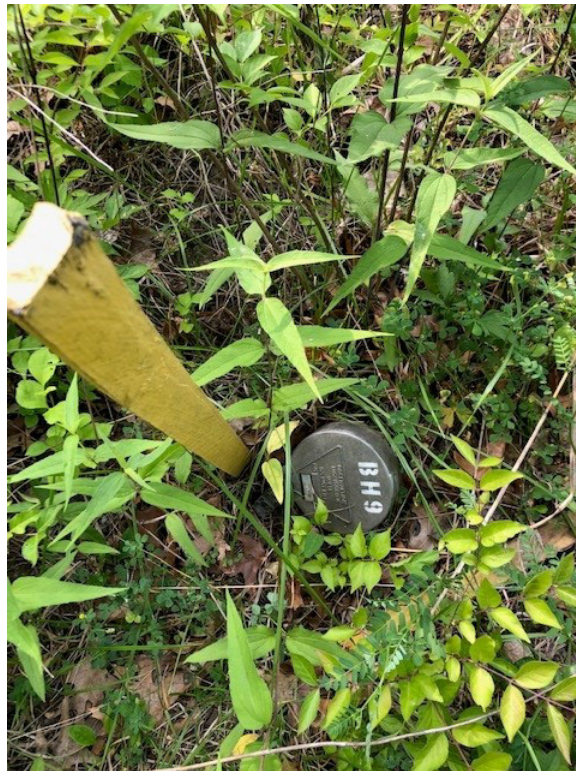
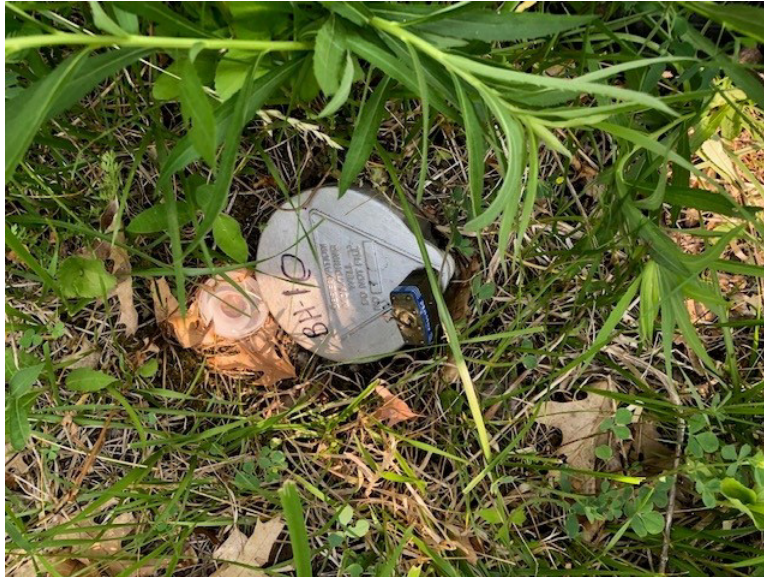
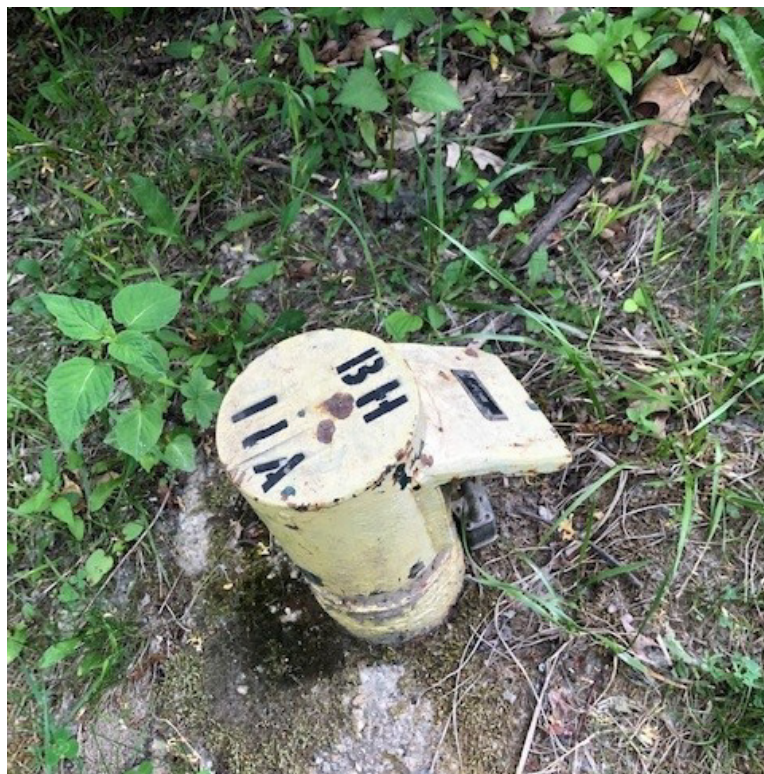
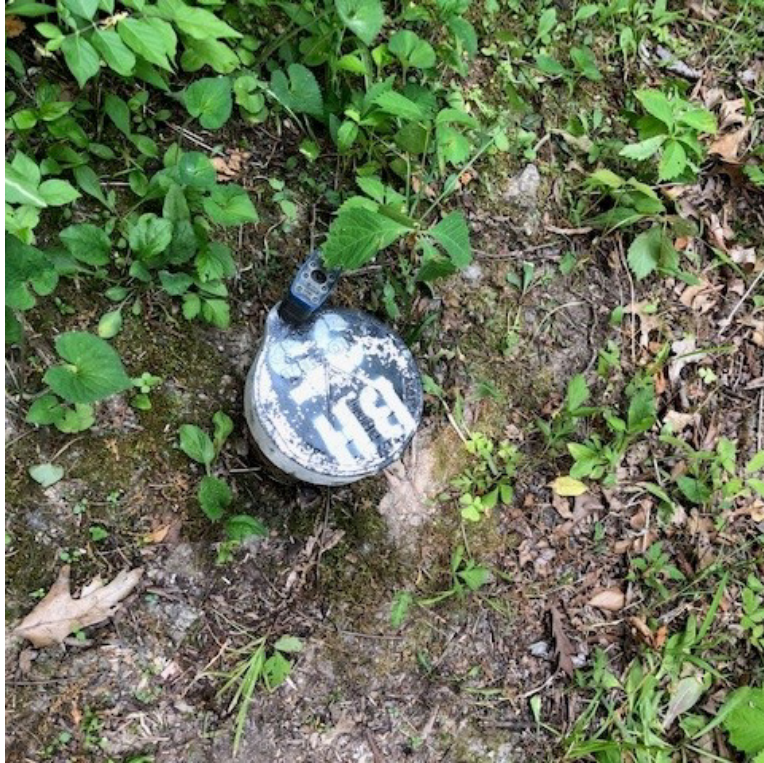
All groundwater wells at Plot M were locked and intact and found to be in good condition. During the inspection, Argonne noted that the identification found on the well cap to BH26 was absent. Immediate action by Argonne involved re-painting and affixing a new label to the BH26 well cap. This was cited as an improvement opportunity, and further discussed in Section 5.0 of

this report. Photographs P01 through P09 show the various monitoring wells at Plot M. Argonne personnel are keeping the Plot M monitoring wells secure and in good condition.

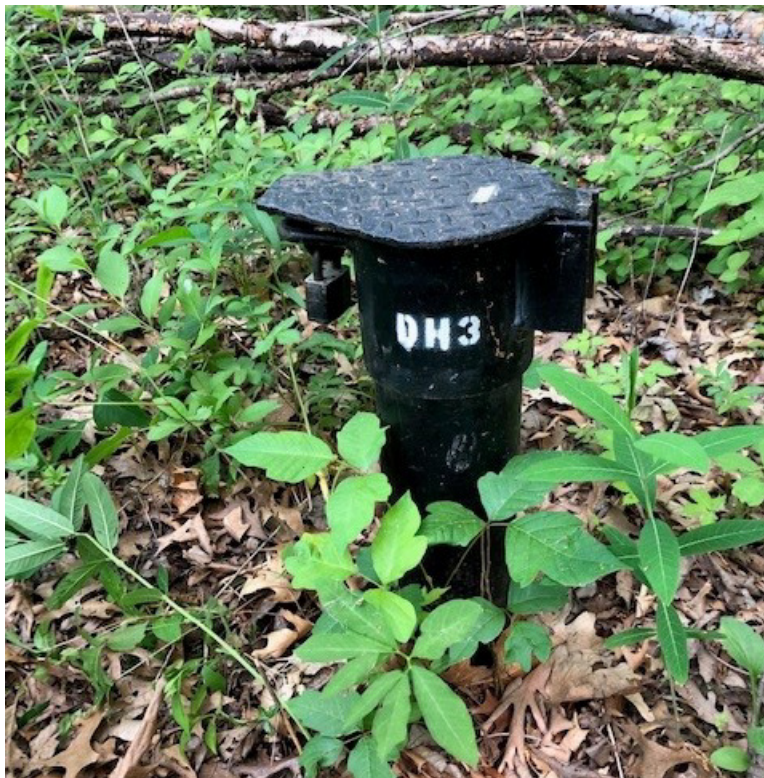
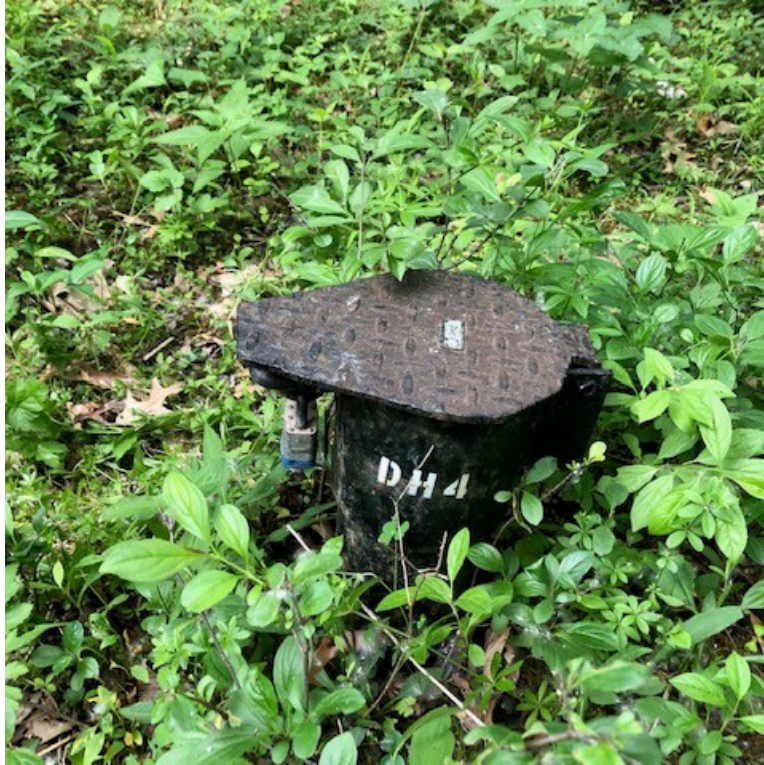
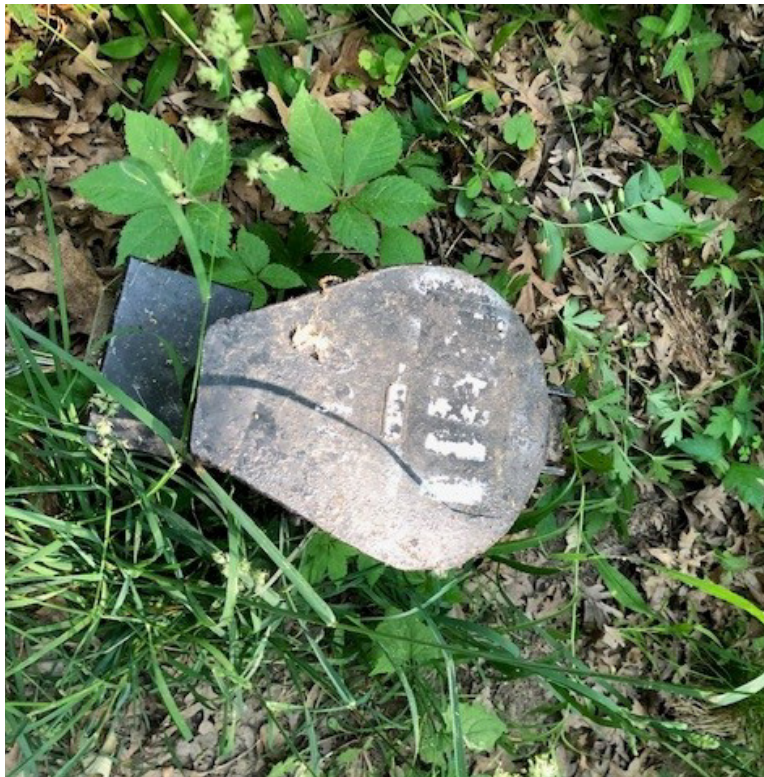
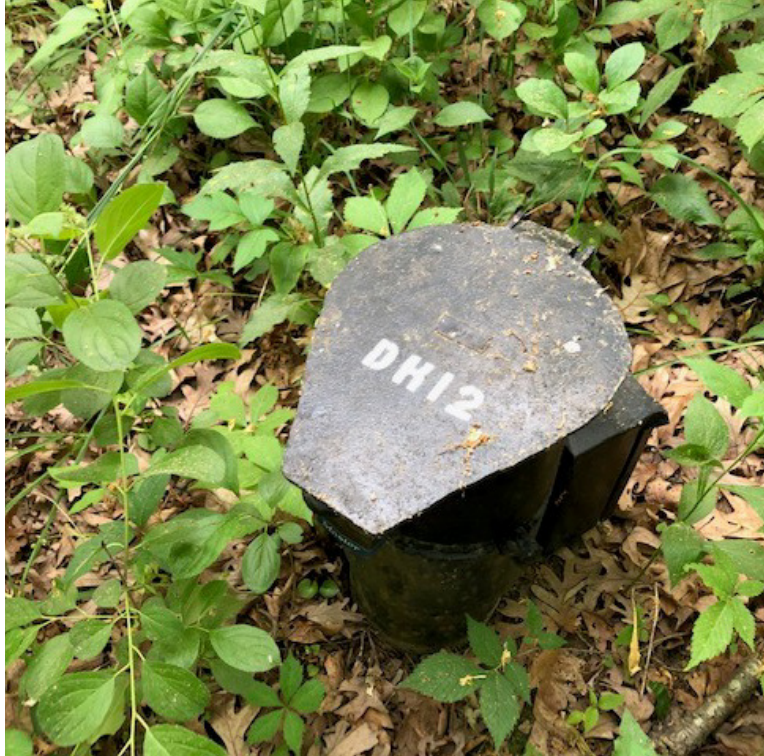
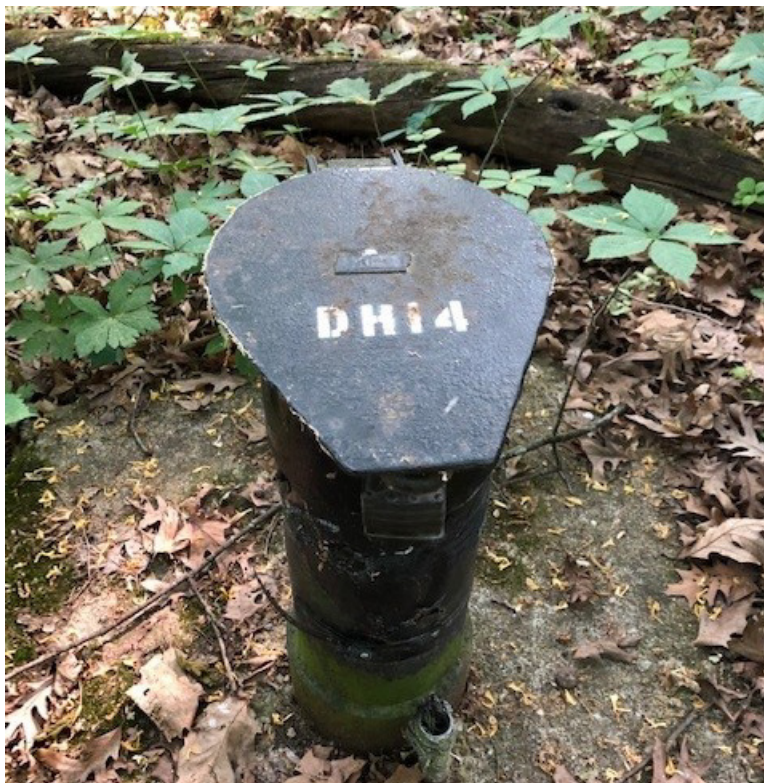
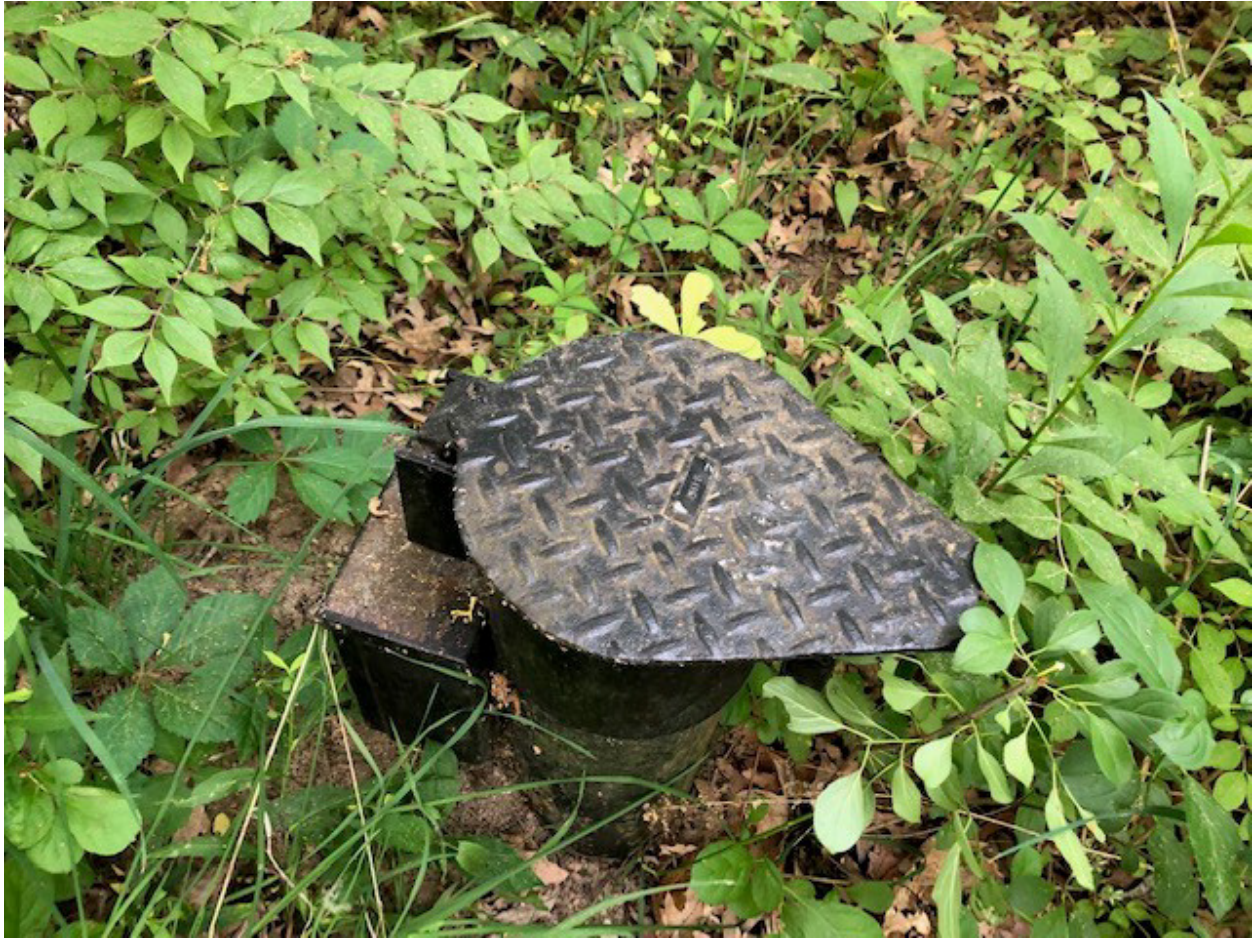
Six dolomite wells, shown in Photographs P12-P17, were all locked and intact and in good condition with all well numbers on the outer casing. Argonne personnel are keeping the Red Gate Woods monitoring wells secure and in good condition.

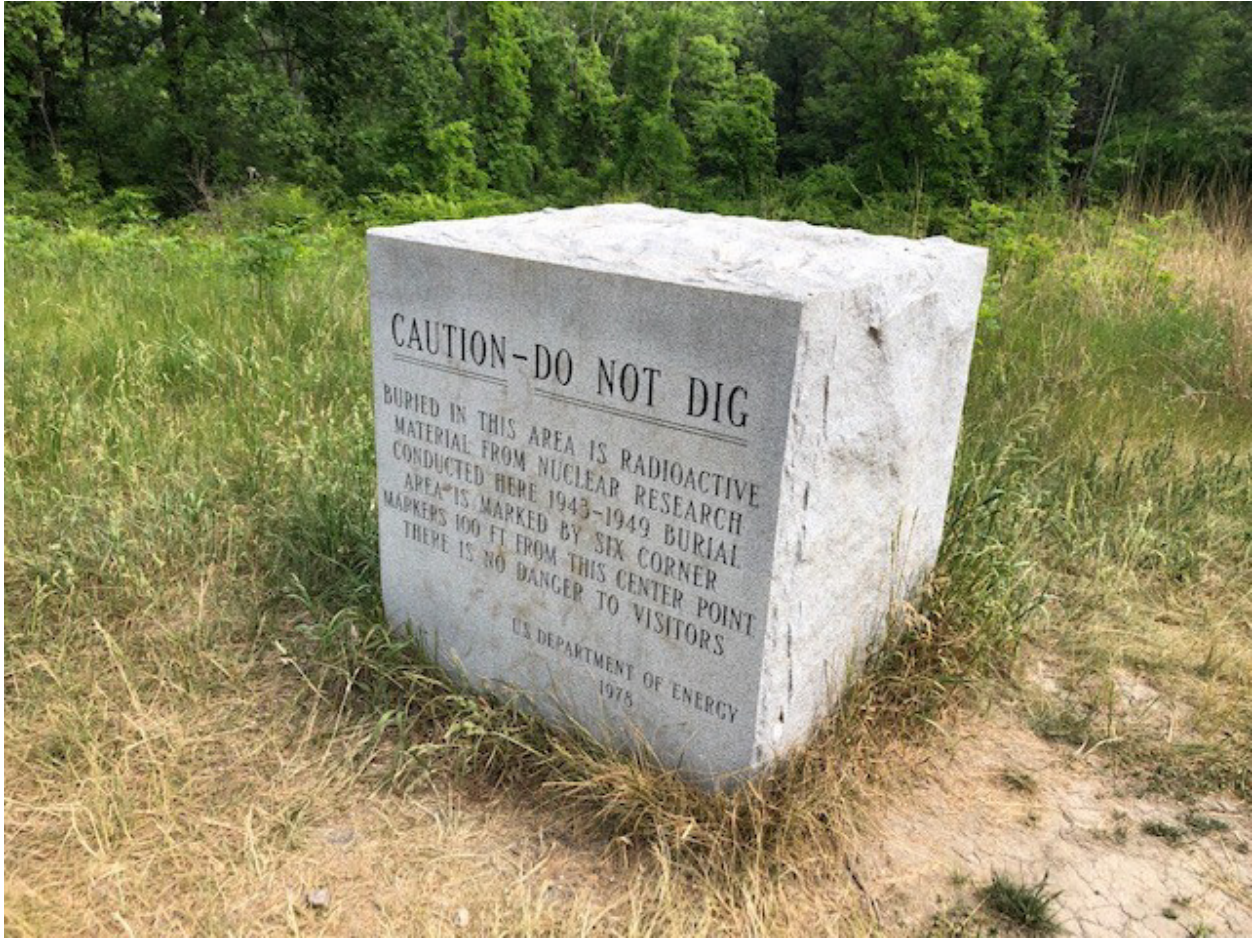
P18 - Plot M Monument, Front View

The Plot M monument was replaced in May 2021. Several letters had been chiseled off the old monument by vandals as reported several years ago. Photographs P18 and P19 show the new monument at Plot M; it remains in good condition. During the inspection, graffiti, which appeared to be made using charcoal, was observed on the rear face of the Plot M monument. Noted as an improvement opportunity, and further discussed in Section 5.0 of this report, Argonne will remove the graffiti. All six corner markers of Plot M were located during the inspection and found to be in good condition. Photograph P20 shows one of the Plot M corner markers, with the Plot M monument in the distant background. Erosion controls have been reasonably effective with the addition of four additional landscape timbers installed in 2020 along the north trail. Argonne conducts quarterly maintenance reviews of the cap and north trail. Photograph P21 shows the terraced steps along the eastern slope of Plot M. Photograph P22 shows erosion control measures recently carried out by Argonne in the Spring of 2023.

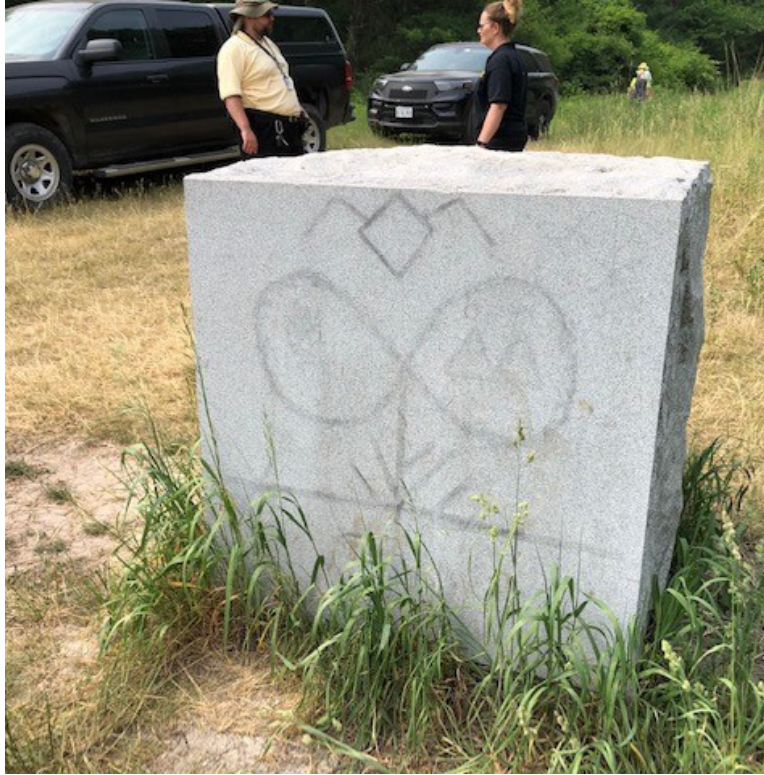
P19 – Plot M Monument, Rear View, with IEMA Representatives in Background

1. **Improvement Opportunity #1:** At the time of the inspection, the rear of the Plot M monument was observed to have been tagged with graffiti, which appeared to be made using charcoal.

Corrective Action: Argonne personnel will remove the graffiti from the rear of the Plot M monument prior to November 1, 2023.

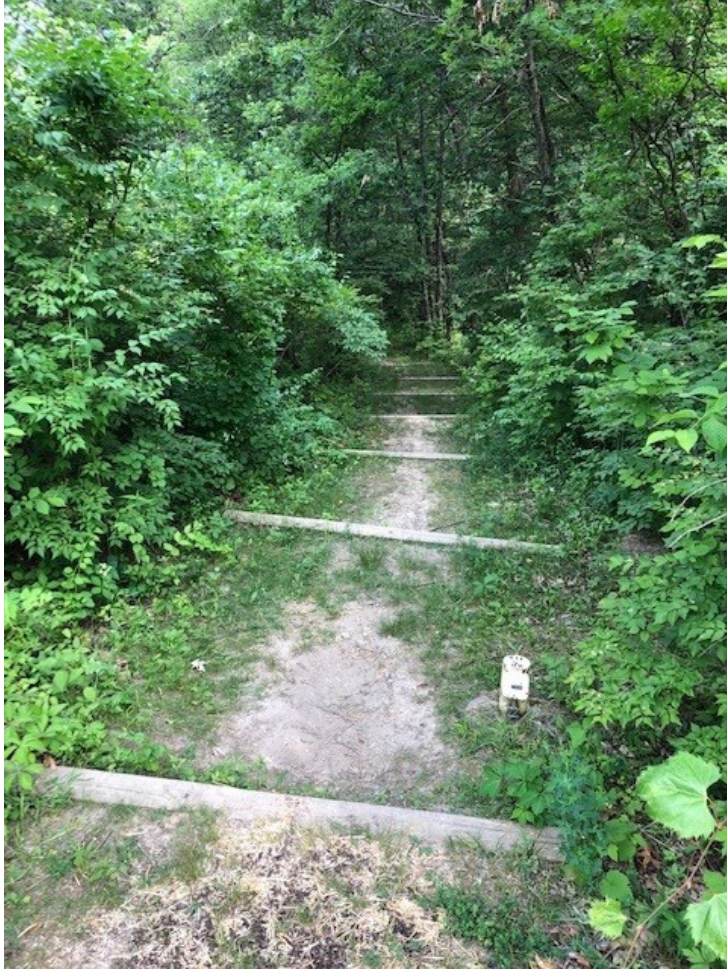
P21 – Terraced Steps Along Eastern Slope of Plot M

During the May 2018 Annual Inspection, increased erosion was noted along the path from the northeast corner of Plot M heading down towards the creek. Twelve timber steps were installed by Argonne during the Summer 2018 to reduce erosion along the northeast trail. In 2020, four additional timber steps were installed on the steep, top portion of the northeast trail. During the Spring of 2023, additional erosion control measures at this location, such as the addition of clay and topsoil, grass seeding, followed with the placement of biodegradable turf netting, were carried out by Argonne personnel. At the time of the inspection, it was observed that the installation of the additional timber steps and erosion control measures has been effective in reducing erosion along this trail.

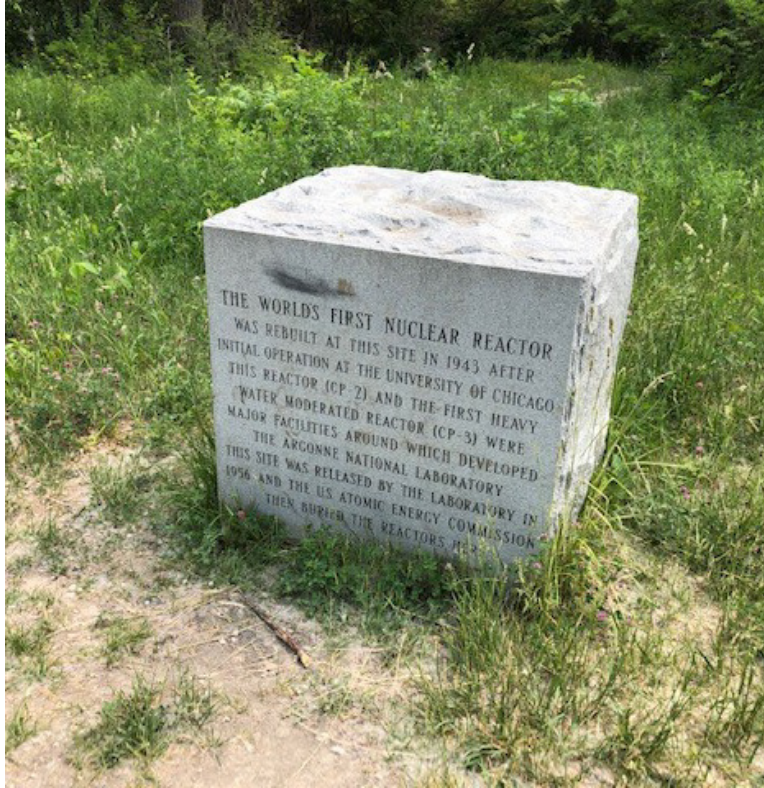
P23 – Site A Monument, Front View

The Site A monument was replaced in May 2021. Visible cracks were present in the old monument. Photographs P23 and P24 show front and rear views, respectively, of the new monument at Site A, which remains in good condition. At the time of the inspection, a small amount of graffiti, which appeared to be made using charcoal, was observed on the front and near the top surface of the Site A monument. Argonne identified this as an improvement opportunity and is further discussed in Section 5.0 of this report.

3. **Improvement Opportunity #3:** During the inspection, the front, near the top surface, of the Site A monument was observed to have been tagged with graffiti, which appeared to be made using charcoal.

Corrective Action: Argonne personnel will remove the graffiti from the front of the Site A monument prior to November 1, 2023.
