# **Thermal Hydraulic Experimental Test Article – Fiscal Year 2023 Final Report**

Matthew Weathered, Christopher Grandy, Derek Kultgen, Edward Kent, Jordan Rein, Alex Grannan, Evan Ogren

Nuclear Science & Engineering, Argonne National Laboratory

September 2023

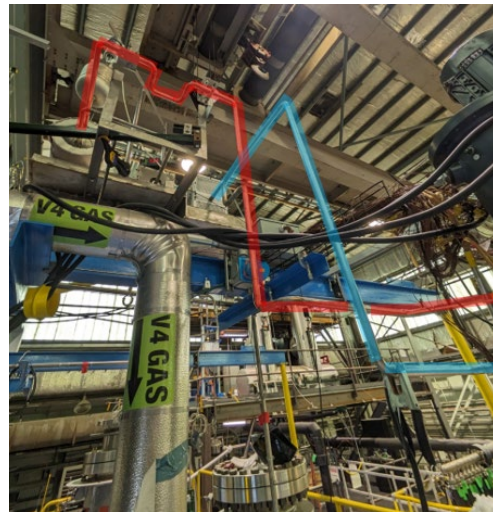
Figure 3: Photographs showing the THETA secondary system components installed on the platform structure (left) and the hot return and cold supply secondary sodium piping (right). Note the hot return and cold supply sodium pipes have been highlighted with red and blue, respectively.

The Thermal Hydraulic Experimental Test Article (THETA) is a METL vessel experiment designed for testing and validating sodium fast reactor components and phenomena. Figure 1 to Figure 3 provide drawings and photographs of the THETA primary and secondary system. THETA possesses all the major thermal hydraulic components of a pool type sodium cooled reactor. Figure 4 provides a P&ID of the THETA primary and secondary system. THETA has been scaled using a non-dimensional Richardson number approach to represent temperature distributions during nominal and loss of flow conditions in a sodium fast reactor (SFR) [1]. THETA was designed in collaboration with systems code experts to inform the geometry and sensor placement to acquire the highest value code validation data.

The secondary system process piping was installed, consisting of ¾” and ½” SCH40 316/L dual certified and 316H stainless steel piping Figure 3. Nondestructive examination of all the welds was performed, Figure 62. A mass spectrometer leak detection was performed by pulling a vacuum of 14 millitorr on the piping and secondary components. No detectable leaks above  $1 \times 10^{-8}$  atm-cc/sec were measured with helium tracer gas. Dye penetrant examination was also performed on the welds by Argonne’s Central Shop’s quality assurance department. In addition, all piping welds were radiographed; some of the piping sections were able to be bench top welded which facilitated radiography to be performed offsite. However, in order to complete the piping assembly, there were 24 field welds that were required to be radiographed onsite. ANL engineers coordinated with an outside contractor to perform the weld radiography. The contractor performed the analysis on the radiograph films in addition to a qualified ANL senior welding engineer. Two of the field welds were determined to be unacceptable due to misalignment of the piping; these welds were replaced, and radiography performed again to ensure they passed.

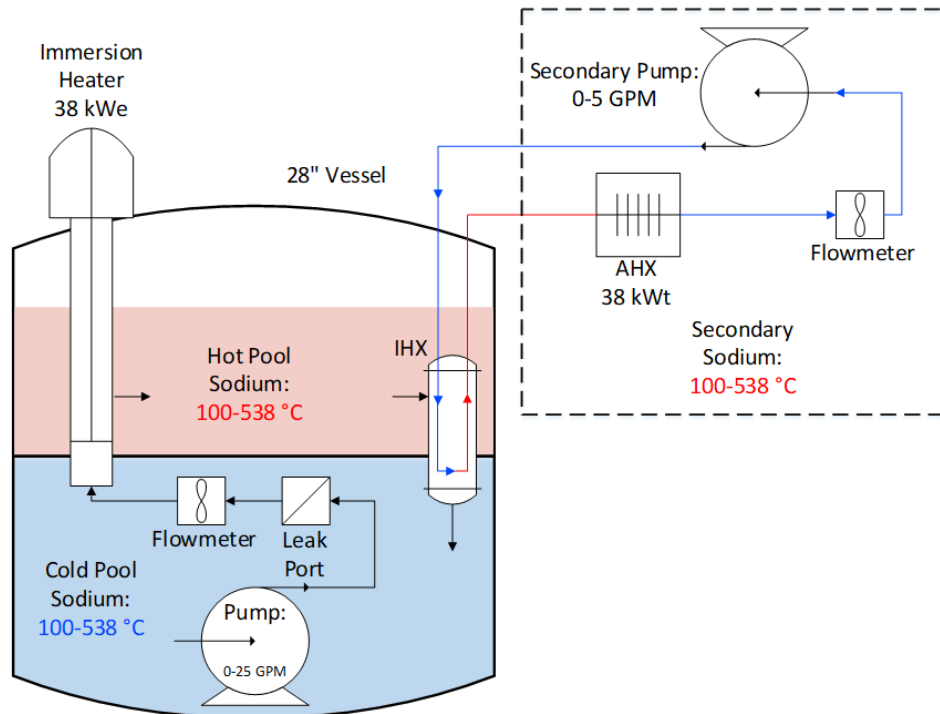
Figure 4: P&ID schematic of THETA

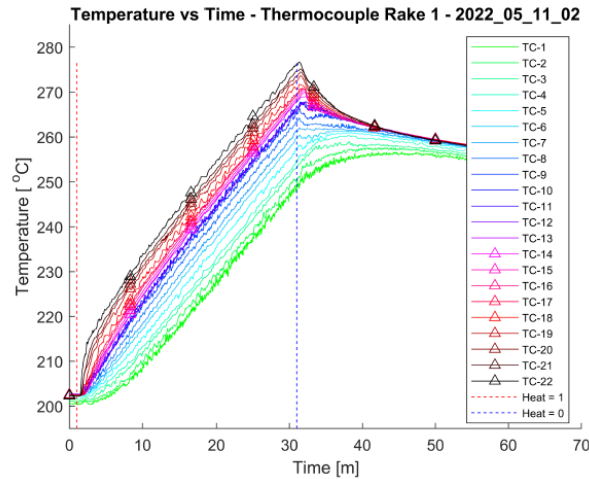
Figure 5: Temperature response during a thermal stratification transient test in THETA. Conditions for test included as Test #1 in Table 1. Thermocouples are part of a single vertical multi-junction probe spanning the cold and hot pools. Thermocouples are numbered in sequential order starting with TC-1 at the bottom of the cold pool. TC-14-22 are in the hot pool and include a triangle marker on the plotted line for clarity. As can be seen a vertical red dotted line indicates the core electrical power being turned on and the blue dotted line indicates the core electrical power being turned off.

A testing campaign was completed to acquire thermal stratification data in the primary system. A portion of the testing matrix which includes ~12 tests was included in Table 1 for reference. During these tests the pump was set to a constant speed and the hot and cold pools were brought to an isothermal condition of around 200 °C. During the entirety of the tests, the vessel heaters were either turned off or set to maintain a quasi-adiabatic condition, balancing heat loss from the outside of the vessel insulation with heat input from the vessel band heaters. A transient was then initiated where the immersion heater was brought to 100% duty cycle (38 kWe), creating thermally stratified hot and cold pools. After a period of 30 minutes the immersion heater was turned off and the thermally stratified volumes returned to their isothermal condition over a period of 30 minutes. This testing was used for validation data to tune systems code and was used to determine required upgrades needed in the primary system cold pool component insulation, as will be discussed. A plot showing the hot and cold pool thermocouple response for one Test #1 from Table 1 has been included in Figure 5. As can be seen, the hot and cold pools become stratified quickly after turning on the core immersion heater and return to their isothermal condition when the core is turned off.

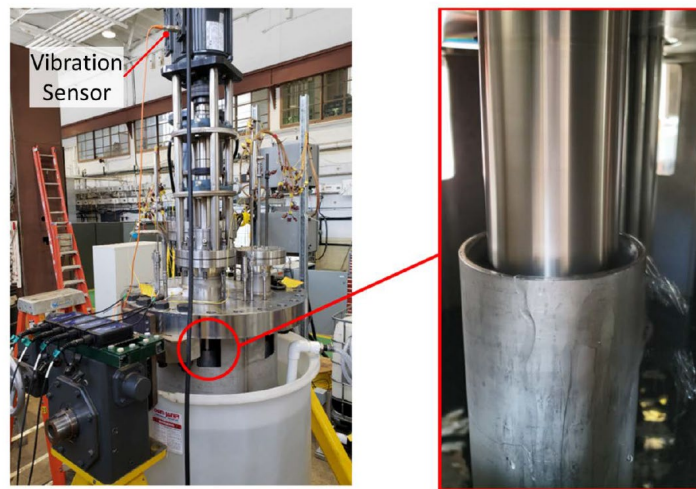
Figure 6: Photo showing water escaping the top of the column pipe

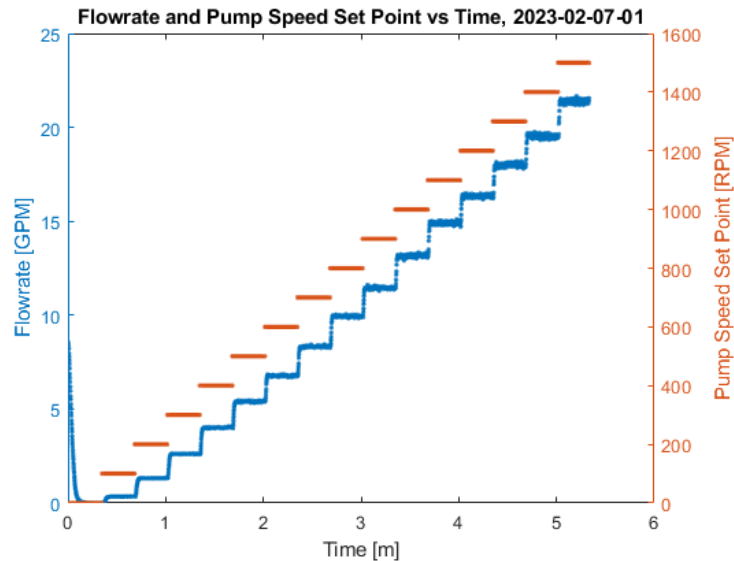
Figure 9: Sodium flowrate and pump speed as a function of time.

The pump speed was increased from 0-1500 RPM in 100-RPM increments for a period of 20 seconds for each increment. The test described herein was labeled test number 2023-02-07-01. A plot showing the pump speed set point and flowrate as a function of time has been included in Figure 9. As can be seen during the first 10 seconds of the test the flowrate is reduced from around 7.5 GPM to zero GPM, this is because the pump was running for a period of 1 hour before commencing this test to ensure isothermal temperature throughout the system. A plot showing the pump inlet temperature and flowmeter magnet temperature vs time can be found in Figure 10.

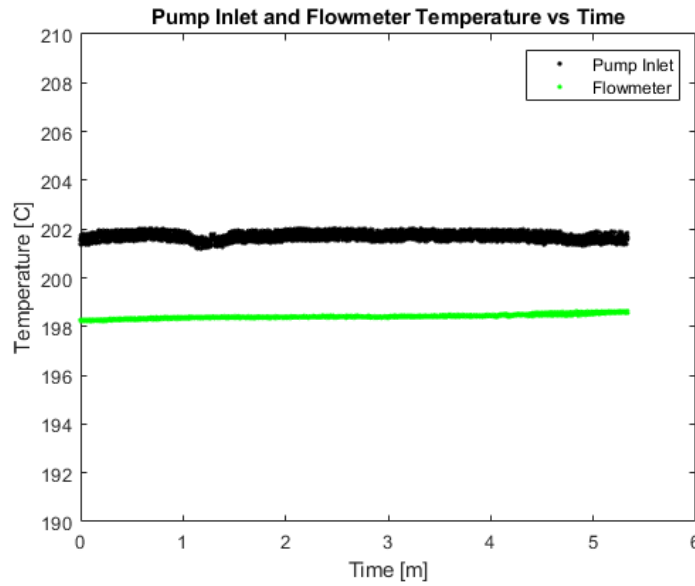
Figure 10: Pump inlet and flowmeter temperature vs time

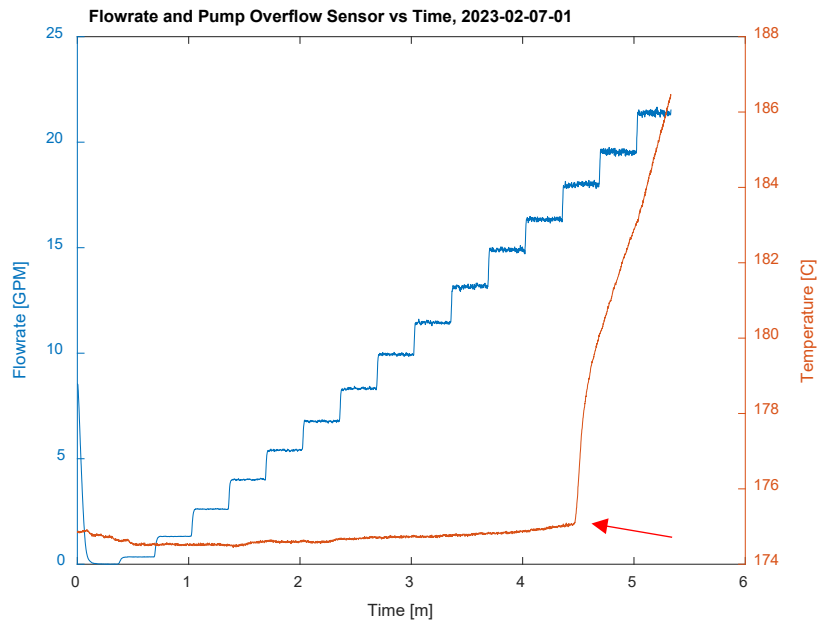
Figure 11: Sodium flowrate and pump overflow sensor temperature vs time. Red arrow pointing to the point at which sodium touches the overflow sensor temperature, indicating when sodium is leaking out of the column pipe surrounding the pump shaft.

The overflow thermocouple sensor temperature was plotted alongside the flowrate as a function of time in Figure 11. Figure 12 provides a zoomed in view of the point at which a discrete jump in overflow sensor temperature was witnessed. As can be seen, the jump occurs at flowrates at or above 18 GPM. This indicates that the maximum operating flowrate that can be conservatively maintained without risk of leaking out of the top of the column pipe is 16.5 GPM. This flowrate corresponds to a pump speed of 1200 RPM, representing the maximum pump speed for sodium at approximately 200 °C, Figure 13 and Figure 14.

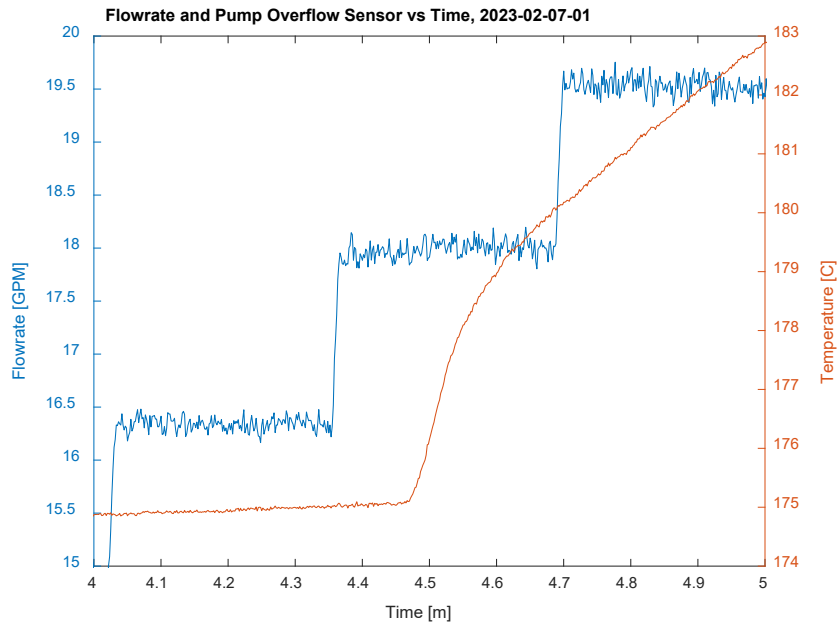
Figure 12: Sodium flowrate and pump overflow sensor temperature vs time

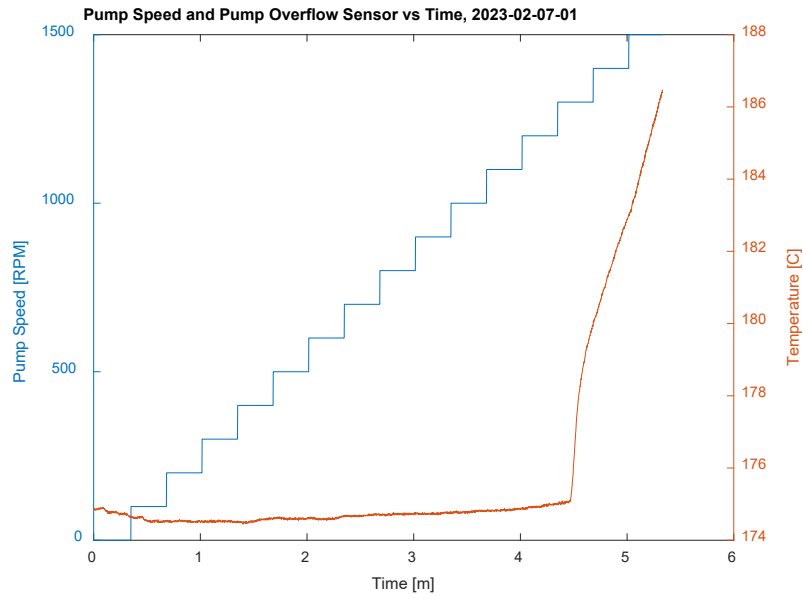
Figure 13: Pump speed set point and pump overflow sensor temperature vs time

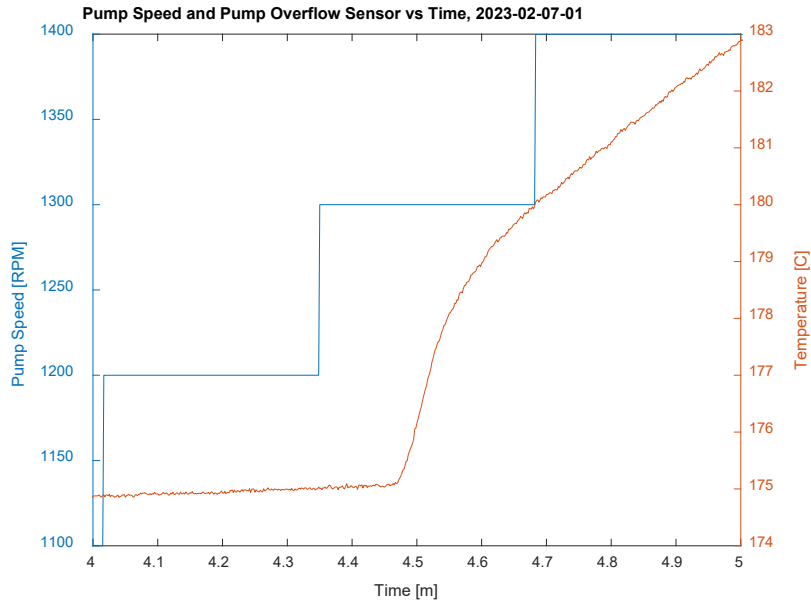
Figure 14: Pump speed set point and pump overflow sensor temperature vs time

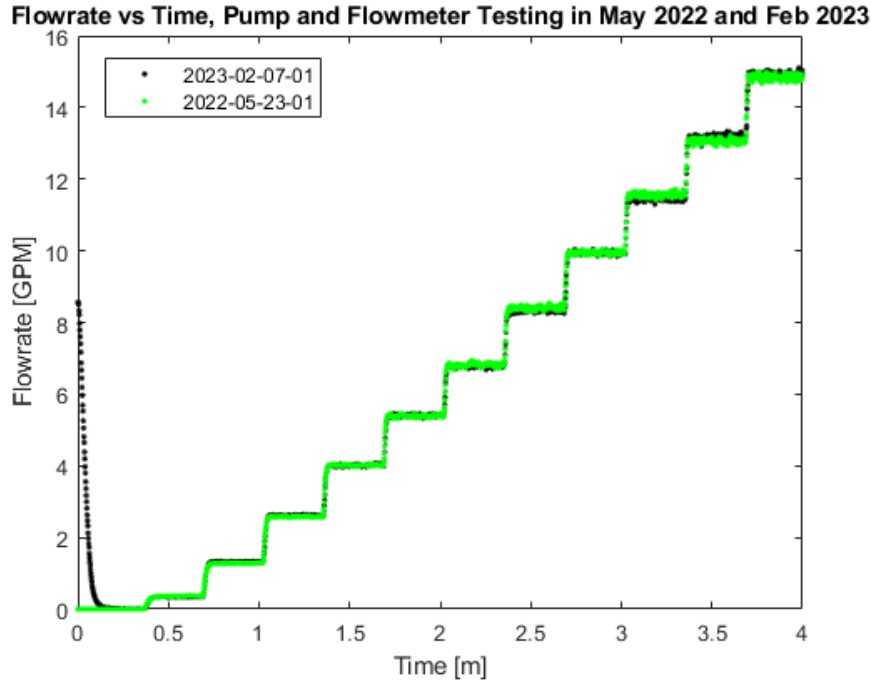
Figure 15: Flowrate vs time for identical pump speed transient demonstrating sustained performance of pump and flowmeter over a period of ~9 months. Average sodium pump inlet temperature for 2023 test: 201.7 C with a standard deviation of 0.15 C. Average sodium pump inlet temperature for 2022 test: 203.1 C with a standard deviation of 0.20 C.

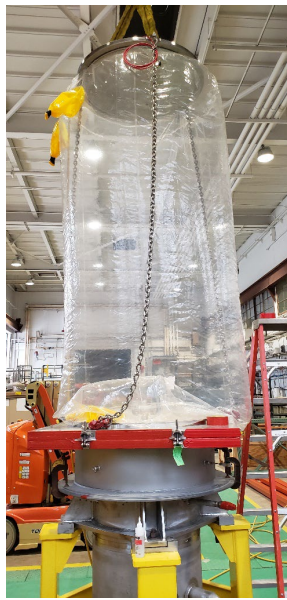
Figure 16: 28” Flexicask being tested with air to ensure glovebag and gate valve assembly gaskets are all working correctly

The METL 28” Flexicask system was assembled and tested for the first time in order to facilitate the removal of THETA. Figure 16 shows the Flexicask bottom gate, top gate, glovebag and top mounting plate being tested on a 28” flange. The glovebag was pressurized with an air compressor to just above atmospheric pressure to ensure all the sealing surfaces were gas tight. A custom plate was made to interface the Flexicask top mounting ring with a load spreader with lifting points appropriate for the THETA primary flange’s two lift points, Figure 17.

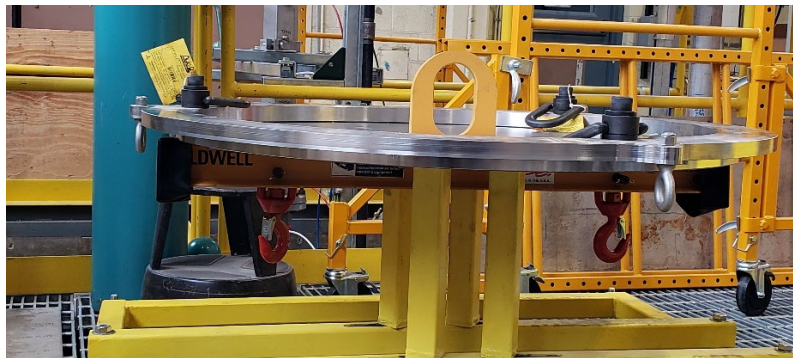
Figure 17: Custom top mounting plate was designed and installed into Flexicask assembly to accommodate a load spreader with the correct dimensions and weight rating for the THETA test article.

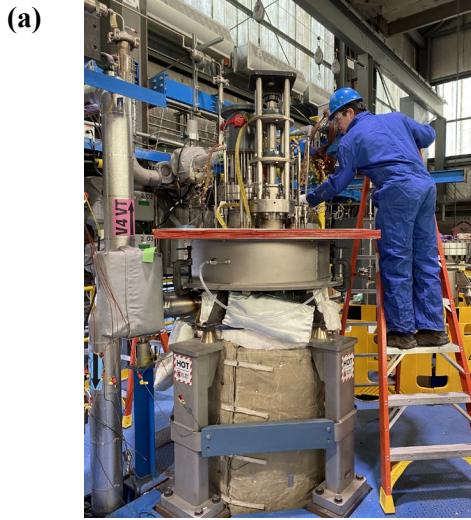
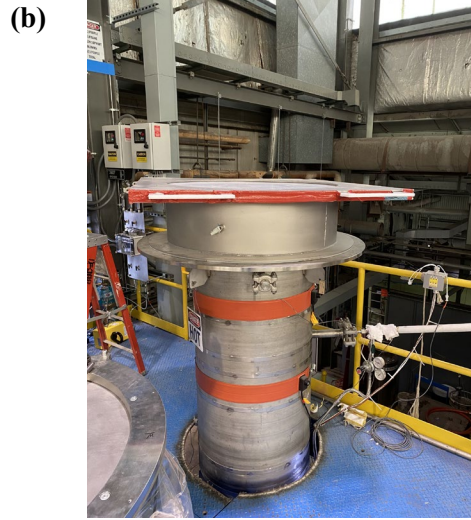
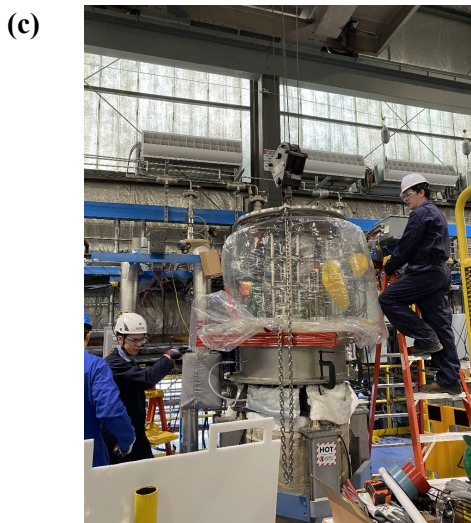
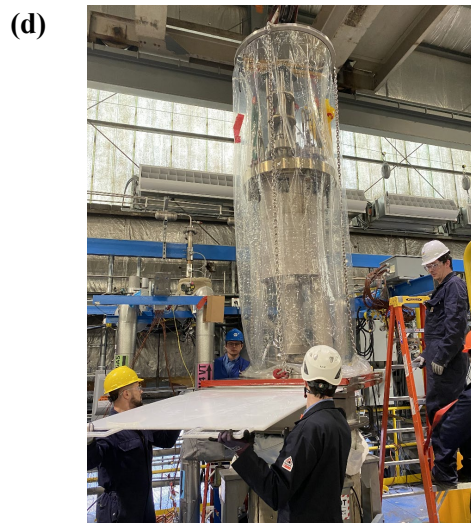
Figure 18: Operation of the 28” Flexicask system to remove THETA for carbonation. Steps have been described in detail in the text.

Figure 18 provides pictures detailing the overall steps in using the 28” Flexicask to remove THETA. As can be seen in Figure 18.a the motor on the primary pump was removed to reduce the overall height of the primary system and to move the center of gravity of the system further inward. Bottom gates were installed on both the THETA vessel and the carbonation system, Figure 18.a and Figure 18.b. Both of these vessels were then inerted with argon. The Flexicask top gate, glovebag, and mounting plate assembly with spreader bar were then rigged to the top of the THETA primary system, Figure 18.c. At this point an argon gas line was attached to the bottom gate of the Flexicask and a port on the top of the Flexicask mount plate was opened to inert the glovebag, pushing air out of the top of the system with the heavier-than-air argon gas.

The THETA system was then lifted from the vessel and the bottom gate was inserted into the bottom gate assembly to reduce oxygen ingress into the METL vessel, Figure 18.d. When the bottom of the THETA test article cleared the top gate assembly, the top gate was inserted and the two gate assemblies could be separated, Figure 18.e. The crane was then used to transport THETA, under inert cover gas via the Flexicask, to the carbonation system vessel, Figure 18.f. The top and bottom gate assemblies were attached together at the carbonation system vessel and their respective gates were removed, Figure 18.g. THETA could then be lowered into the carbonation system until the THETA primary flange mated with the carbonation system flange, Figure 18.h..

A blank flange was then picked up with the Flexicask system and the Flexicask top gate assembly was reattached to the bottom gate assembly as in Figure 18.i. The glovebag could then be inerted with argon before removing the bottom gate to facilitate lowering the blank 28” flange onto the METL vessel to seal the system. Finally, the blank flange was bolted to the vessel to maintain an inert environment while THETA was being upgraded, Figure 18.j.

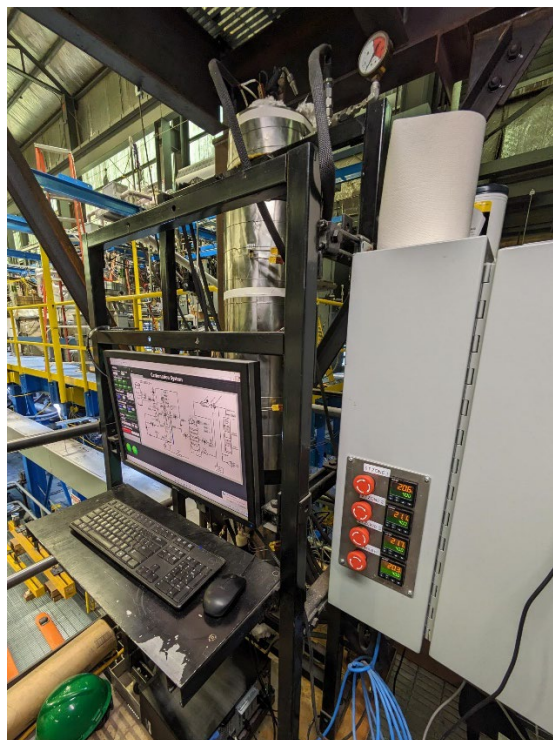
Figure 19: Photo of the carbonation system showing the control computer, process heater controllers, and CO<sub>2</sub> sparging tank.

THETA was reacted in the carbonation system for a period of 1 week with the  $\text{CO}_2$ –water sparging tank at 80-85 °C. The flowrate of the moist  $\text{CO}_2$  was varied between 5-10 SLPM. A photo of the current carbonation control system is included in Figure 19 where the sparging tank and human-machine-interface can be seen. Photos of THETA after removal from the carbonation system can be found in Figure 20 to Figure 26. As can be seen in Figure 21, large droplets of sodium that were frozen to the bottom of the inner

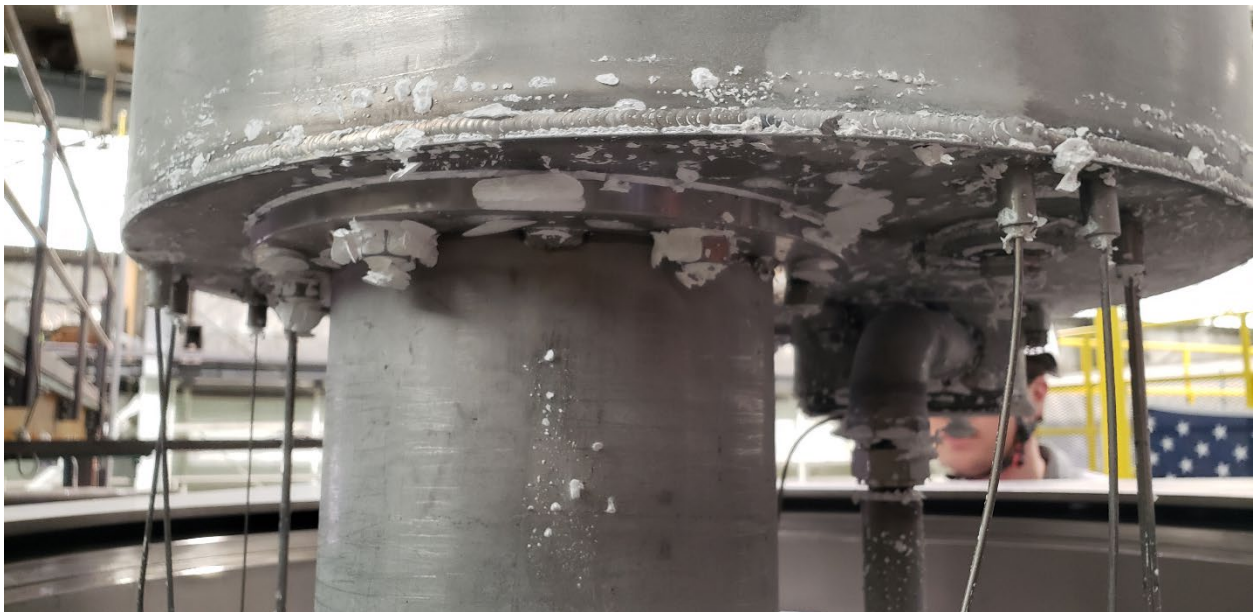
Figure 21: Photo of some of the sodium (bi)carbonate residue on the bottom of the hot pool inner vessel as THETA was being hoisted from the carbonation vessel.

vessel were sufficiently wetted to the surface that they were fixed in place during carbonation and formed sodium carbonate surface ‘stalactites’ with pure sodium cores. All the sodium that resided on horizontal surfaces were reacted as well but left some residual pure sodium beneath the carbonate, Figure 22. The carbonate was chipped off easily into a catch pan with a scraper, Figure 23. Crystalline formations were also observed on some of the carbonate surfaces, Figure 24. A large amount of sodium resided in the bottom of the hot pool but was sufficiently exposed to fully react with the carbonation process with a small amount of solid sodium remaining, as will be discussed in the next section, Figure 25-Figure 26.

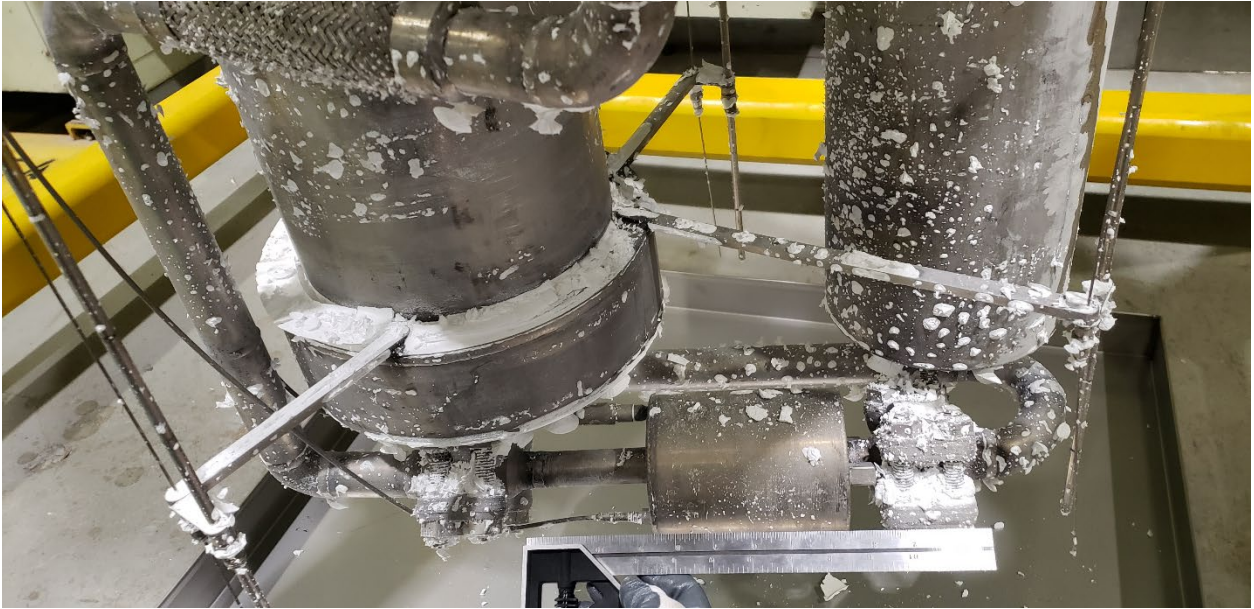
Figure 22: Photo showing sodium (bi) carbonate residue on the lower cold pool ponents.

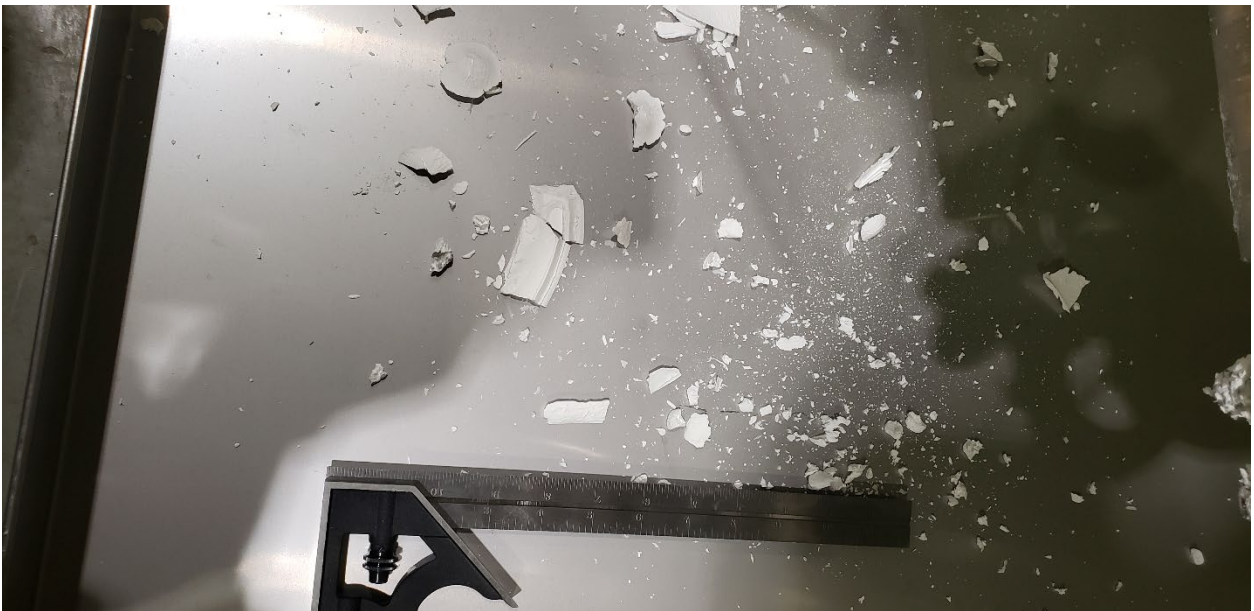
Figure 23: Photo showing sodium (bi) carbonate residue that was mechanically chipped off of the surfaces into a stainless-steel catch pan with ease. The bi(carbonate) was then processed in the METL burn stall with dry steam, wet steam, then water, all with no detectable chemical reaction.

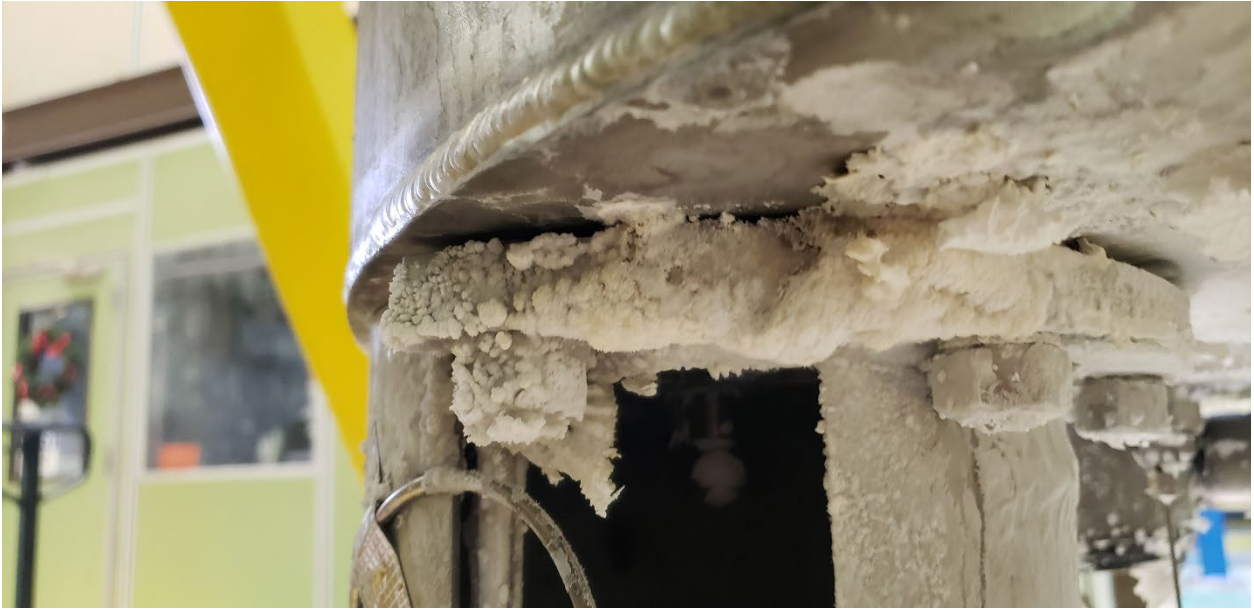
Figure 24: Photo showing some of the (bi)carbonate reaction product on the underside of the THETA inner vessel, near the outlet of the IHX. As can be seen, some crystallized formations seem to have developed during the carbonation reaction process.

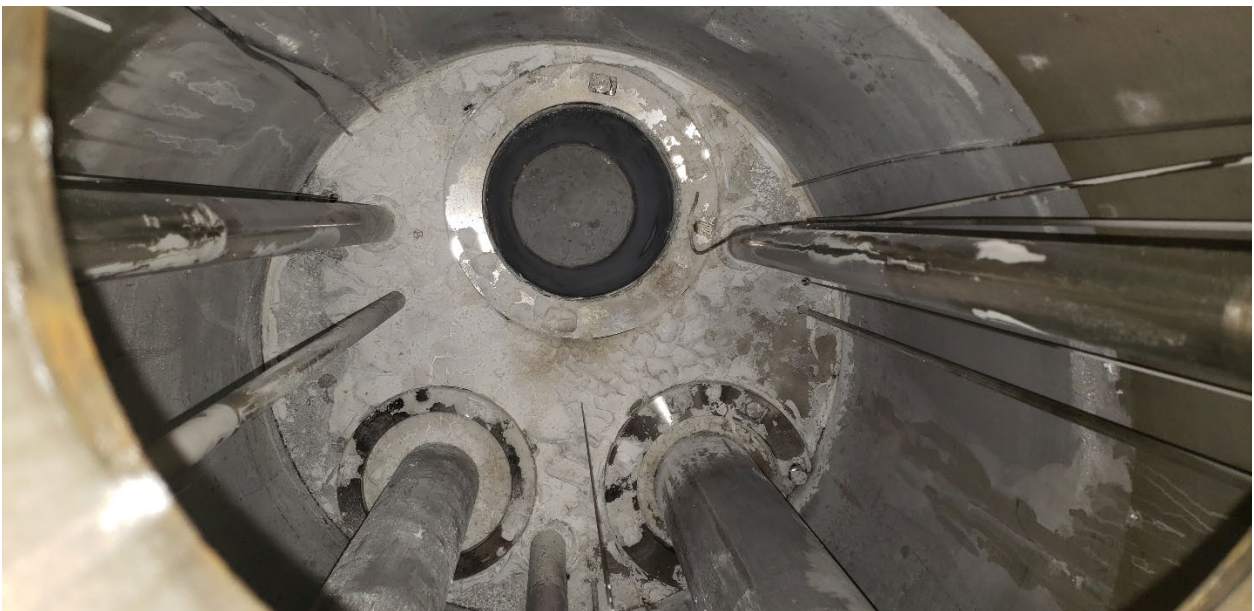
Figure 25: Photo showing the inside of the THETA hot pool inner vessel with the core immersion heater removed. The carbonation process reacted the sodium in this large cavity quite well. The bi(carbonate) was mechanically scraped and a dedicated vacuum was used to remove the biproduct into a plastic bag for sodium decontamination. Small pockets of pure sodium remained under the carbonation product which were cleaned with ethanol then deionized water.

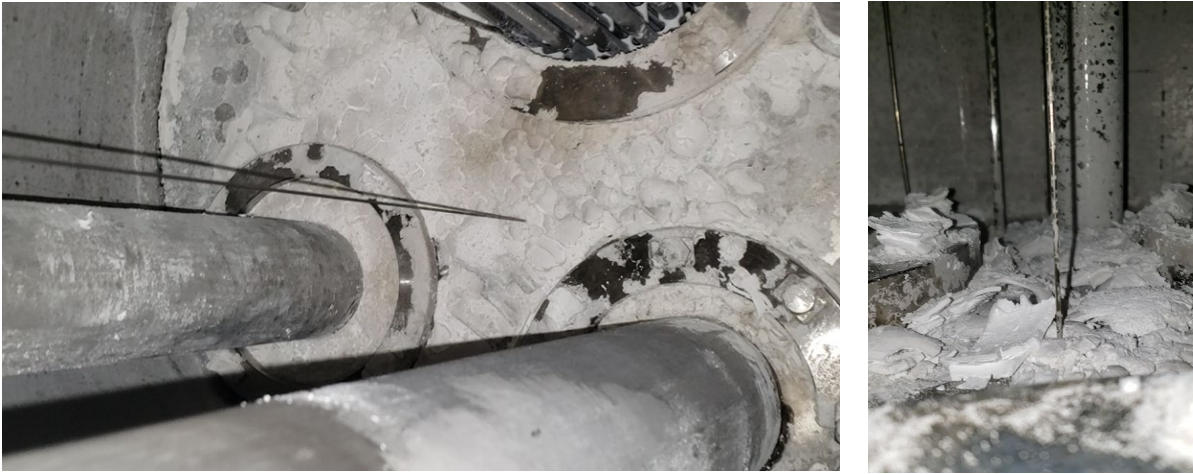
Figure 26: Photo showing a closer view of the carbonation byproduct in the inner vessel.

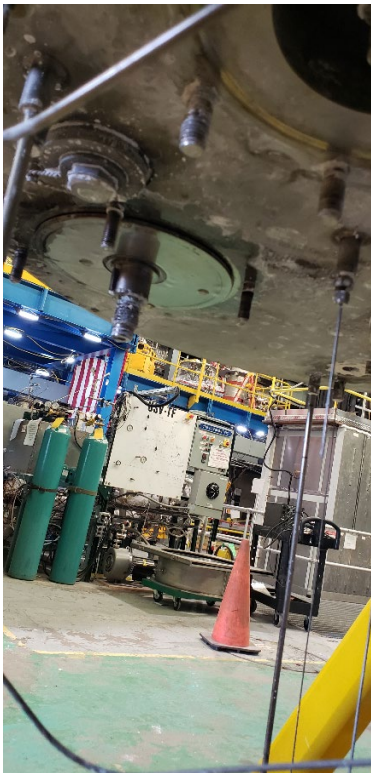
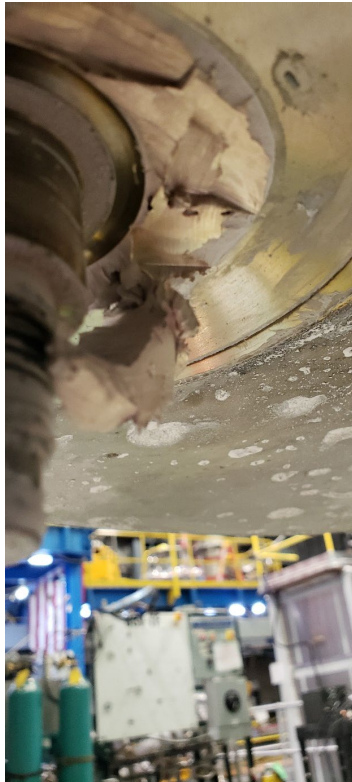
Figure 30: Labyrinth seal with pump shaft protruding, left. Labyrinth bottom plate removed and sodium scraped from the bottom of the vessel, middle. Sodium being cleaned from the shaft to allow for top portion of labyrinth seal to be removed, right.

The labyrinth seal on the pump case trapped a small volume of sodium that was mechanically scraped off and treated with ethanol and deionized water, Figure 30. The two 1” Grayloc flanges were disassembled on either side of the submerged flowmeter, Figure 31; the flowmeter could not be removed as the 1/8” mineral insulated thermocouple and induced voltage cables were fed through the bottom of the hot pool inner vessel. Solid sodium had built up around the feedthroughs on the bottom of the inner vessel, prohibiting the cables from being pulled through the bottom. Similarly, the inner vessel lower feedthroughs for the thermocouples and optical fiber capillaries were also frozen with solid sodium, thus the

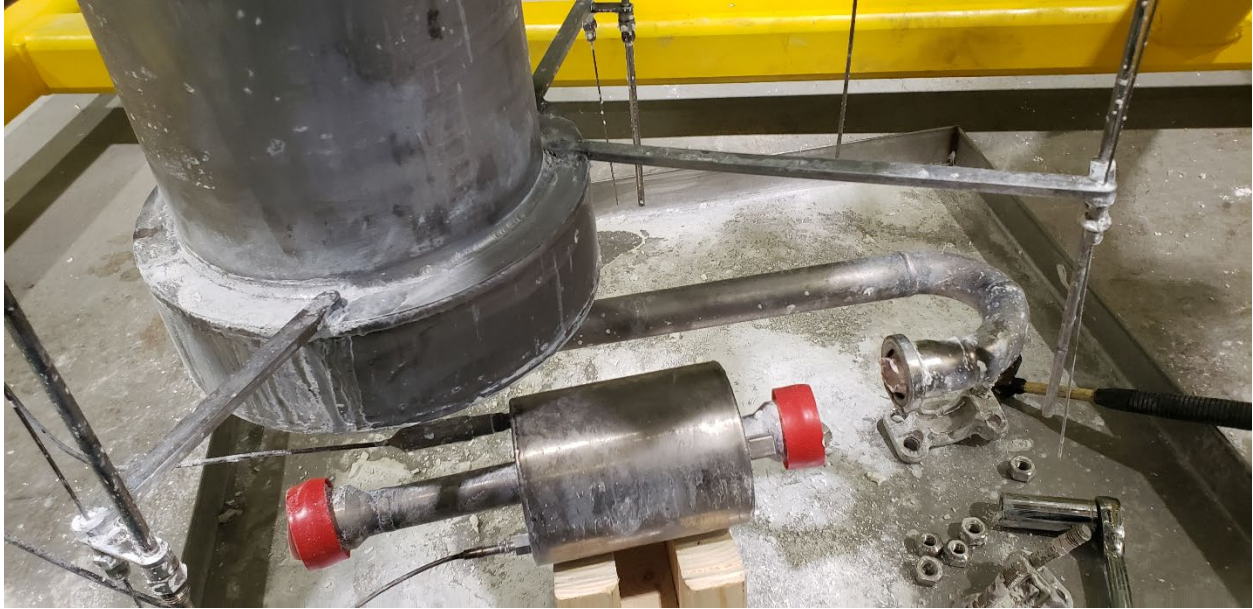
Figure 31: 1" Grayloc connections removed from either side of flowmeter.

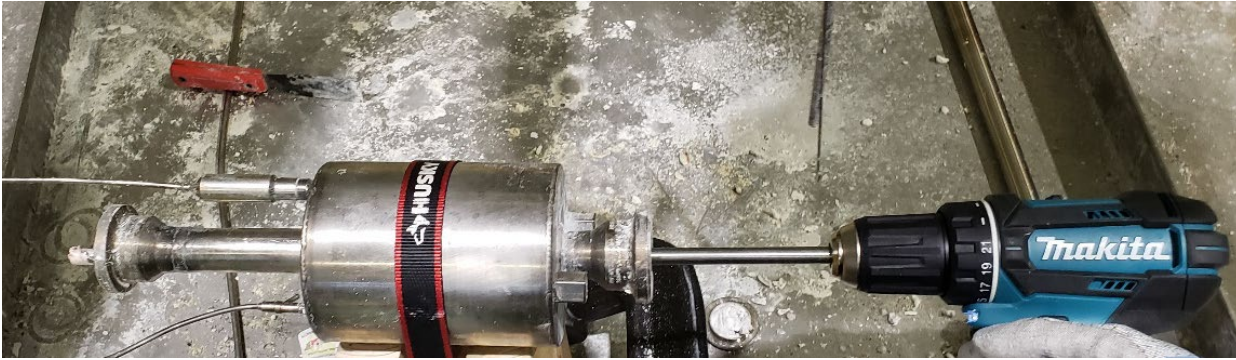
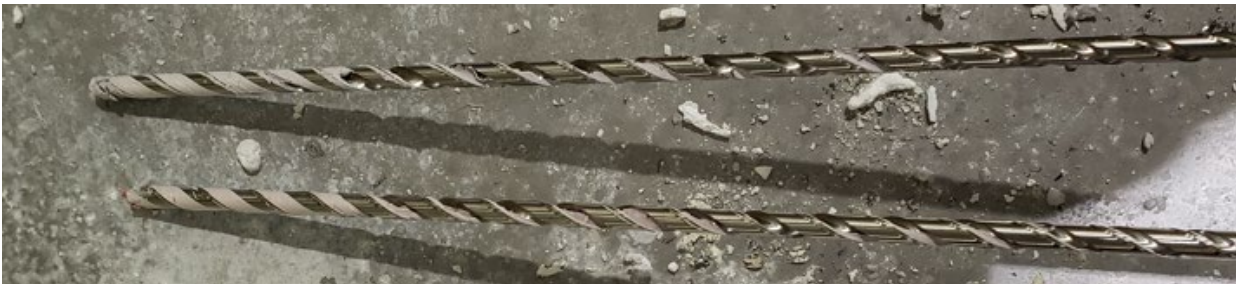
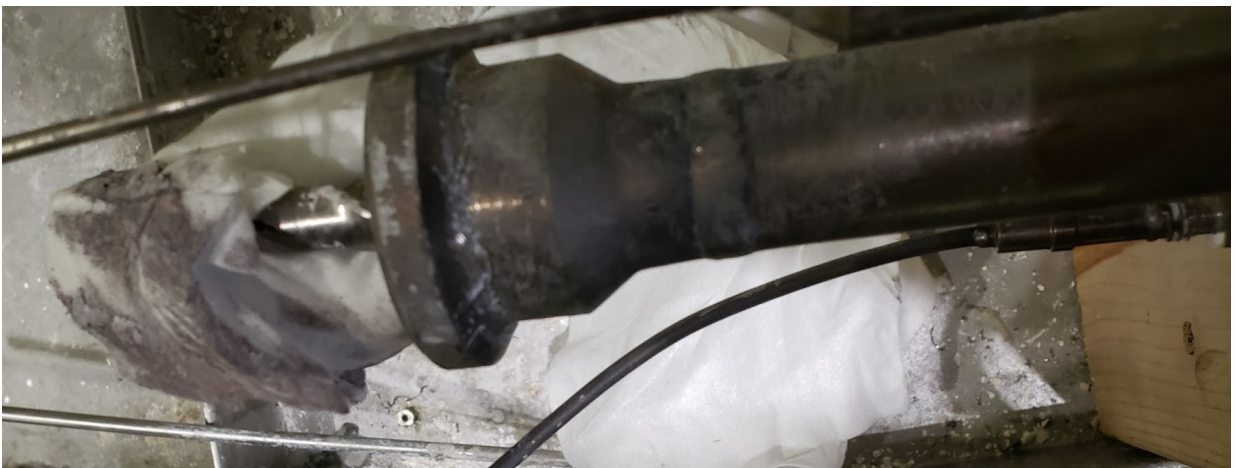
Figure 33: Drill bits were used to remove bulk sodium from the flowmeter, top. The drill bits were treated in the burn stall to remove bulk sodium from the flutes, middle. Dry lint free wipes were then used to remove loose surface sodium on the inner walls of the flowmeter, followed by lint free wipes with ethanol, then ethanol diluted with deionized water, and finally deionized water, bottom.

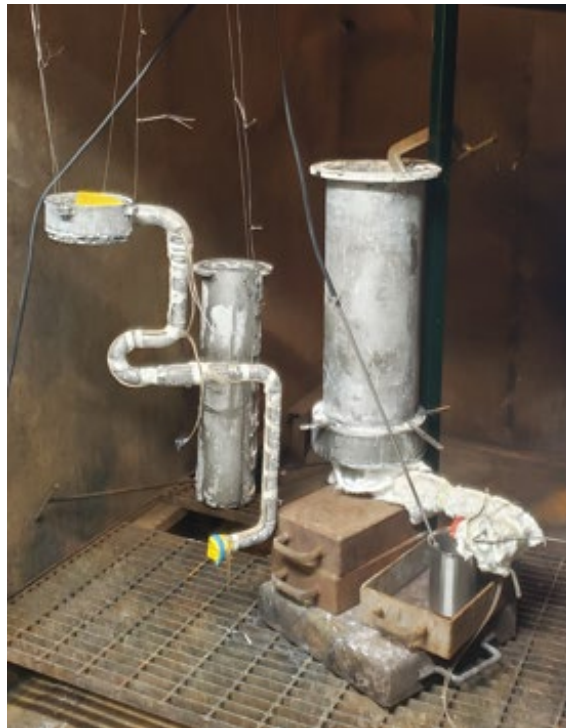
Figure 34: Photo showing the THETA cold pool components with trace heaters and insulation installed. Components oriented to facilitate drainage. Catch pan and argon gas line to inert the pan shown under core barrel piping, prepared for sodium melting.

The core barrel, pump case, intermediate heater exchanger outlet and all cold pool piping were transported to the burn stall to remove the relatively large volume of solid sodium, Figure 34. All sections of piping where solid sodium was suspected to reside were heat traced and insulated. The temperature of these sections was brought to 120 °C. A stainless steel bucket was inerted with argon and the liquified

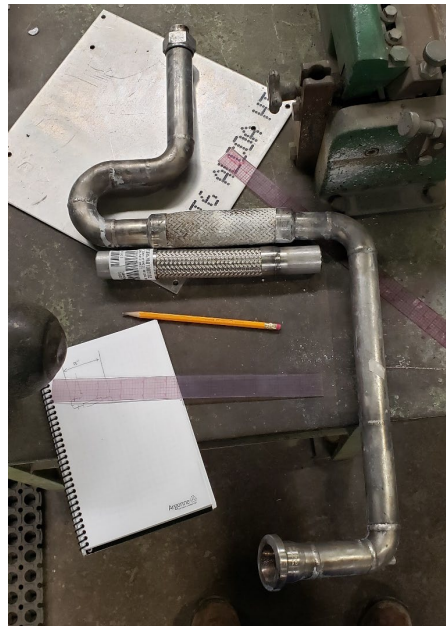
Figure 36: Swollen, damaged expansion joint shown as welded into the piping. New expansion joint that was welded in shown immediately below.

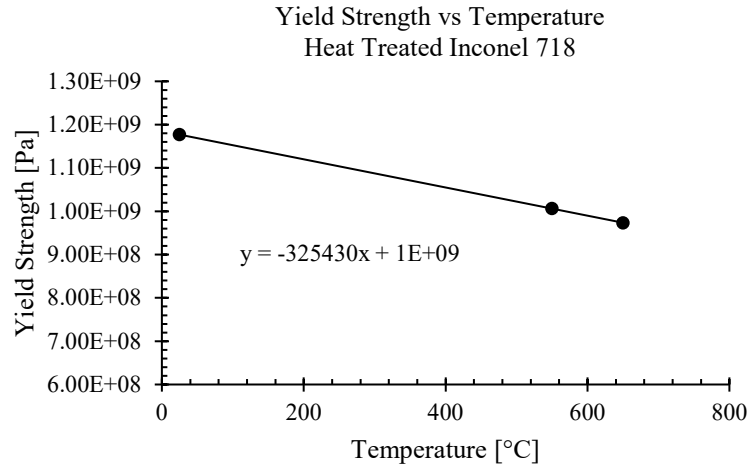
Figure 40: Yield strength of heat-treated Inconel 718 as a function of temperature. Heat treatment schedule (Table 2) and yield strength supplied by ATI Specialty Rolled Products

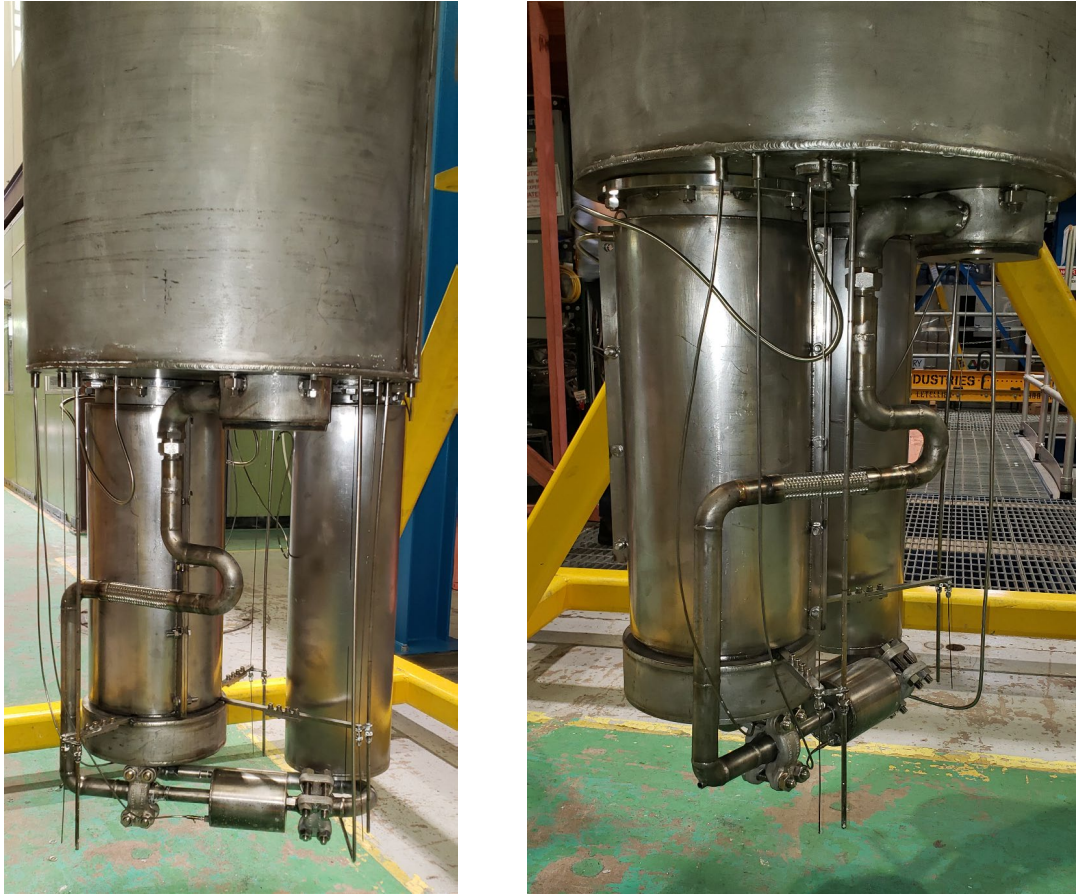
Figure 45: A photo showing the reassembled THETA cold pool components including the upgraded insulation and new thermal expansion piece that was replaced as a result of damage during carbonation volumetric expansion

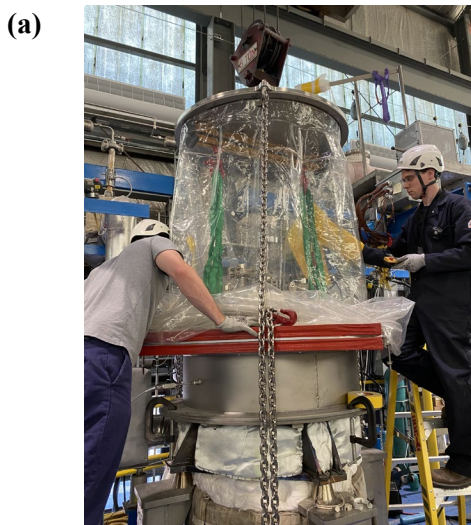
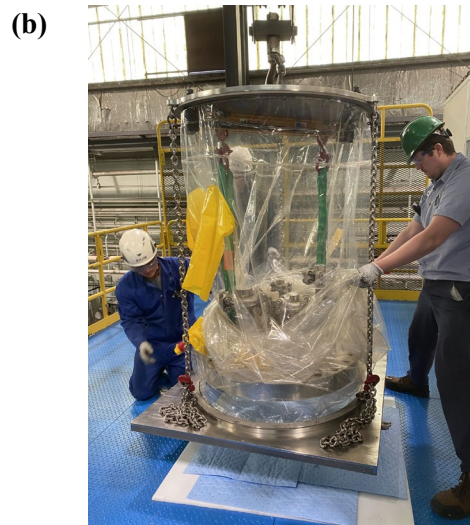
Figure 49: Operation of the 28” Flexicask system to replace THETA back into METL test vessel #4 after cleaning and reassembly. Steps have been described in detail in the text.

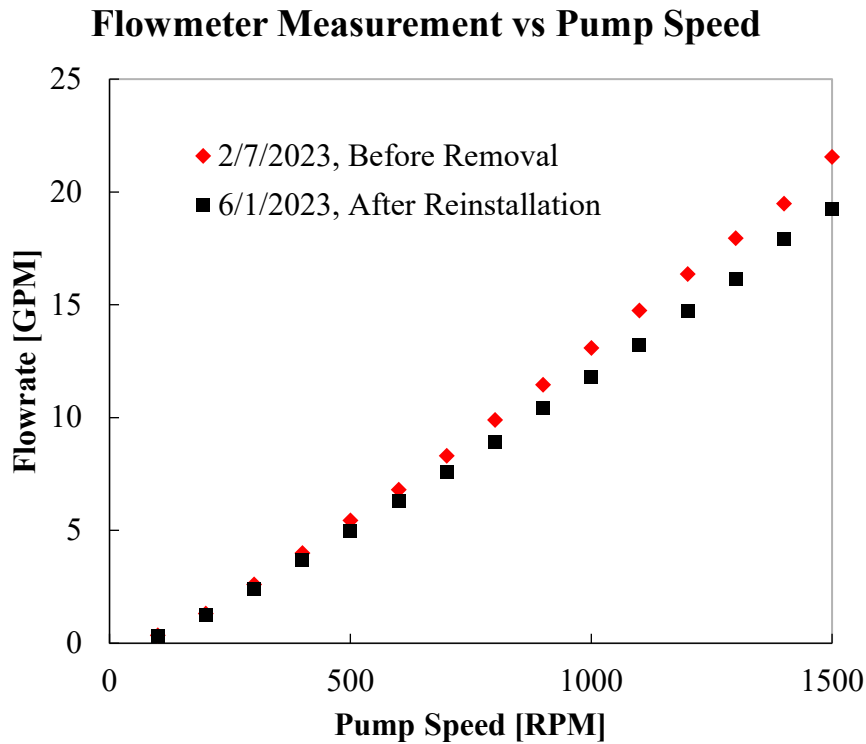
Figure 50: Measured sodium flowrate as a function of pump speed in the THETA primary system. As can be seen, there is a marked reduction in the measured flowrate, which is directly proportional to induced voltage in the electromagnetic flowmeter. Poor wetting, resulting in poor electrical conductivity on the inner pipe wall of the flowmeter, is suspected as a result of removing/replacing the test article.

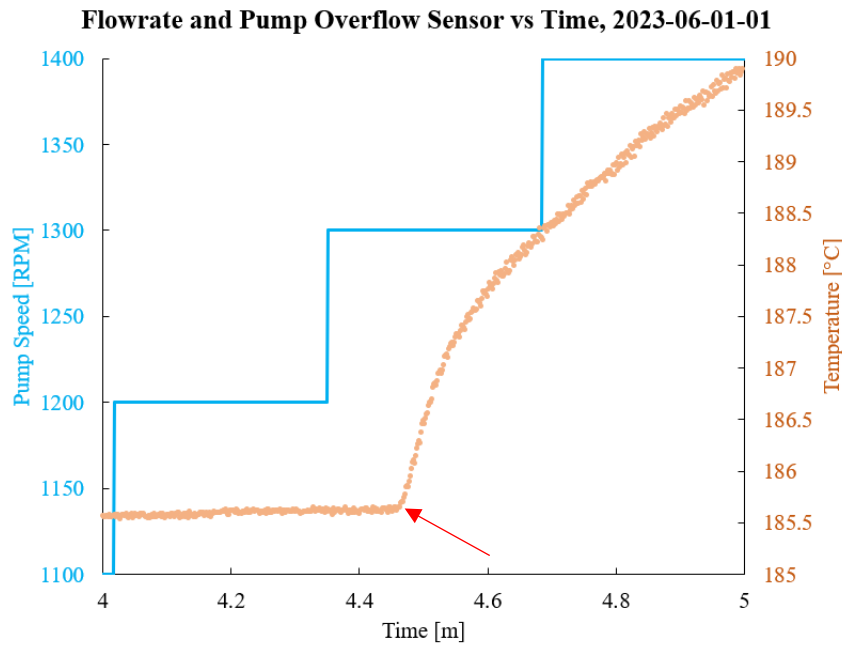
Figure 51: Pump speed and pump leakage thermocouple temperature (Figure 7) as a function of time. Pump maximum speed before leakage the same as before removal from system (Figure 14) suggesting the pump behavior/performance is similar. Red arrow shows where sodium touches the overflow thermocouple indicating a leak out of the top of the column pipe surrounding the pump shaft.
