# **Thermal Hydraulic Experimental Test Article – Fiscal Year 2023 Final Report**

Matthew Weathered, Christopher Grandy, Derek Kultgen, Edward Kent, Jordan Rein, Alex Grannan, Evan Ogren

Nuclear Science & Engineering, Argonne National Laboratory

September 2023

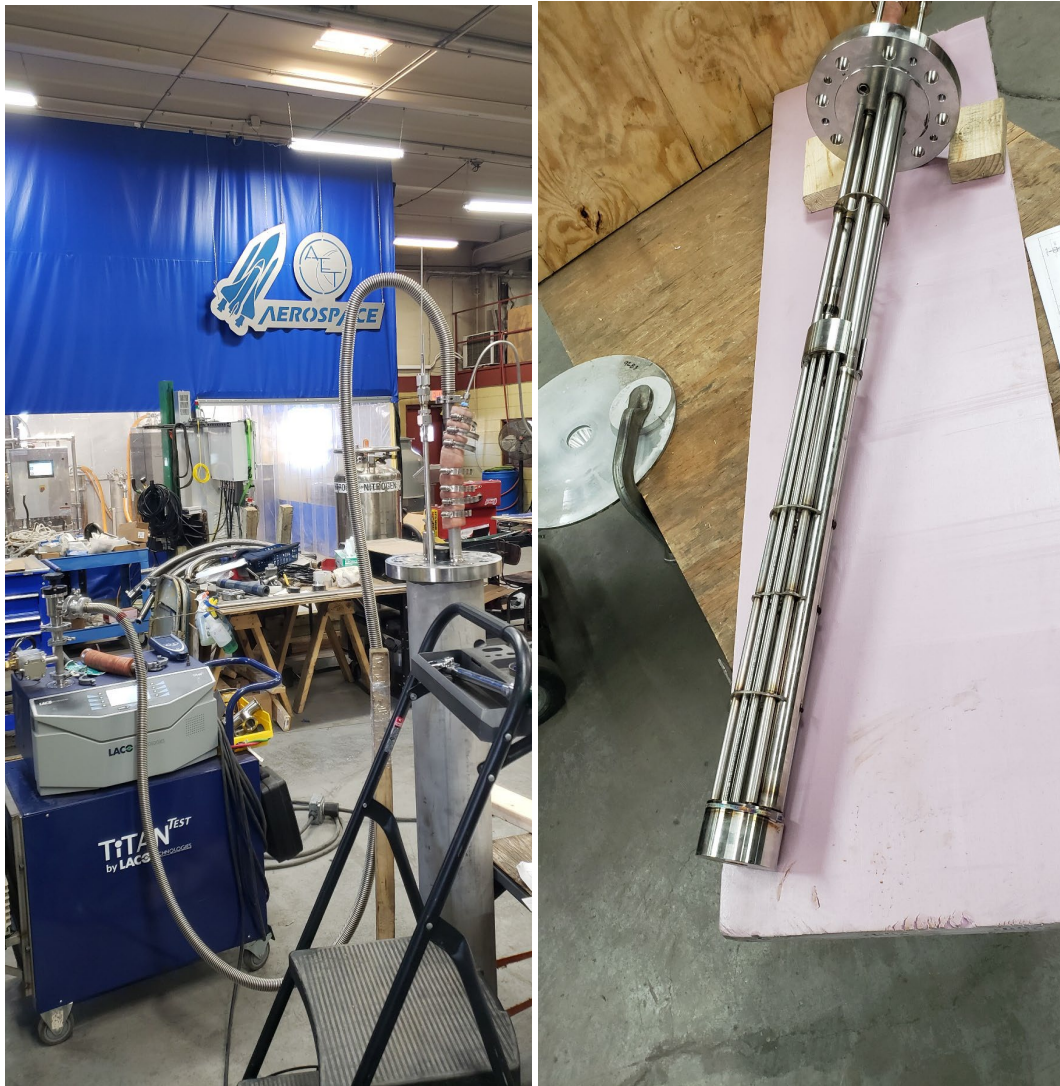
Figure 53: Photos at the IHX manufacturer before accepting the assembly. A helium leak check was performed under vacuum, as seen on left.

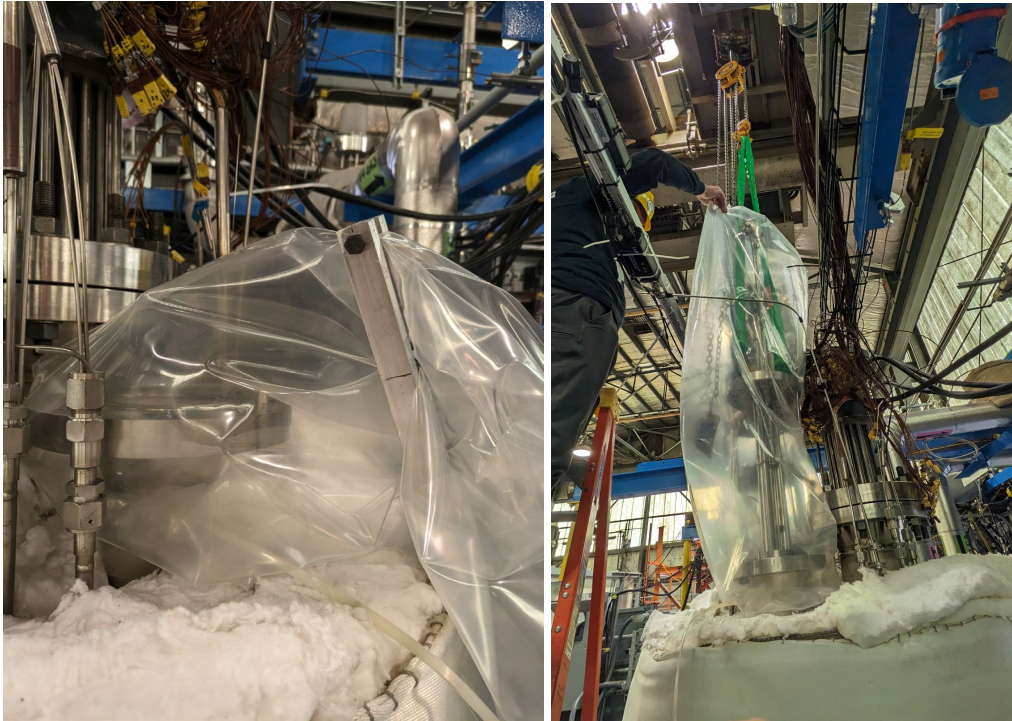
Figure 55: Photos showing the installation of the IHX with the use of the overhead crane and a custom glovebag. On the left the glovebag is being cinched shut with a custom clamp as the glovebag is being inerted with argon. On the right the assembly is being inserted into THETA.

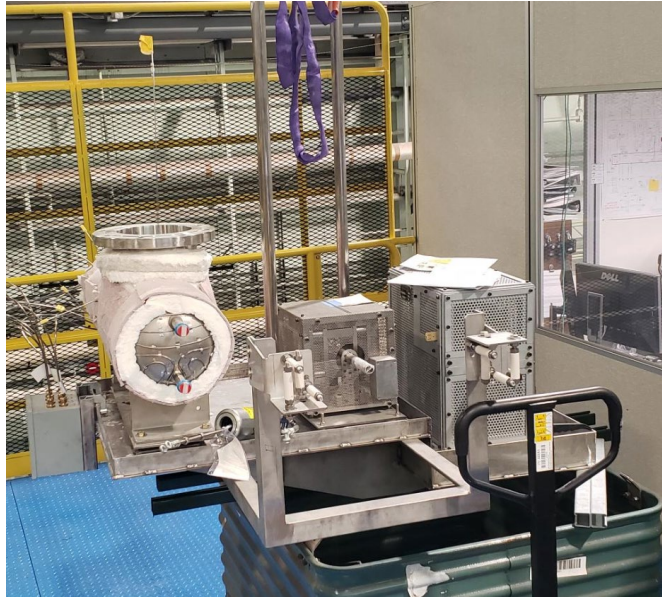
Figure 58: AHX installed on the secondary component support platform along with flowmeter and pump. The heat exchanger, flowmeter and pump were secured to the platform and hoisted as one unit to mount to the platform to the vertical support column. The components were then unbolted to allow for thermal expansion as required by ASME B31.3 piping analysis

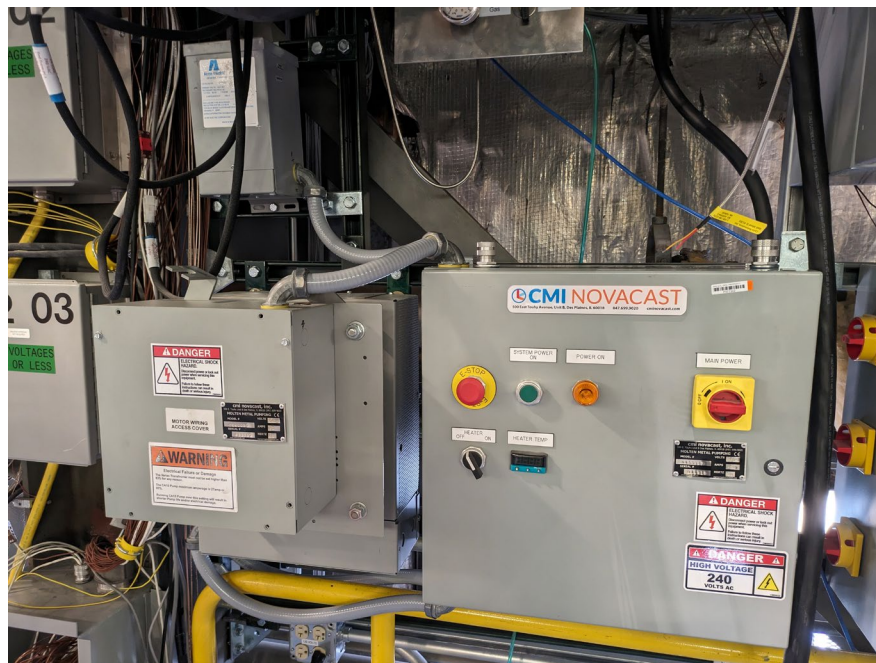
Figure 61: Three electrical cabinets installed for AC conduction pump.

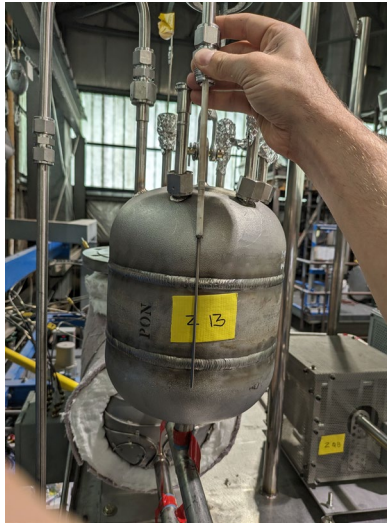
Figure 68: Expansion tank without trace heat or insulation showing the relative position of the lower conductivity probe level sensor.

1. Vacuum/gas line to control the vapor space of the expansion tank, leading to the expansion tank manifold, Figure 67.
2. Measurement thermocouple extending into the sodium space of the piping tee below the expansion tank to acquire a wetted sodium temperature of the hot sodium entering the AHX.
3. Measurement thermocouple to acquire sodium temperature in the expansion tank.
4. Measurement thermocouple to acquire vapor temperature in the expansion tank.
5. Conductivity level sensor to acquire a discrete level measurement at 3.8” above the bottom of the expansion tank, Figure 68, Figure 69.
6. Conductivity level sensor to acquire a discrete level measurement at 5.8” above the bottom of the expansion tank.
